MODEL 211.0 except CODE (413) Panoramic sliding roof

E15/3 Rear interior lamp

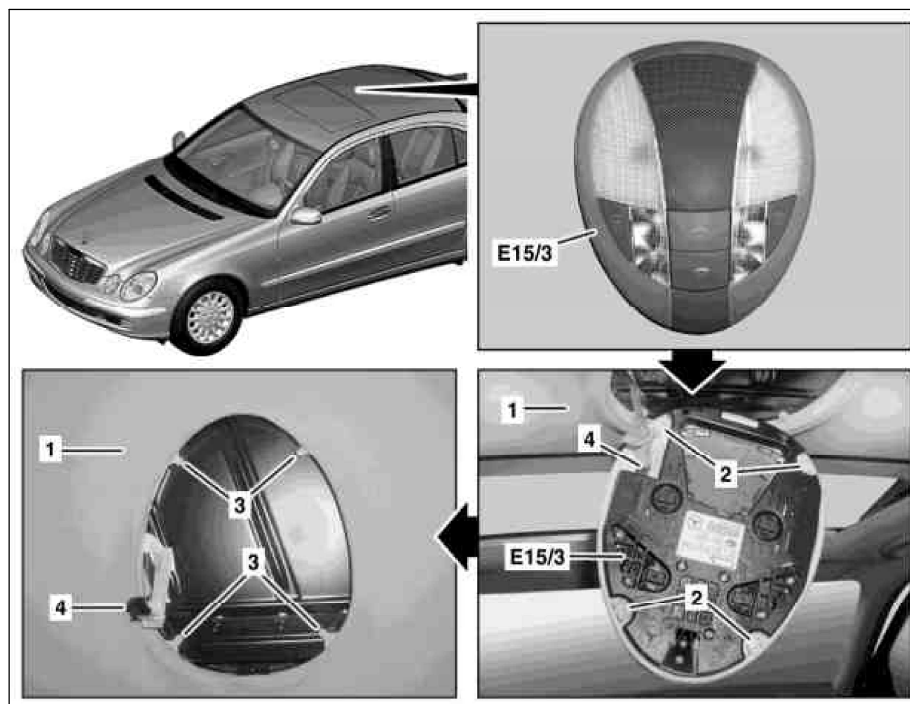
P82.20-2390-06

Shown on model 211.0

- 1 Headliner
- 2 Catch hook
- 3 Pin
- 4 Electrical connector

Remove/install		
1.1	Switch off the ignition and remove the transmitter key from the EIS control unit	On vehicles without code (889) Keyless Go	
1.2	Switch off ignition, remove transmitter key from transmission range of vehicle	On vehicles with code (889) Keyless Go	
2	Remove rear interior lamp (E15/3) using mounting wedge from headliner (1)	<ul style="list-style-type: none"> <li>⚠ Remove rear interior lamp (E15/3) carefully, as ribbon cable may be damaged.</li> <li>🔧</li> <li><b>i</b> <b>Installation:</b> make sure that the catch hook (2) latches into the notch (3).</li> </ul>	*110589035900
3	Disconnect electrical connector (4) and remove rear interior lamp (E15/3)	⚠ Carefully disconnect electrical connector (4) as ribbon cable could be damaged.	
4	Install in the reverse order
