AR72.20-P-3520GH	Remove/install tailgate liner	28.2.97
------------------	-------------------------------	---------

MODEL 163

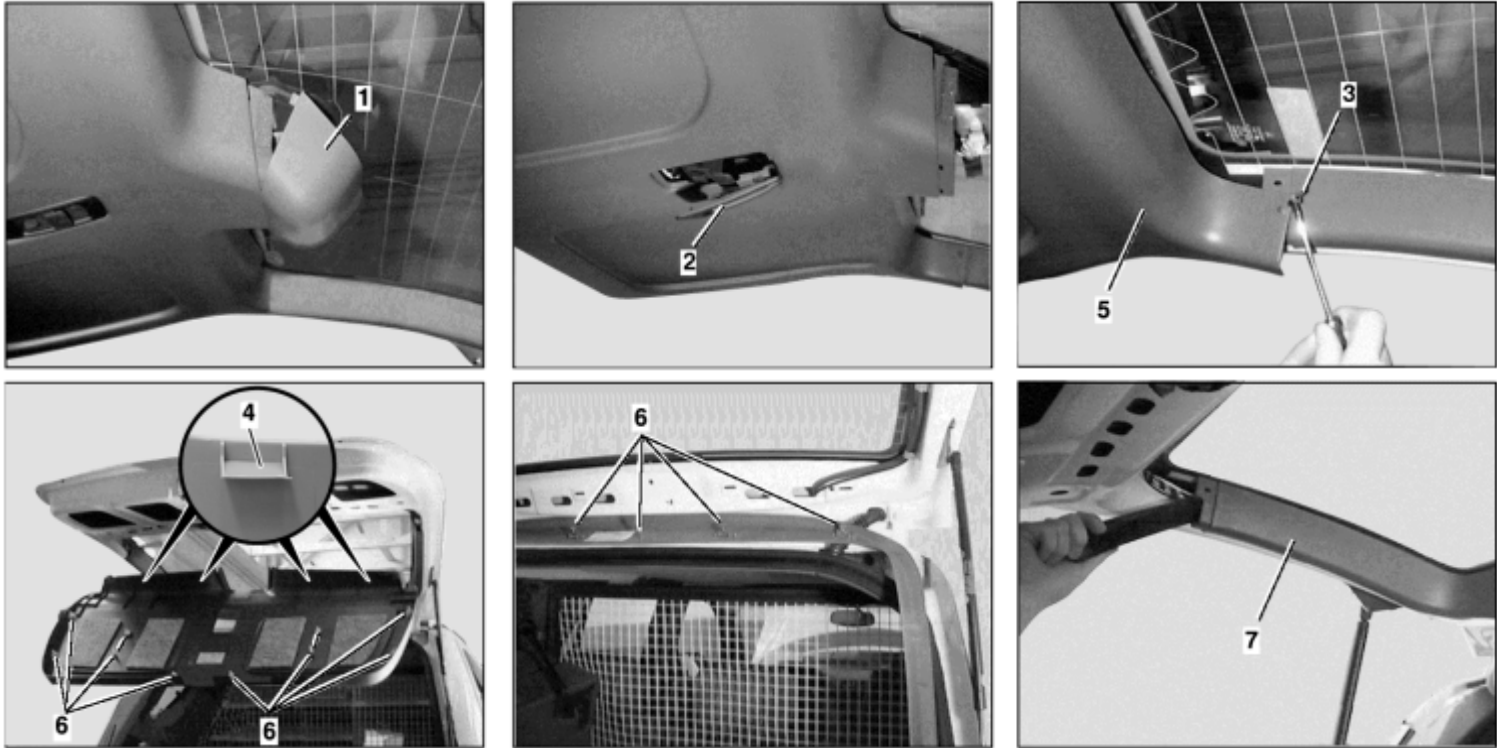
P72.20-2043-09

- 1 Cover for center high-mounted stop lamp
- 2 Door handle cover
- 3 Mounting clips

- 4 Bracket
- 5 Door liner bottom section
- 6 Clips

- 7 Door liner top section

- 8 Flaps
- 9 Bolts
- 10 Expanding rivets
- 11 Expanding anchor

Remove/install		
	<b>Risk of breakage and tearing</b> of plastic trims and corresponding clip retainers		
1	Remove cover from center high-mounted stop lamp (1)	Press cover together on left and right and tilt backward	
2	Remove cover on door handle (2)	Press cover upward and remove.	
		Assembly wedge	<a href="#">110 589 03 59 00</a>
3.1	Open flaps (8) for first-aid kit and

warning triangle	<b>i</b> As of vehicle identification number A289565, X754620.	
4.1	Remove first aid kit and warning triangle	<b>i</b> As of vehicle identification number A289565, X754620.

5.1	Unscrew screws (9)	<b>i</b> As of vehicle identification number A289565, X754620.	
6.1	Remove spreading rivets (10)	<b>i</b> As of vehicle identification number A289565, X754620. To remove body-bound rivets, completely press out pin.

7.1	Remove expanding anchor (11)	<b>i</b> As of vehicle identification number A289565, X754620. If installed. Replace expanding anchors.	
8	Unclip clip retainers (3) for door liner on both sides		
9	Pull brackets (4) out of clips on inner door panel in upper area of door liner bottom section (5)	<b>i</b> Start at center of door liner bottom section	
10	Completely unclip door liner bottom section (5) from inner door panel	<b>i</b> Position assembly wedge directly next to clips (6) As of vehicle identification number A289565, X754620: There are no longer any clips on right and left next to the door handle.	
		<b>🔧</b> Assembly wedge	<a href="#">110 589 03 59 00</a>
11	Remove door liner bottom section (5)	<b>i</b> <b>Installation:</b> Replace clips (6).	
12	Unclip door liner top section (7)	<b>i</b> Start at the left and right side. Position assembly wedge directly next to clips (6)	
		<b>🔧</b> Assembly wedge	<a href="#">110 589 03 59 00</a>

13	Remove door liner top section (7)	<b>i</b> <b>Installation:</b> Replace clips (6).	
14	Install in the reverse order
