ENGINE 112.913 in MODEL 211.061 /261

ENGINE 112.949 in MODEL 211.065 /265

Shown on AIR management control system with actuator motor

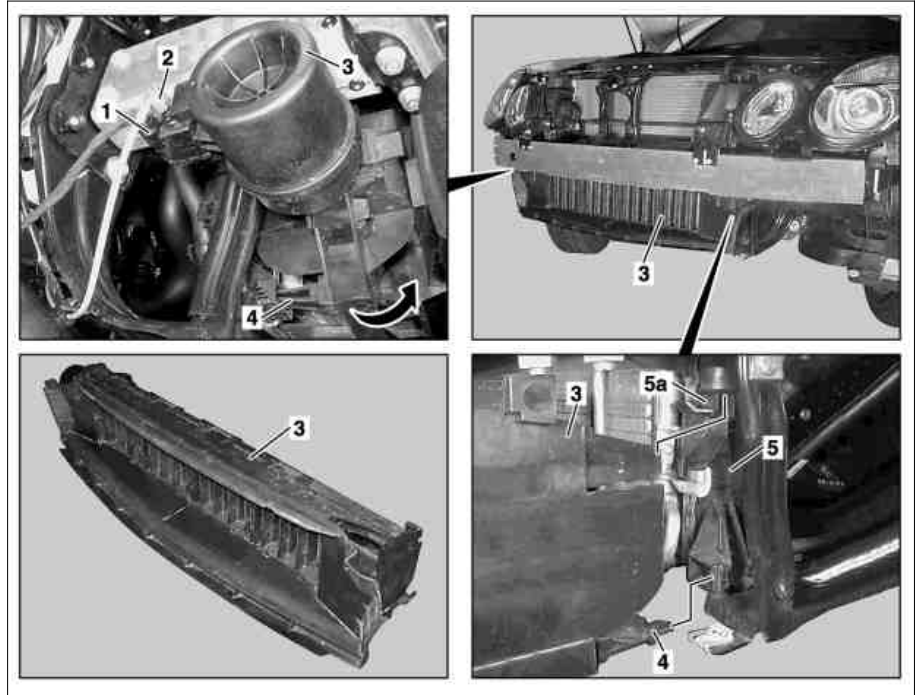
P20.20-2128-06

- 1 Electrical connector
- 2 Pneumatic line
- 3 Air control system
- 4 Detent
- 5 Radiator
- 5a Lug

☒ ☒	Remove/install		
⚠ Danger!	Risk of death caused by vehicle slipping or toppling off the lifting platform.	Align vehicle between columns of vehicle lift and position four support plates at vehicle lift support points specified by vehicle manufacturer.	AS00.00-Z-0010-01A
1	Remove front bumper		AR88.20-P-2000T
2	Disconnect electrical connector (1)	Vehicles with AIR management control system with actuator motor	
3	Detach pneumatic line (2) from AIR management control system (3)	Vehicles with AIR management control system with actuator motor	
4	Unlock left and the right catch (4) and turn the AIR management control system (3) in the direction of the arrow		
5	Drive out the AIR management control system (3) from the catches (5a) of the radiator (5) in the downward direction	<p>i If the AIR management control system (3) is replaced then only the air duct without actuator motor with number A 221 505 07 30 is available. In this case close the pneumatic line (2) with a rubber cap with the number A 604 070 02 55 and fix together with the electrical connector (1) by means of a cable tie.</p>

6	Install in the reverse order		
7	Connect STAR DIAGNOSIS and set coding to "Radiator shutters not installed"	<p>When replacing the AIR management control system (3) with actuator motor by one without actuator motor</p> <p>i Coding takes place in the control unit menu → Body → signal acquisition and actuation module for front passenger → Inert gas adaptation → Read coding and alter if necessary.</p>
