MODEL 211.0/ 2/ 6

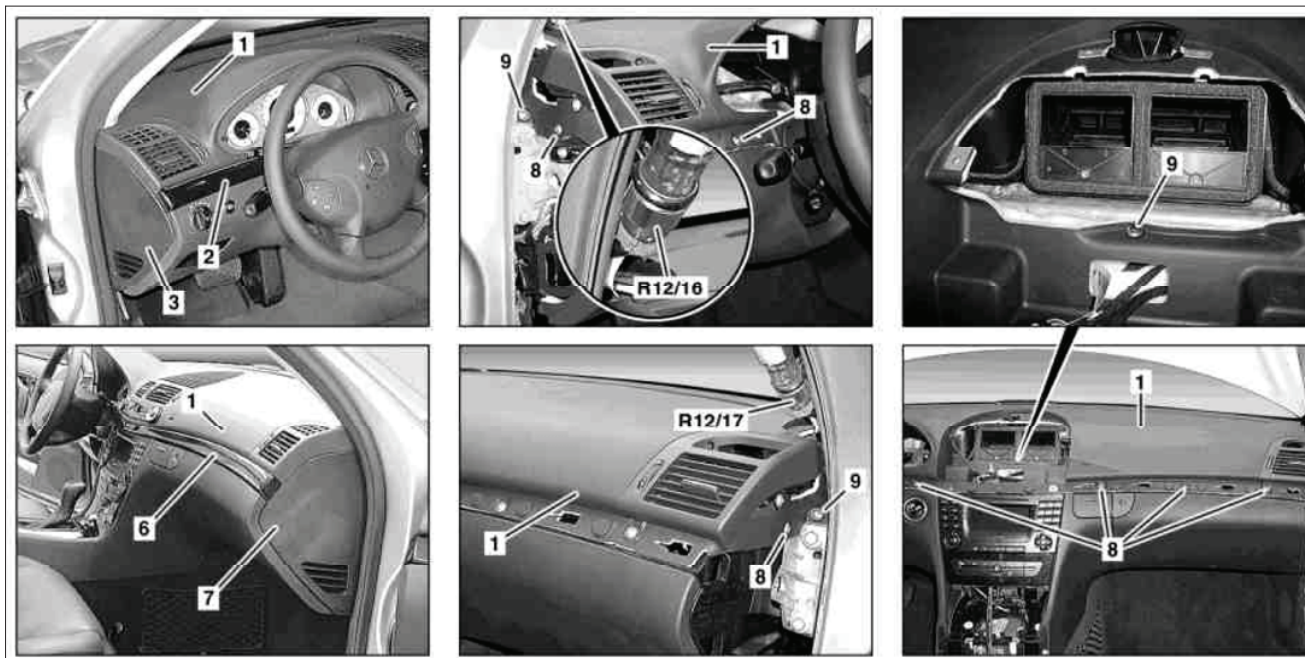
P68.10-2988-09

- 1 Instrument panel upper section
 2 Left trim strip
 3 Left cover
 6 Right trim strip

- 7 Right cover
 8 Bolts
 9 Bolt

- R12/16 Left front window bag squib (on model 211.0 and 211.2)
 R12/17 Right front window bag squib (on model 211.0 and 211.2)

Remove/Install		
1	Remove instrument cluster		AR54.30-P-6015T
2	Remove paneling from left A-pillar		AR68.30-P-4050T
3	Unclip left cover (3) with mounting wedge		*110589035900
4	Remove left trim strip (2) from instrument panel.		AR68.10-P-1180T
5	Remove paneling on right A-pillar		AR68.30-P-4050T
6	Unclip right cover (7) with mounting wedge		*110589035900
7	Remove right trim strip from instrument panel		AR68.10-P-1180T
8	Remove front pushbutton control module		AR83.40-P-6350T

9	Remove bolts (8)		
⚠ Danger!	Risk of fire and explosion caused by machining/treating magnesium components	Keep away from ignition sources and open flames.	AS60.00-Z-0006-01R
10	Remove bolts (9)	i The cross member below the instrument panel into which the bolts (9) are screwed, consists of a magnesium alloy.	
ⓘ	Notes on processing magnesium components		AH60.00-P-0023-01R
11	Lift instrument panel upper section (1) and disconnect electrical connectors (4) from air nozzles (5)		
12	With the help of a second person, detach instrument panel upper section (1) from the right side to the rear of the cross member under the instrument panel	ⓘ On model 211.0 and 211.2 carefully move instrument panel bottom section (1) along right A-pillar. Otherwise the electrical connector on the right front windowbag squib (R12/17) can break. i On vehicles with code (220a) Parktronic system (PTS), remove only until electrical connector (arrow) on center instrument panel PTS warning display (A44/4) is accessible.

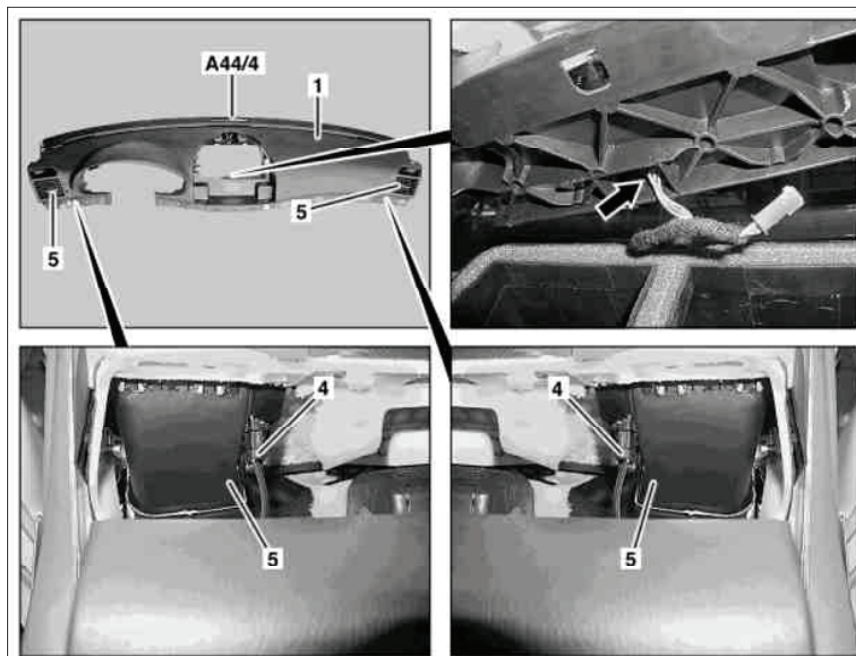
P68.10-2726-06

- 1 Instrument panel upper section
 4 Electrical connector
 5 Air nozzle

A44/4 PTS warning display, center of instrument panel

13.1	Disconnect electrical connector (arrow) from the center instrument panel PTS warning indicator (A44/4)	On vehicles with code (220a) Parktronic system (PTS) i While disconnecting the electrical connector, the instrument panel upper section (1) must be held by a second person.	
14	With the help of a second person, detach instrument panel upper section (1) from the left side to the rear from the cross member under the instrument panel and remove out of the vehicle	ⓘ On model 211.0 and 211.2 carefully move instrument panel bottom section (1) along left A-pillar. Otherwise the electrical connector on the left front window bag squib (R12/16) can break.	
15	Install in the reverse order
