Campaign No. 2020040011, June 2020

SUBJECT: **Models C-Class, CLK-Class, E-Class, and CLS-Class (203, 209, 211, and 219 platform)**
Model Years 2001-2011
Sliding Roof Bonding - Phase 2

Check/test procedure A

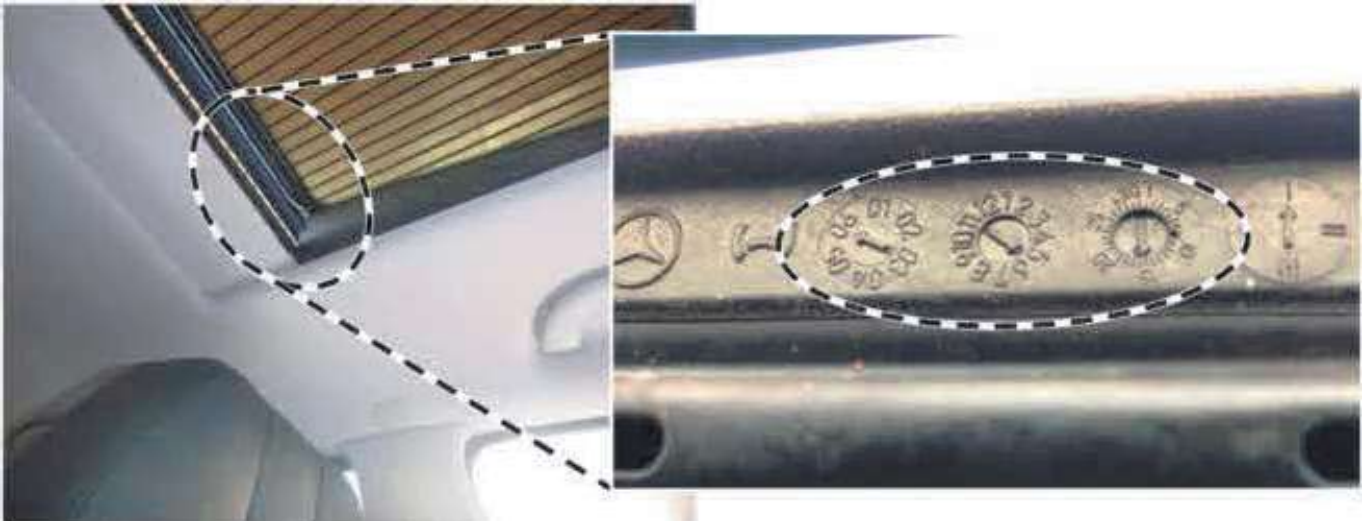
Figure 1 (The production date in the sample picture is **06 year / 5 month / 15 day**)(5-15-2006)

1. Move sliding sunroof to tilt position and check production date (**figure 1**).

i The production date **must** be on or **after 01-16-2006** or on or **before 07-09-2006**.

- A.** Production date between 01-16-2006 and 07-09-2006: Carry out **check/test procedure B**.
- B.** Production date **not** between 01-16-2006 and 07-09-2006: **End measure**.

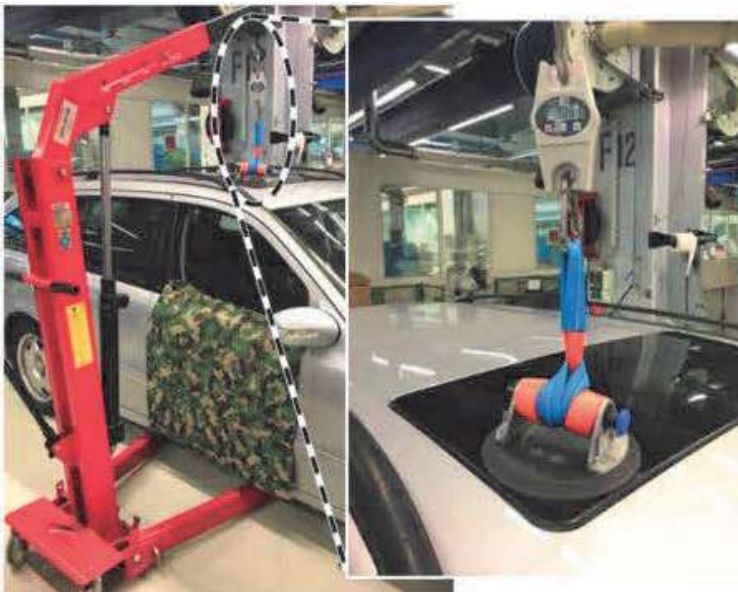
Figure 2

3. Position cup suction tool (**figure 2**) and pull as **vertically** as possible (tolerance of ± 10 degrees) using lifting tool.

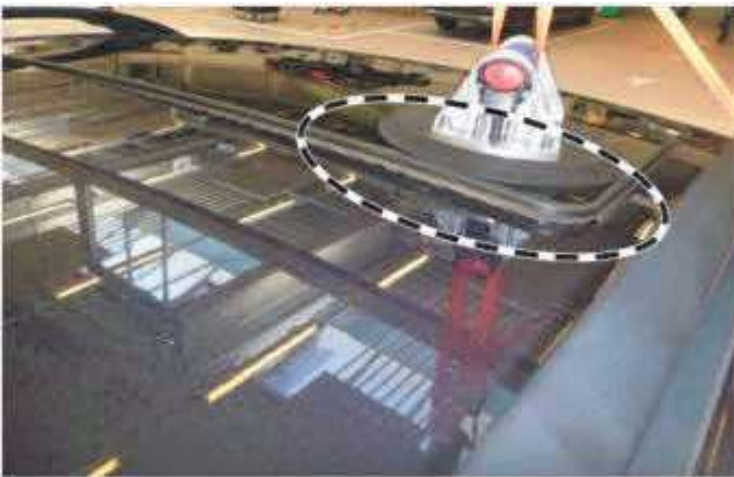
Figure 4

- i** The sliding roof panel is lifted out of the roof frame noticeably at the rear test positions 1 and 5 (figure 4).
- i** If the sliding roof panel detaches from the padding of the tilting/sliding roof frame at one of the test positions (see figure 5), the sliding roof panel must be replaced.

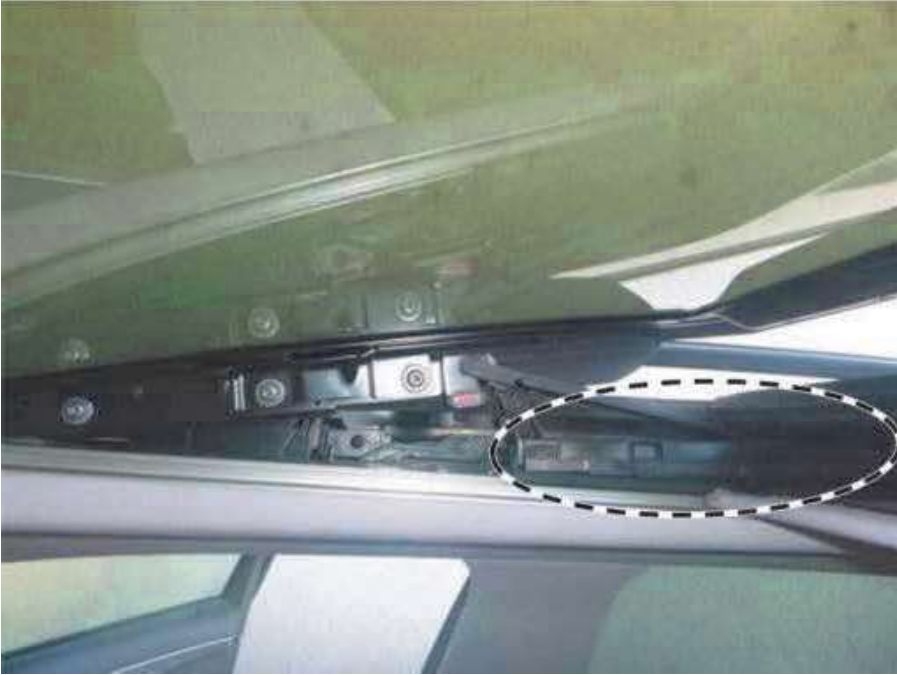
Figure 6

i The accordion boot **need** not be removed completely. It is sufficient to slide it back (**figure 6**).
