MODEL 219.3

M40/1 Pneumatic pump for dynamic seat control

P91.25-2268-04

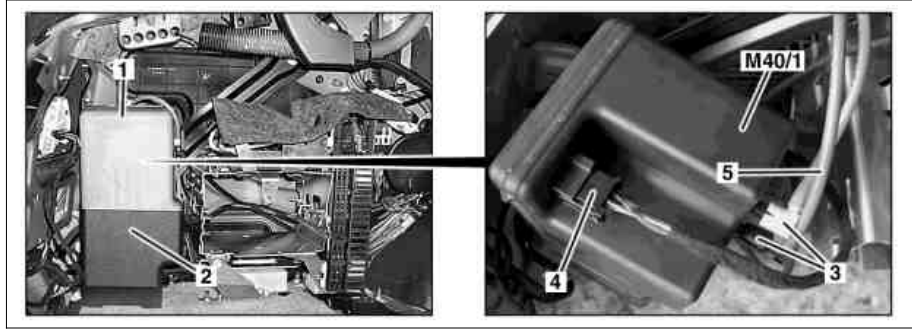
- 1 Soundproofing
- 2 Bracket
- 3 Pneumatic lines
- 4 Electrical connector
- 5 Vent line

Remove/install	
			1 Remove side paneling in left side of trunk	AR68.30-P-4800TX
			2 Fold up soundproofing (1) from pneumatic pump for dynamic seat control (M40/1)	
			3 Remove vent line (5) from soundproofing (1)	
			4 Disconnect electrical connector (4)	
			5 Seal off pneumatic lines (3) of pneumatic pump for dynamic seat control (M40/1)	*000589043700
			6 Remove pneumatic pump for dynamic seat control (M40/1) with soundproofing (1) upwards out of bracket (2)	
			7 Remove strut in front of overpressure reservoir for dynamic seat control	Only when installing a new pneumatic pump for dynamic seat control (M40/1), on vehicles up to 31.8.06 AR91.25-P-1570TX
			8 Install new pneumatic wiring harness for dynamic seat control pneumatic pump (M40/1)	Only when installing a new pneumatic pump for dynamic seat control (M40/1), on vehicles up to 31.8.06 AR91.25-P-1580-01T
			9 Install in the reverse order

10 Activate pneumatic pump for dynamic seat control (M40/1) AD Connect STAR DIAGNOSIS and read out fault memory	After installing new pneumatic pump for dynamic seat control (M40/1). AD00.00-P-2000-04A
			11 Carry out function check
