MODEL 212.0/1

Remove/install
Remove/install

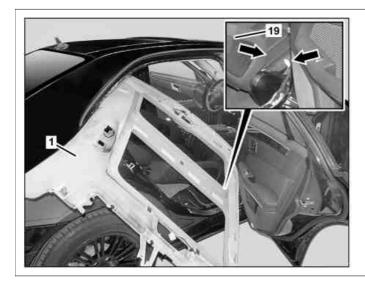
P68.30-3417-09

- Headliner
- 2 Cable duct
- 3 Headliner cover
- C-pillar paneling
- 5 Clips
- 6 Hook
- Clip
- 8 Inside rearview mirror bracket
- 9 Electric wiring harnesses
- 10 Electrical connector
- Grab handle 11
- 12 Sun visor
- A-pillar cover 13

- 14 Edge guard 15 Frame
- 16 Cover
- Rear PARKTRONIC warning A44/3 indicator (with code (220) PARKTRONIC or with code (230) Exclusive parking assist)
- B38/2 Rain/light sensor E14/1 Left sun visor mirror lamp
- A67 Inside rearview mirror
- E14/2 Right sun visor mirror lamp
- E15/3 Rear dome lamp
- Overhead control panel control N70 unit (with code (414) Power
- glass tilting/sliding sunroof) N70/3 Overhead control panel electronics (without code (414)
 - Power glass tilting/sliding sunroof)
- Electrical connector for interior protection (with code (882) X42/28 Interior monitoring (with ATA

only))

4.3	Remove side upholstery	On vehicles with code (882) Interior monitoring (with ATA only) and with code (287) Through-loading feature	AR91.12-P-1710CW
5	Detach bottom paneling on left B-pillar so that		
6	top paneling can be removed Remove top paneling from left B-pillar	i Lay top paneling down to side with belt end fitting attached.	
7	Remove bottom paneling and top paneling from right B-pillar	Lay top paneling down to side with belt end fitting attached.	
8	Remove left and right C-pillar paneling (4)	$\fbox{\begin{tabular}{c} \hline \end{tabular}}$ Lay C-pillar paneling (4) down to side with belt end fitting attached.	AR68.30-P-4490EW
9	Detach remaining edge guards (14) in area of headliner (1)		
10	Open cable duct (2), disconnect electrical connector on interior protection (X42/28) and expose wiring harness on headliner and sliding roof (18) from cable duct (2)	On vehicles with code (882) Interior monitoring (with ATA only)

11	Unclip headliner cover (3) and remove	PARKTRONIC or with code (220) PARKTRONIC or with code (230) Exclusive parking assist, disconnect electrical connector on rear PARKTRONIC warning indicator (A44/3).	
12	Remove rear dome lamp (E15/3)	Only when replacing headliner (1).	
13 14	Unclip clips (5) from headliner (1) Remove roller sun blind (12) from		
	counterbearing		
15	Remove overhead control panel control unit (N70) or overhead control panel electronics (N70/3)	i Depending on vehicle equipment.	AR82.20-P-1000CW
16	Remove left sun visor mirror lamp (E14/1) and right sun visor mirror lamp (E14/2)	Only when replacing headliner (1).	
17	Remove inside rearview mirror (A67)		
18	Unclip and remove cover (16)		
19	Disconnect electrical connector (10) from rain/ light sensor (B38/2)		
20	Remove inside rearview mirror bracket (8)		
21 22	Remove clip (7) Remove grab handles (11) on roof		
23	Move driver and passenger seat (19) toward rear and position backrest downward so that largest possible gap (arrows) is present between passenger seat and B-pillar	On vehicles with code (864) Rear entertainment system, when folding down backrest, ensure that the left rear display and right rear display are not damaged This clearance (arrows) is required to remove the headliner (1) from the vehicle through the right rear door cutout.

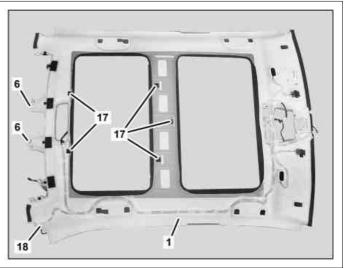
P68.30-3418-08

Shown with CODE (413) Panorama sliding roof

- Headliner
- 6 Hook

- 17 Velcro strip
- 18 Wiring harness for headliner and sliding roof
- 19 Passenger seat

24	Detach headliner (1) on Velcro strips (17) from roof paneling		
25	Unhook headliner (1) from frame (15) of sliding roof and panoramic roof	On vehicles with code (413) Panorama sliding roof or code (414) Power glass tilting/sliding roof	
26	Slide headliner (1) toward rear until hooks (6) disengage from mounts on roof paneling. Then lay headliner (1) down on seats	i Installation: Position headliner (1) below A-pillar panelings (13) when moving forward. Position headliner (1) above electrical wiring harnesses (9)	
27	Arch headliner (1) at front and rear with aid of helper, then align headliner in vehicle so that headliner (1) can be moved out of rear door cutout toward rear.	Do not arch headliner (1) excessively, otherwise headliner (1) can be damaged.	
28	Guide headliner (1) through gap (arrows) toward rear out of right rear door cutout. Always keep headliner (1) arched.	When moving out headliner (1), ensure that the edge areas of the headliner (1) are not kinked or graze against the adjacent components. Otherwise the headliner (1) can be damaged.
