P72.12-2754-09

Shown on model 204.0

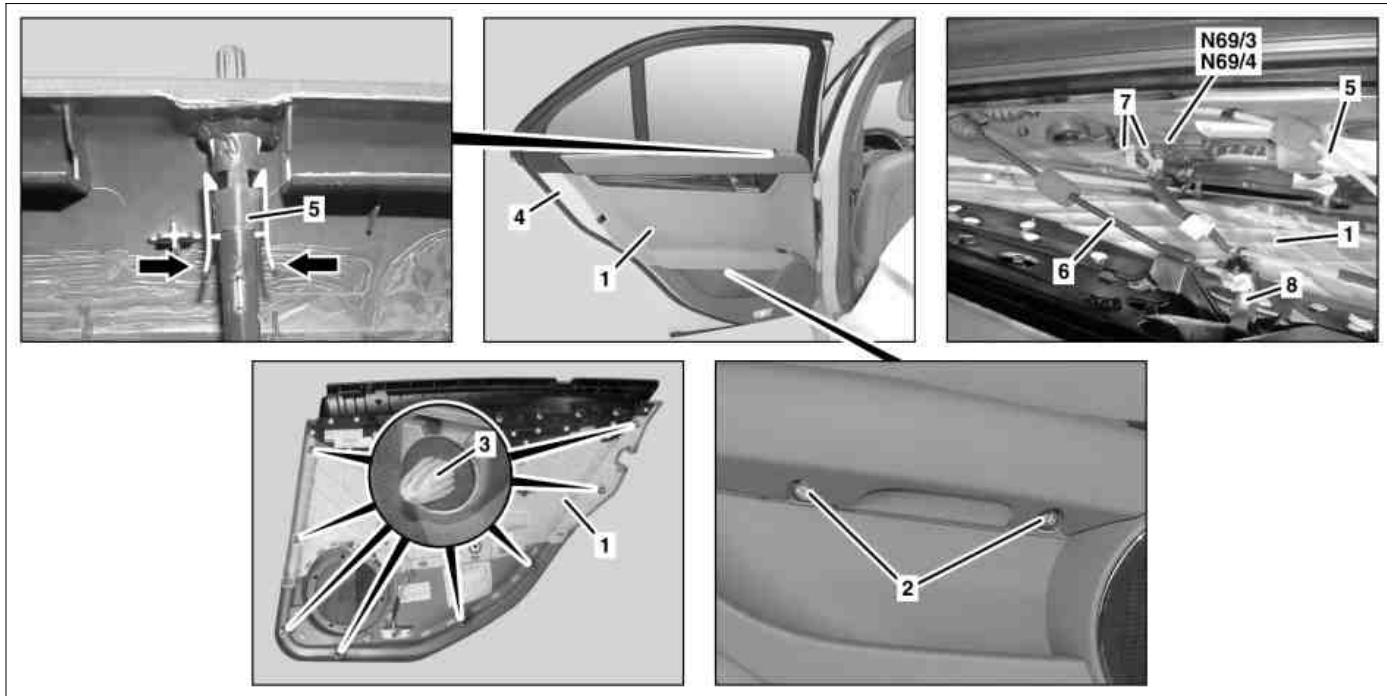
| 1 Door lining | 5 Bowden cable end safety cap | N69/3 Left rear door control unit |
| 2 Screws/bolts (model 204) | 6 Inside door opener Bowden cable | N69/4 Right rear door control unit |
| 3 Mounting clip | 7 Electrical connectors | |
| 4 Rear door | 8 Inner door handle | |

Remove/install		
1.1	Remove bolts (2)	Model 204.0/2	
1.2	Unclip covers and unscrew bolts (2)	Model 204.9	
1.3	Unclip cover (10) with assembly wedge (9) and unscrew bolts (11)	Model 212	
2	Unclip door liner (1) from mounting clips (3)	<ul style="list-style-type: none">

Move assembly wedge directly to mounting clips (3). Otherwise the retaining tabs on the mounting clips (3) of the door liner (1) cannot tear out.

Assembly wedge 	<p>*110589035900</p> <p>*110589035900</p>
3	Detach door lining (1) from rear door (4) horizontally to side until electrical connectors (7) on left rear door control unit (N69/3), right rear door control unit (N69/4), inside door opener Bowden cable (6) and Bowden cable end safety cap (5) are accessible.	<ul style="list-style-type: none">

Carefully detach door lining (1). Danger of breaking mount on Bowden cable end safety cap (5).

4	Press shackles together (arrows) and unclip Bowden cable end safety cap (5) from door lining (1)	<ul style="list-style-type: none">

Installation: Ensure that door lining (1) is seated correctly in inner sealing rails.

5 ⚠	Disconnect electrical connectors (7) from left rear door control unit (N69/3) and right rear door control unit (N69/4) Information on preventing damage to electronic components due to electrostatic discharge		AH54.00-P-0001-01A
6	Unhook inside door opener Bowden cable (6) from inner door handle (8).		
7	Disconnect electrical connector on left rear door sound system tweeter or right rear door sound system tweeter	Model 212 with code (810) Sound system	
8	Install in the reverse order

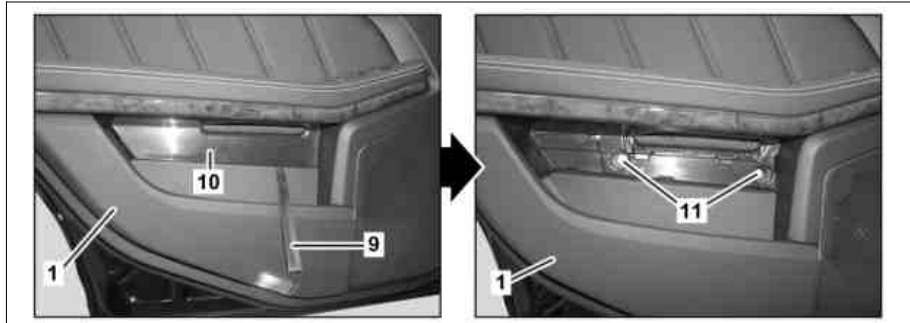
P72.12-2811-04

Model 212

- 1 Door lining
- 9

Assembly wedge
- 10 Cover
- 11 Bolts
