MODEL 204.0/2/9  
 MODEL 212  
 without CODE 224 (Rear individual seat design)

☒ ☒	Remove/install		
1	Move both front seats forwards		
2	Pull rear seat cushion (1) upwards out of the guide sleeves (arrows A)	For vehicles without code (248) Rear seat with integrated child seat ⓘ In model 212 with code (864) Rear entertainment system, catch rear seat cushion (1) while pulling it out. Otherwise the DVD player will be damaged.	
3	Extend child seat cushions (4)	For vehicles with code (248) Rear seat with integrated child seat	
4	Remove left and right footrests (5)	For vehicles with code (248) Rear seat with integrated child seat ⓘ At the marks (arrows B) on the footrests (5) insert a suitable screwdriver, alternately push back the catch hooks (arrows C), then remove the footrests (5) horizontally from the seat frame (7). ⓘ <b>Installation:</b> Insert guides (arrows D) of footrest (5) in cutouts (arrows E) of seat frame (7).	
5	Remove bolts (6) on left and right seat frame (7) of rear seat cushion (1)	For vehicles with code (248) Rear seat with integrated child seat Nm Bolt, rear seat cushion to body	*BA91.12-P-1010-03I

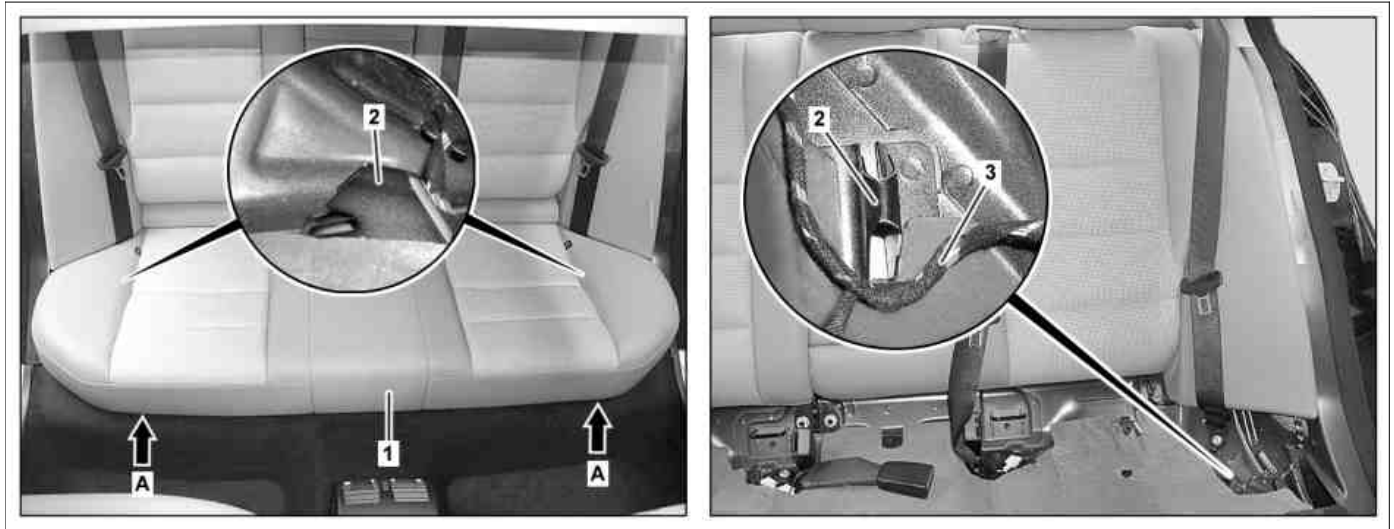
P91.12-3397-08

Shown on model 204.0 without code (248) Rear seat with integrated child seat

- 1 Rear seat cushion
- 2 Support
- 3 Electrical wiring harness

9	Remove rear seat cushion (1)	<p>⚠ Carefully remove rear seat cushion (1) from vehicle. Otherwise components in vehicle interior or at rear doors will be damaged.</p> <p>⚠ <b>Installation:</b> Note routing and fastening of electrical wiring harness (3) in front of mounts (2). Otherwise the electrical wiring harness (3) will be damaged.</p> <p><b>i</b> <b>Installation:</b> Note position of center seat belt buckle.</p>	
10	Install in the reverse order

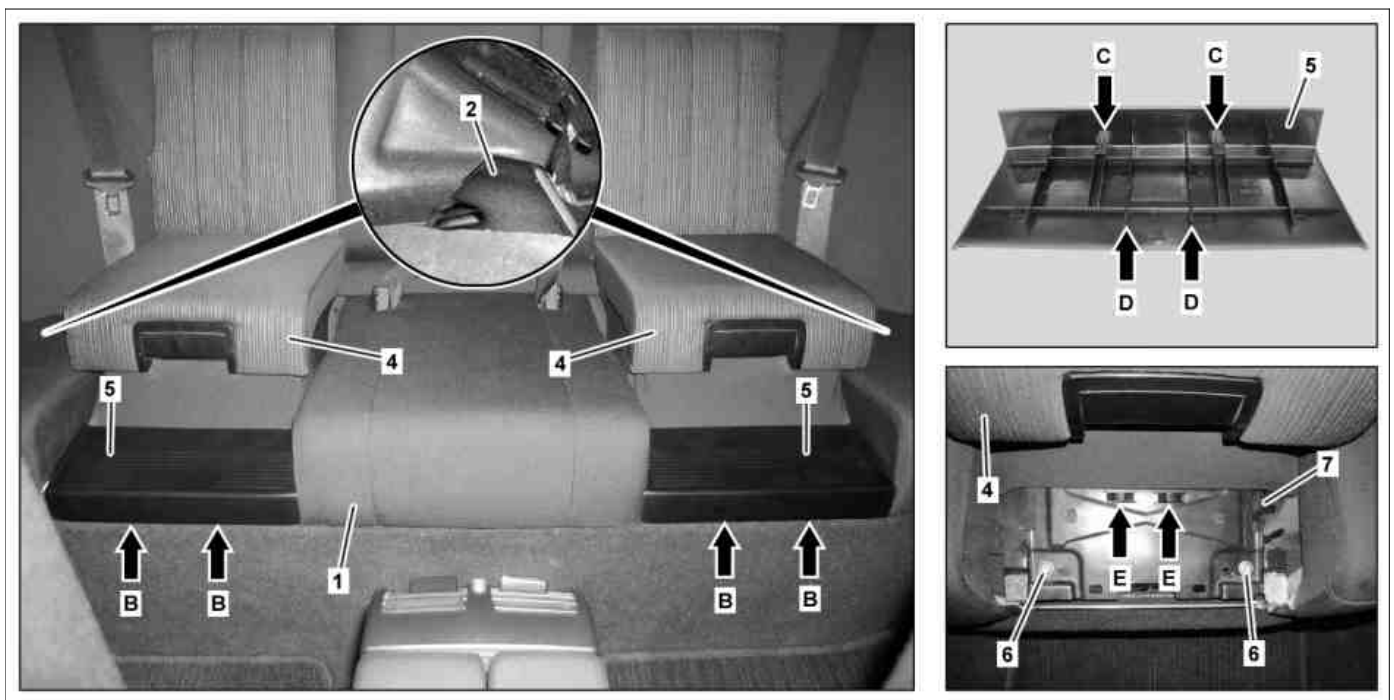
P91.12-3224-09

Shown on model 204.0 with code (248) Rear seat with integrated child seat

- 1 Rear seat cushion
- 2 Support
- 4 Child seat cushions
- 5 Footrest
- 6 Screw
- 7 Seat frame

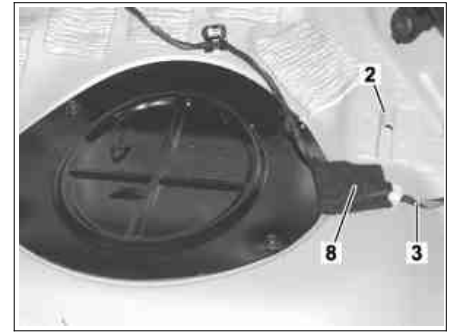
P91.12-3570-01

**Shown on model 204.3, left side of vehicle**

- 2 Support
- 3 Electrical wiring harness
- 8 Adhesive strips

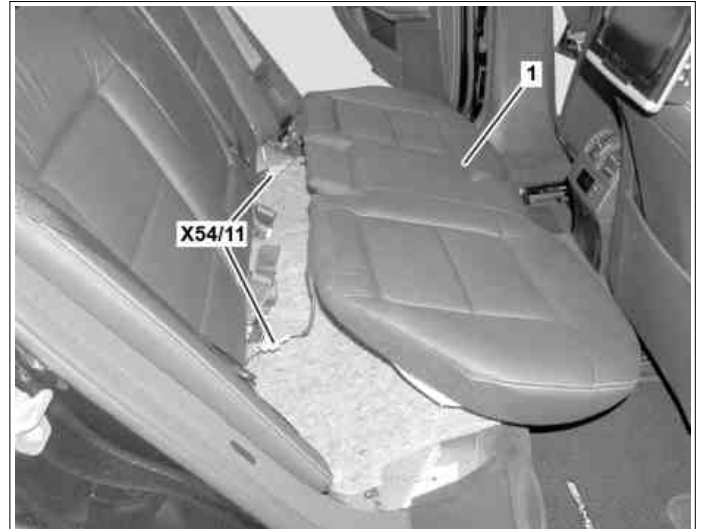
P91.12-3396-11

**Shown on model 212**

- 1 Rear seat cushion
- X54/11 Left and right rear seat heater pad electrical connectors (with code (872) Electric seat heater for left and right rear seat)

6	Remove DVD player paneling	MODEL 212 with CODE 864 (Rear entertainment system) without CODE 224 (Rear individual seat design)	AR82.60-P-7505-01EW
7	Push rear seat cushion (1) far enough back to enable the retaining brackets on the bottom of the rear seat cushion (1) to be extended from the mounts (2)	ⓘ <b>Installation:</b> Ensure that mounting frame bow is seated correctly in mounts (2).	
8	Guide rear seat cushion (1) forward and disconnect left and right rear seat heater pad electrical connectors (X5411)	MODEL 212 with CODE 872 (Electrically heated left and right rear seats)
