# DIY for Adblue Heater:

Codes are 20BD18 and 20BE1B.

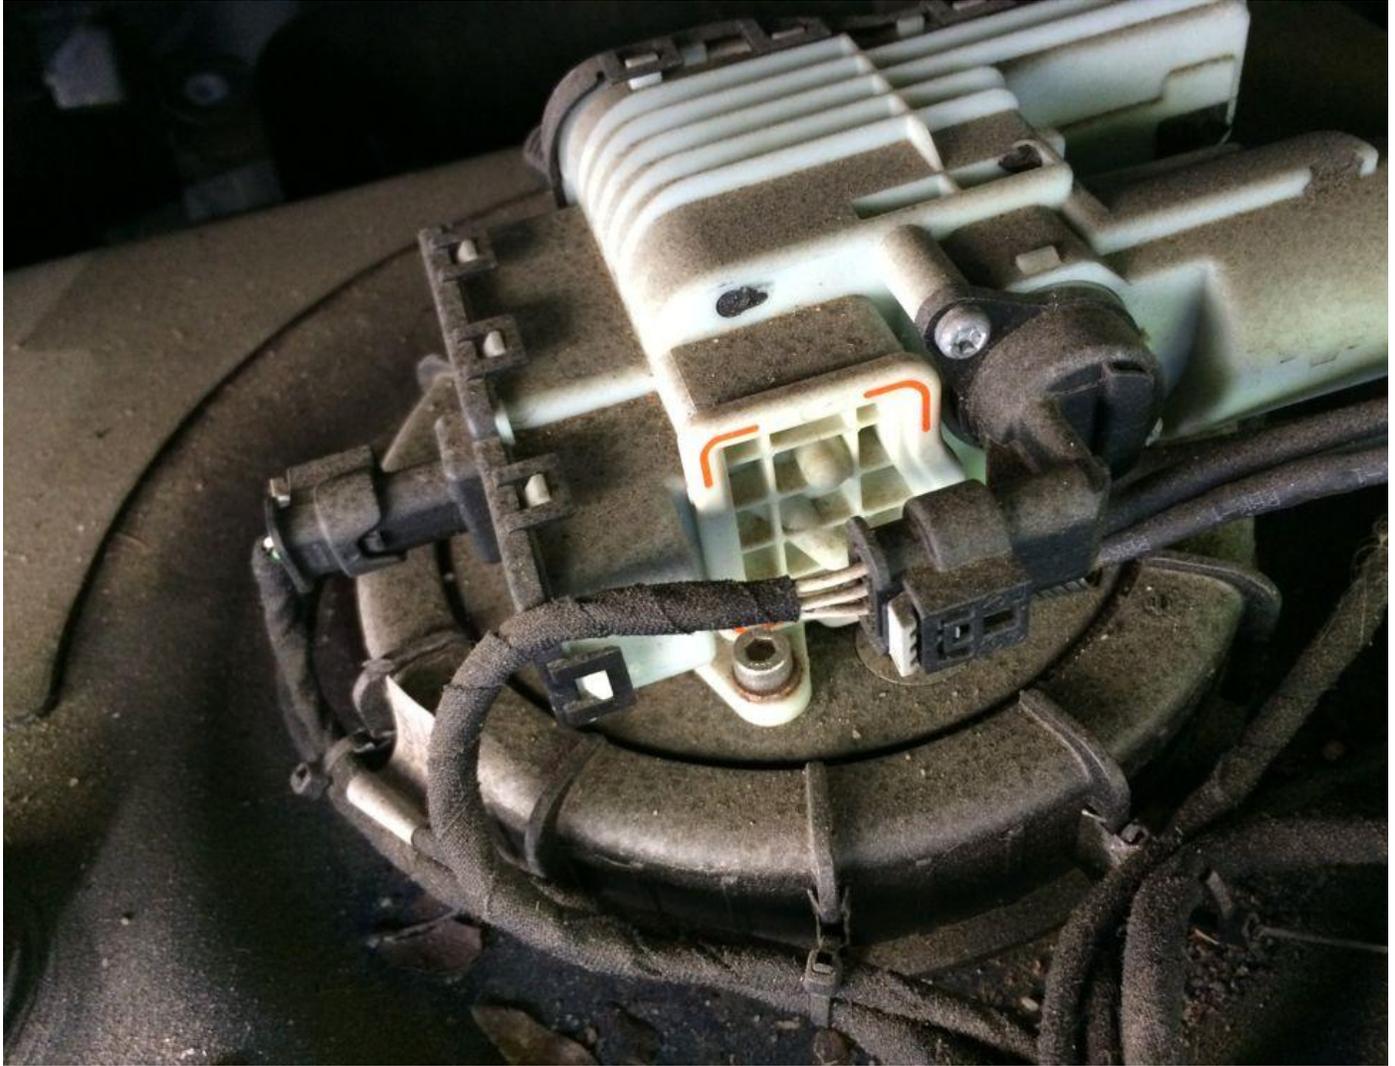
Photos start here because I wanted to take lots of pictures to make sure I remembered where to reconnect everything and where the zip ties were to be restored when finished. This is the pump unit on the lid of the additive tank. It must be disconnected and removed to access failed pre-heater parts which are located inside the additive tank.

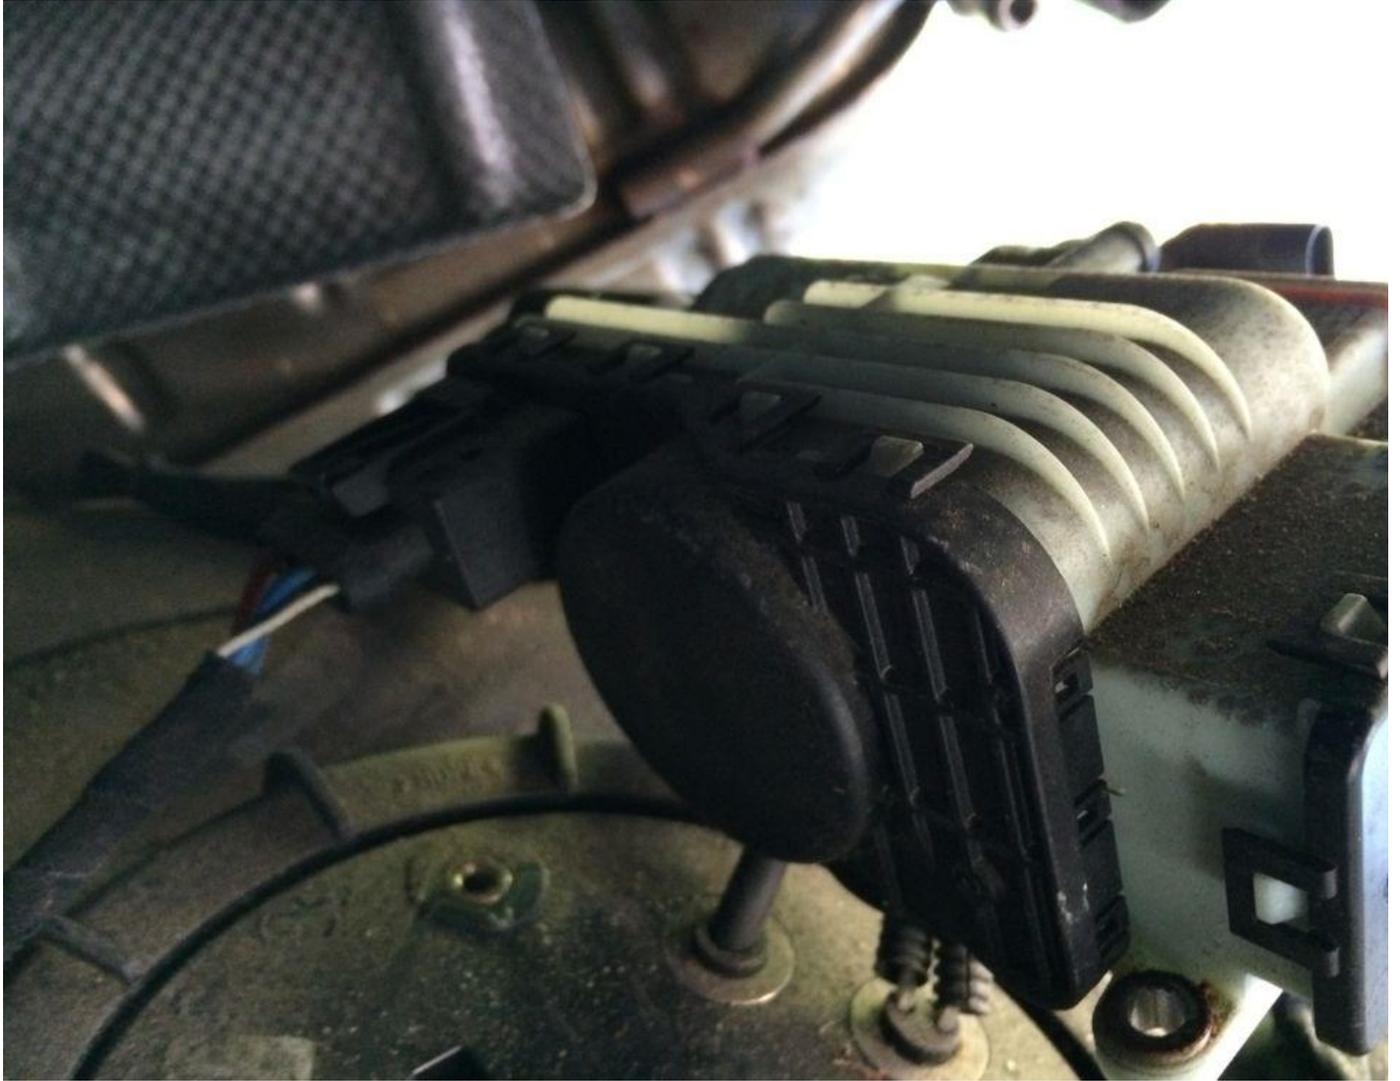
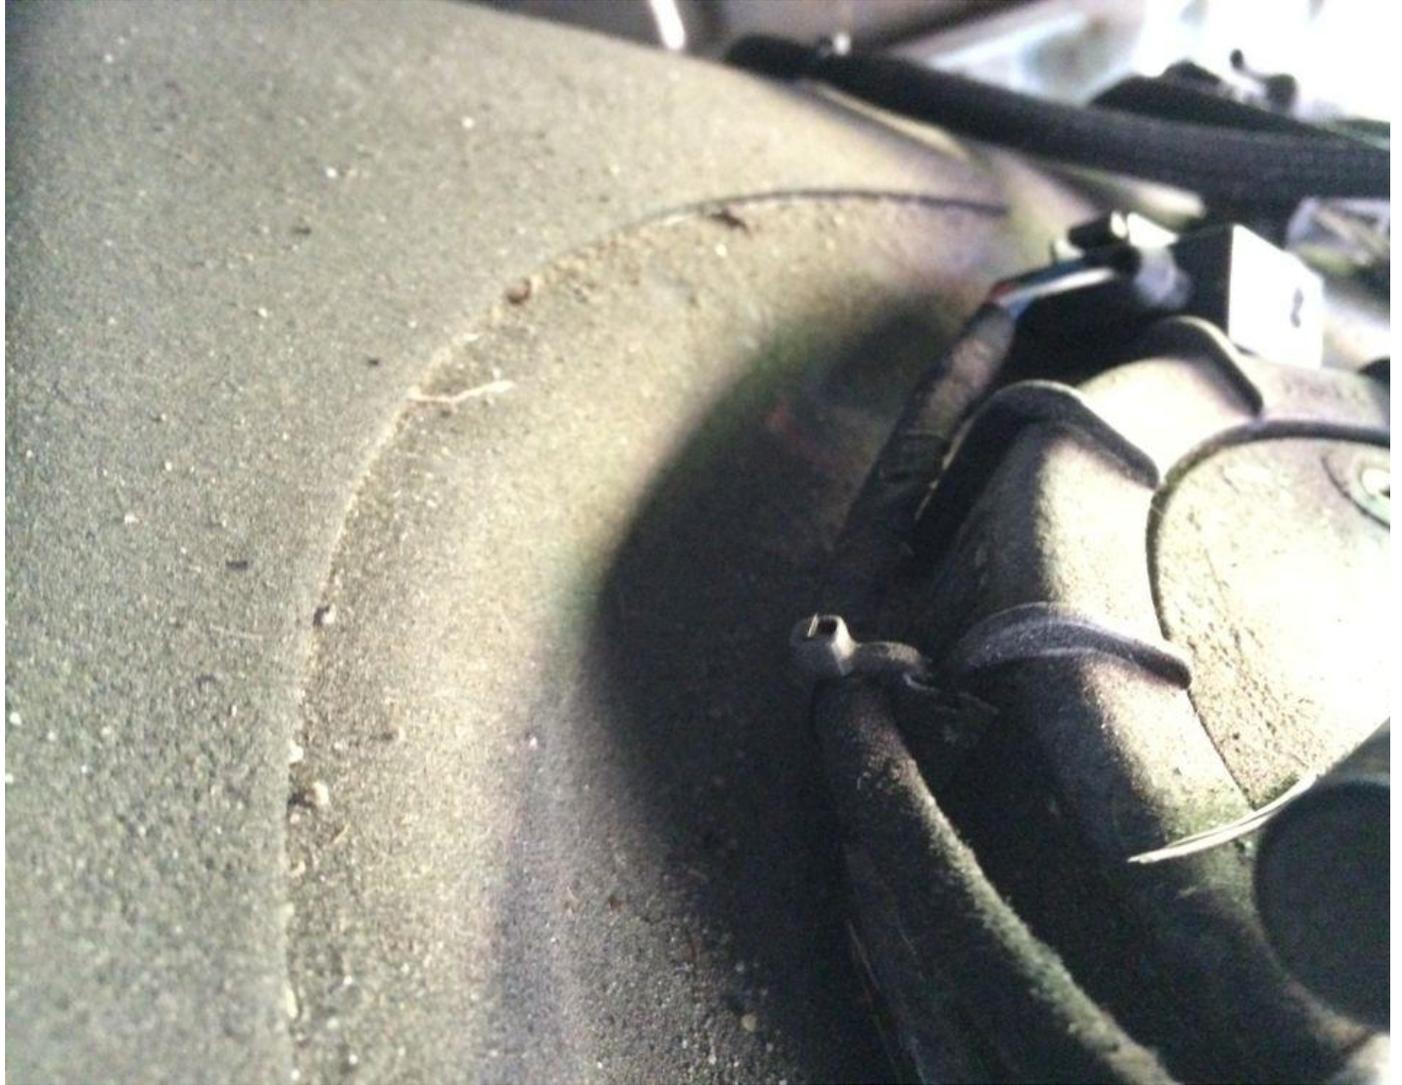
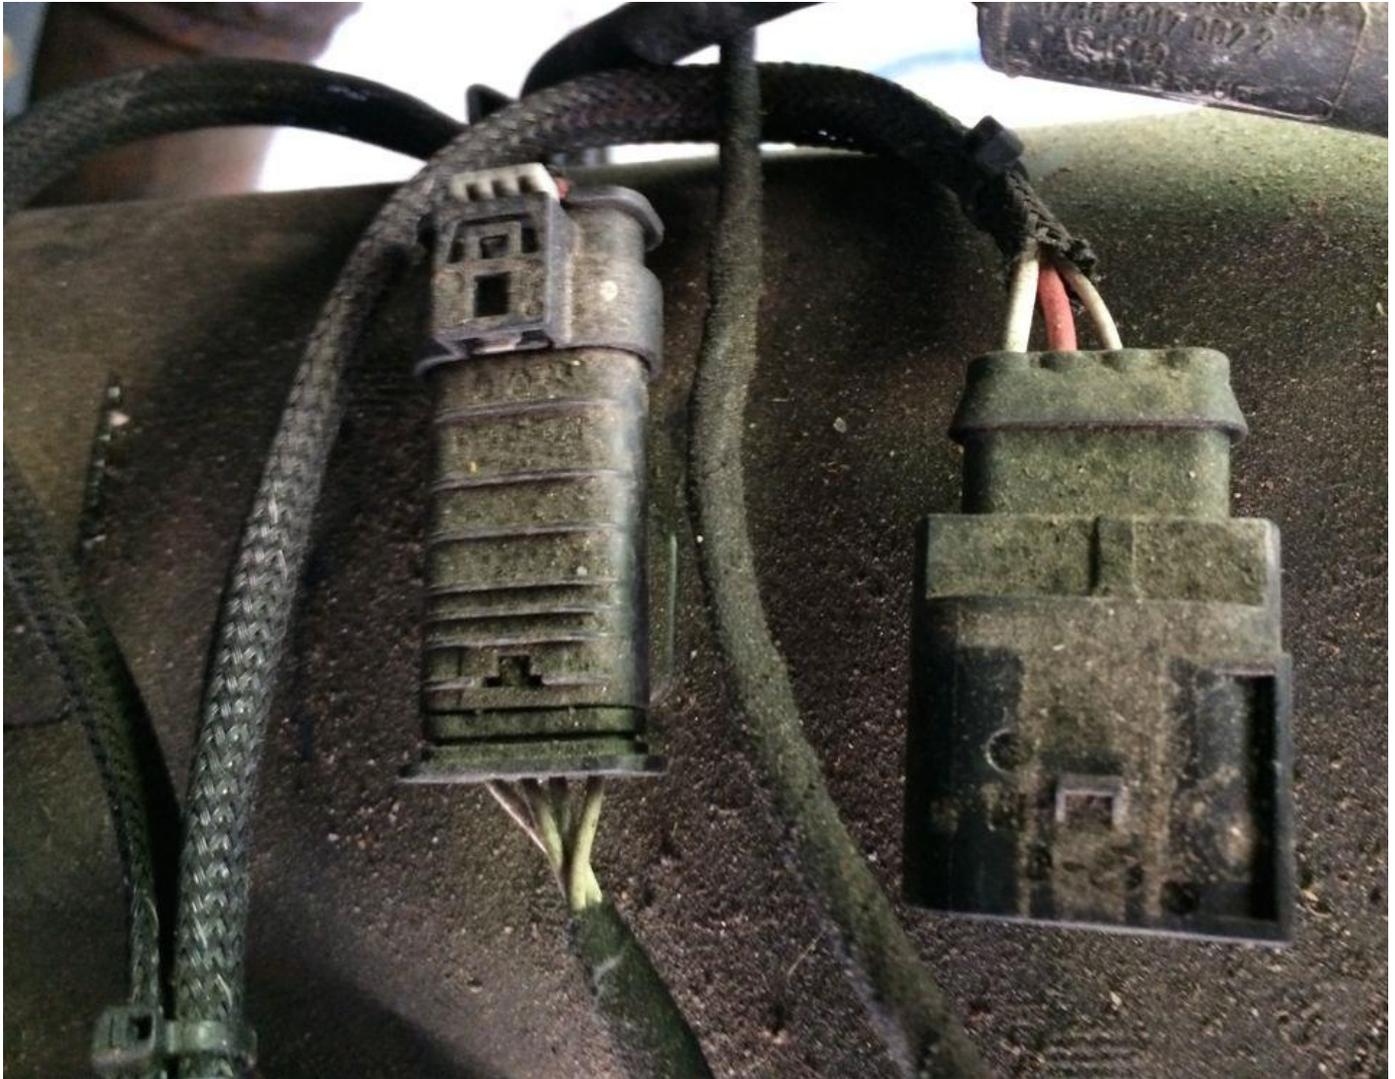
There are four connectors to the pump unit visible from the front. One is the actual additive line to the injector nozzle. There is also a large connector that is located behind the pump unit. I disconnected the four electrical connectors and left the fluid line connected while servicing the tank. Once the connectors were loose, I used a 4mm hex key to remove the three stainless fasteners that anchor the pump to the tank lid.

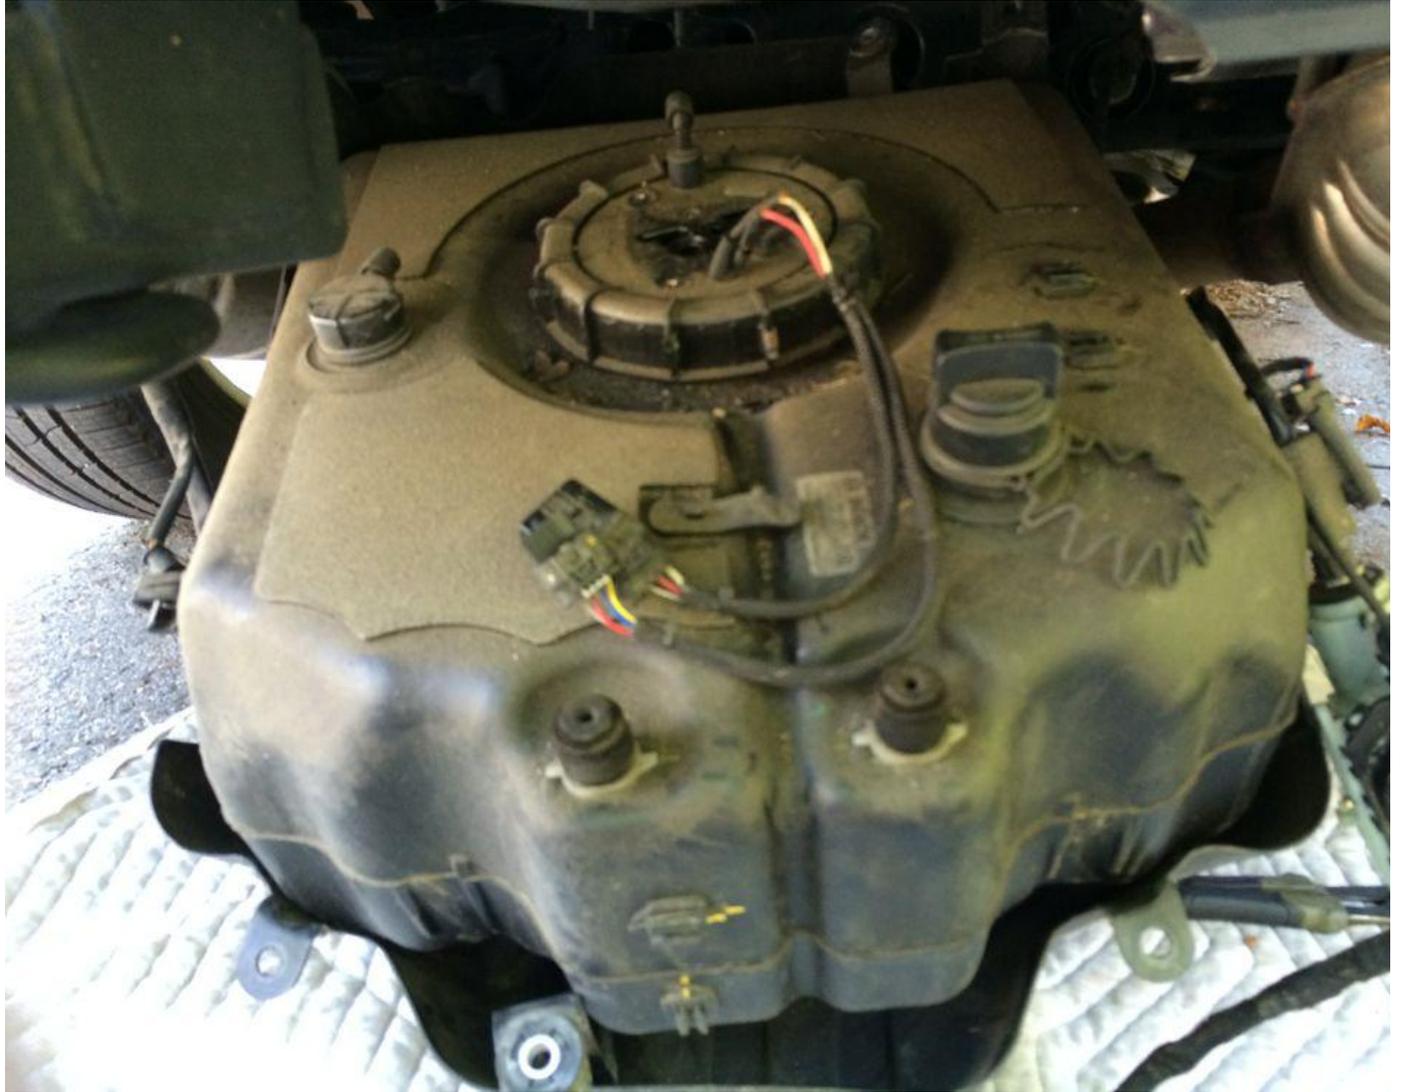
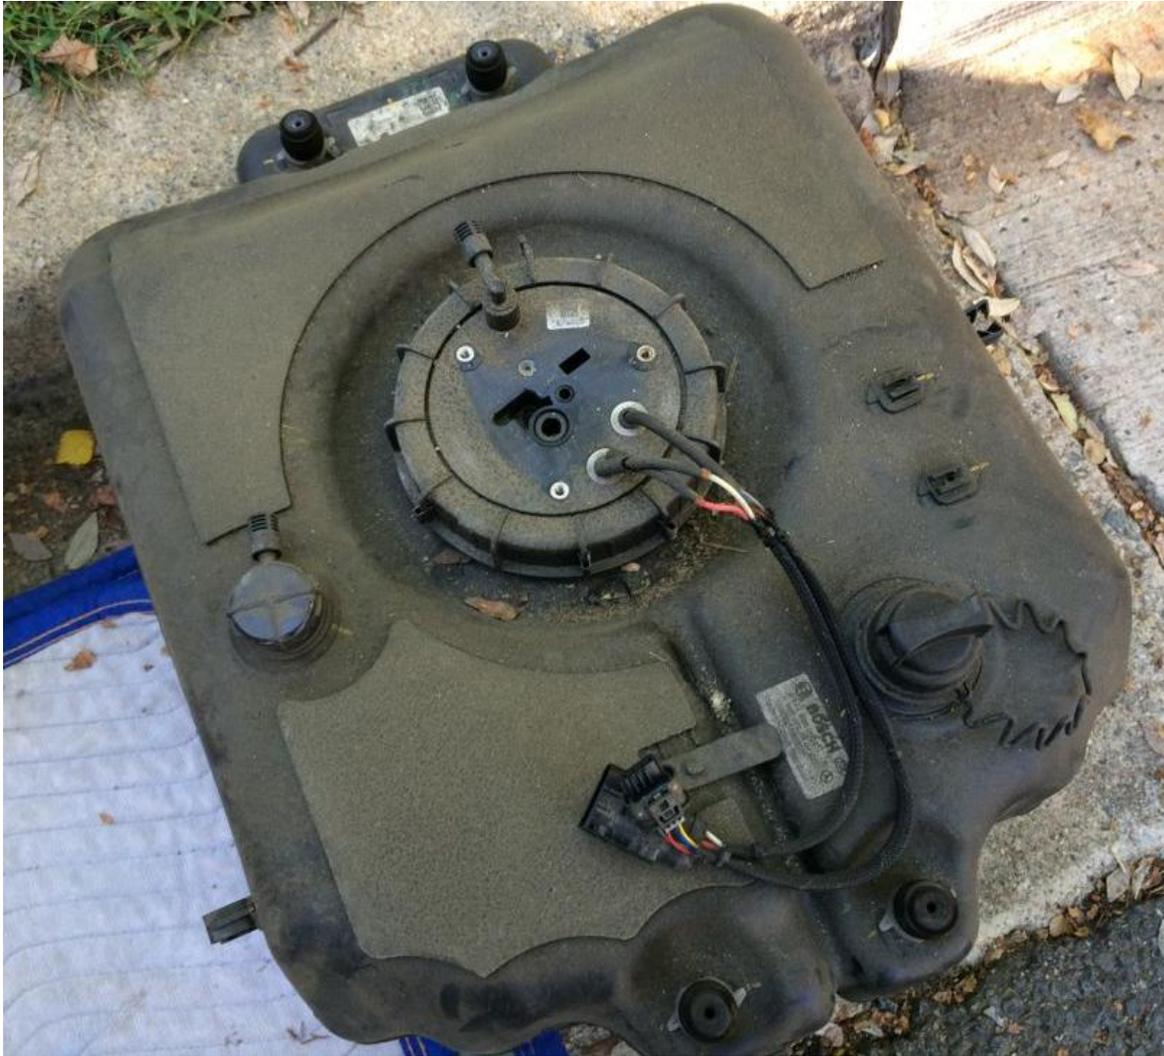
Once the pump was detached, and the other electrical connectors on the rearmost side of the tank were also detached, I was able pull the tank from the support straps and place it on the ground for the next steps.

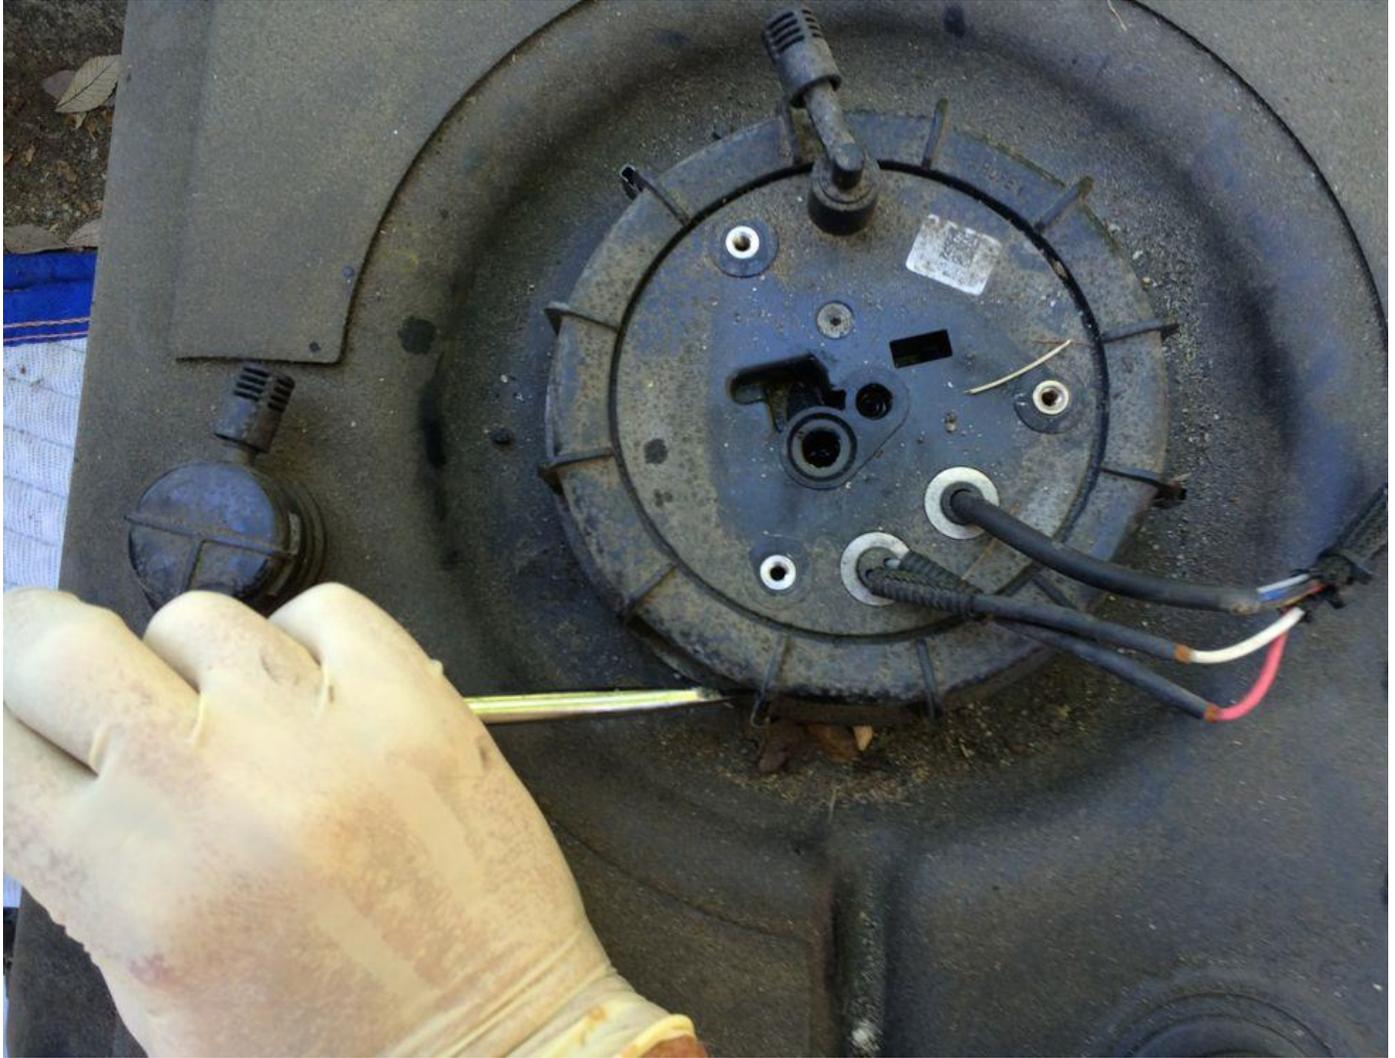
After documenting the position of the zip ties and removing them to free the harness connectors, I used a large flat blade screwdriver and a rubber mallet to knock the locking ring loose on the additive tank lid. It secures a soft silicone rubber gasket within, so it is quite difficult to twist off manually, but it turned easily with a few firm taps of the mallet. It will rotate one full revolution and lift off.

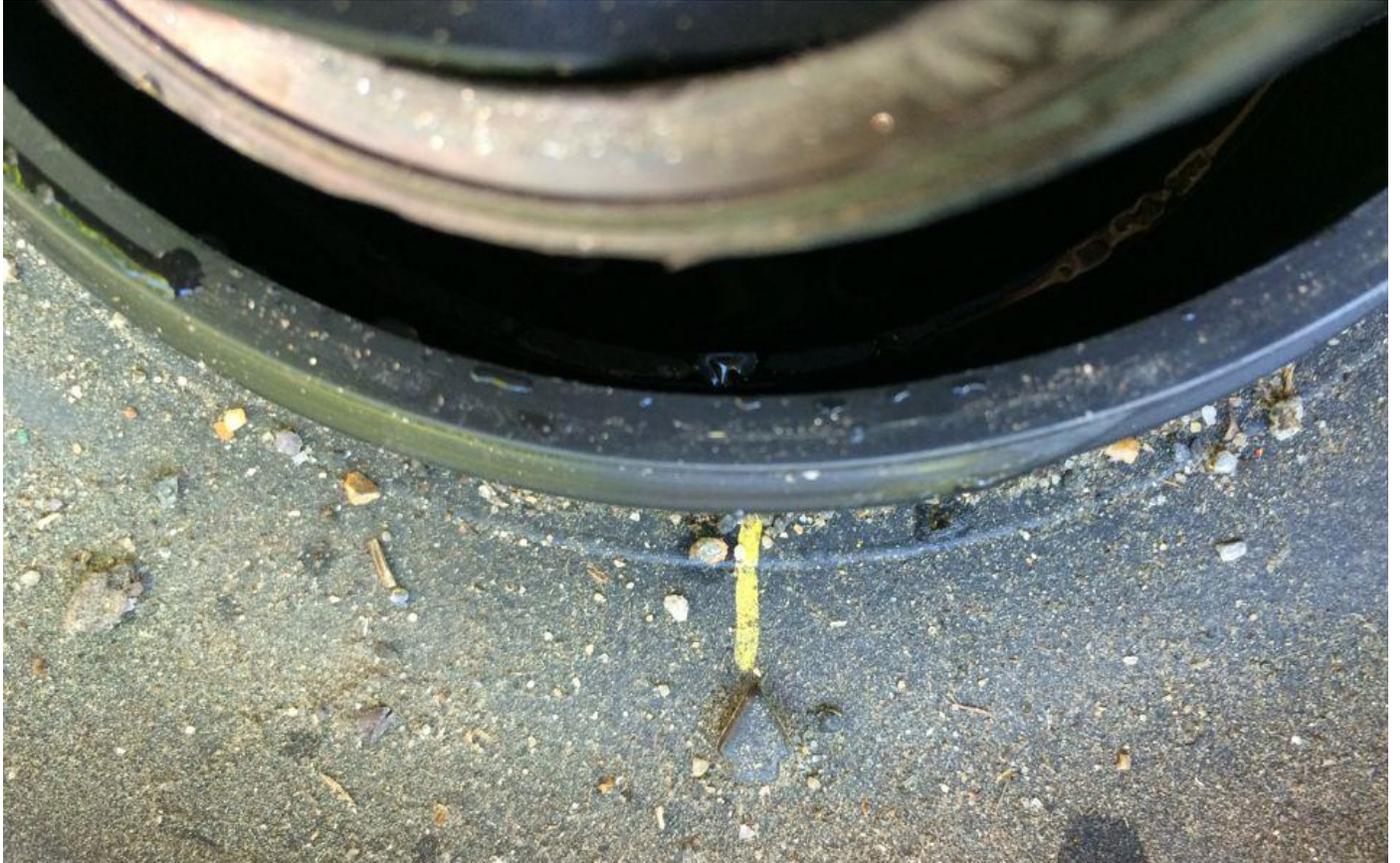
At this time, I noted there is a reference arrow on the tank in the 11 o'clock position as looking from the perspective of the one the ground photo above. This reference is used to index the lid locking ring and the RS pre-heater assembly when installing within the additive tank.

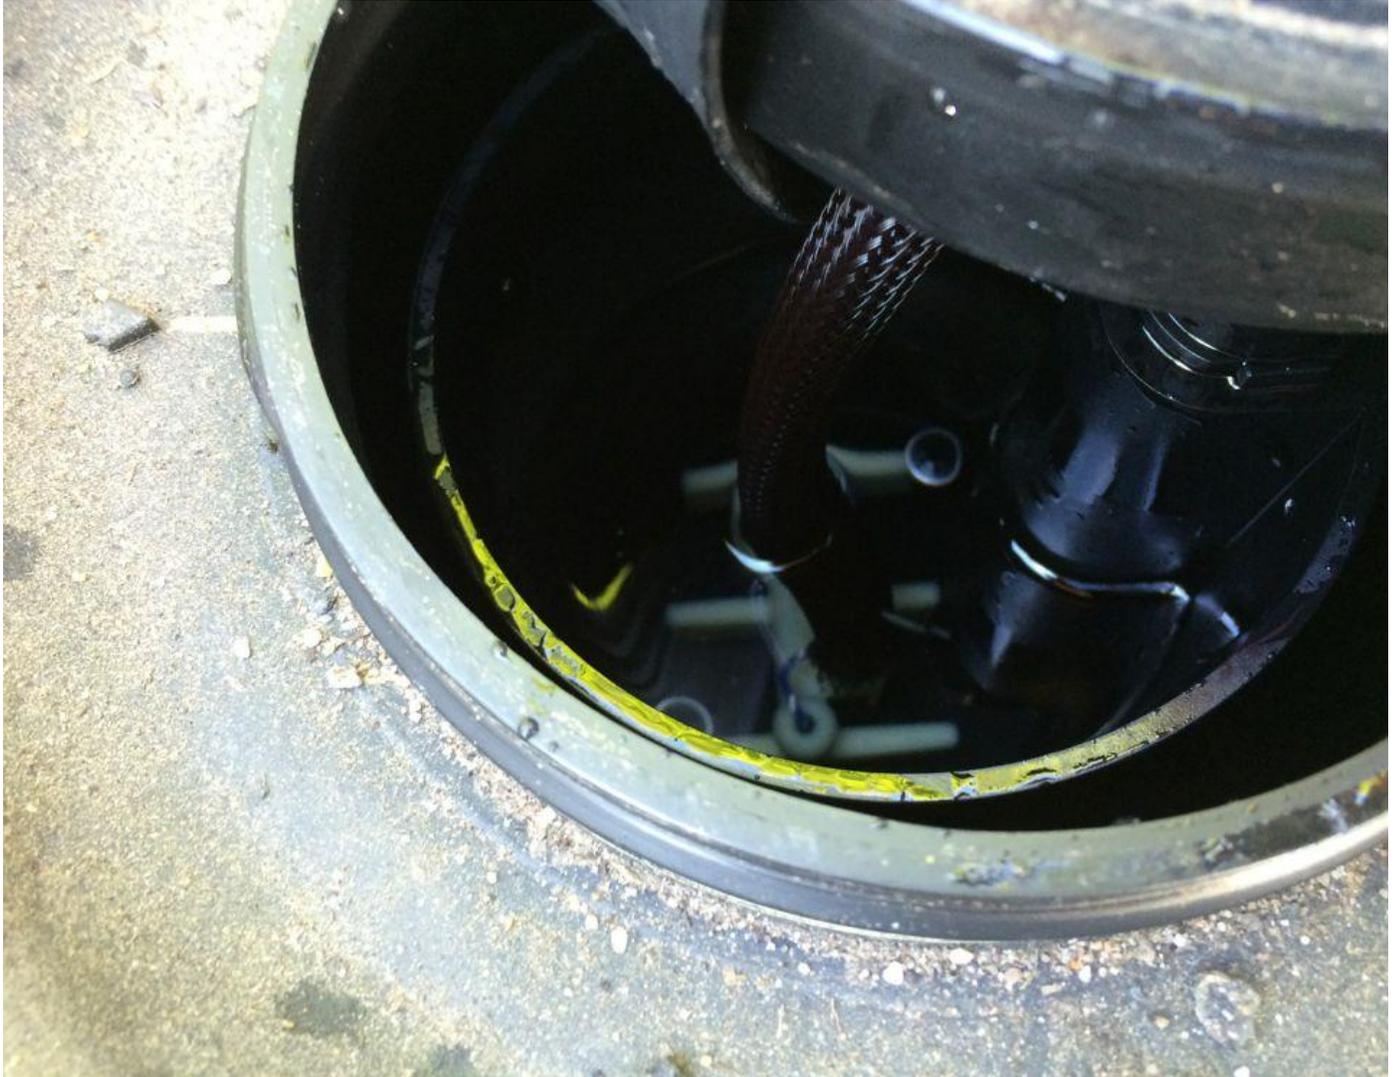
Pulling the rubber gasket from the lid opening, you see the RS pre-heater assembly installed within directly under the lid and pump assembly. There is just enough extra tubing length to be able to fit your fingers within to grab the assembly and twist about 5° counter- or anti-clockwise to loosen it from its anchor tabs.

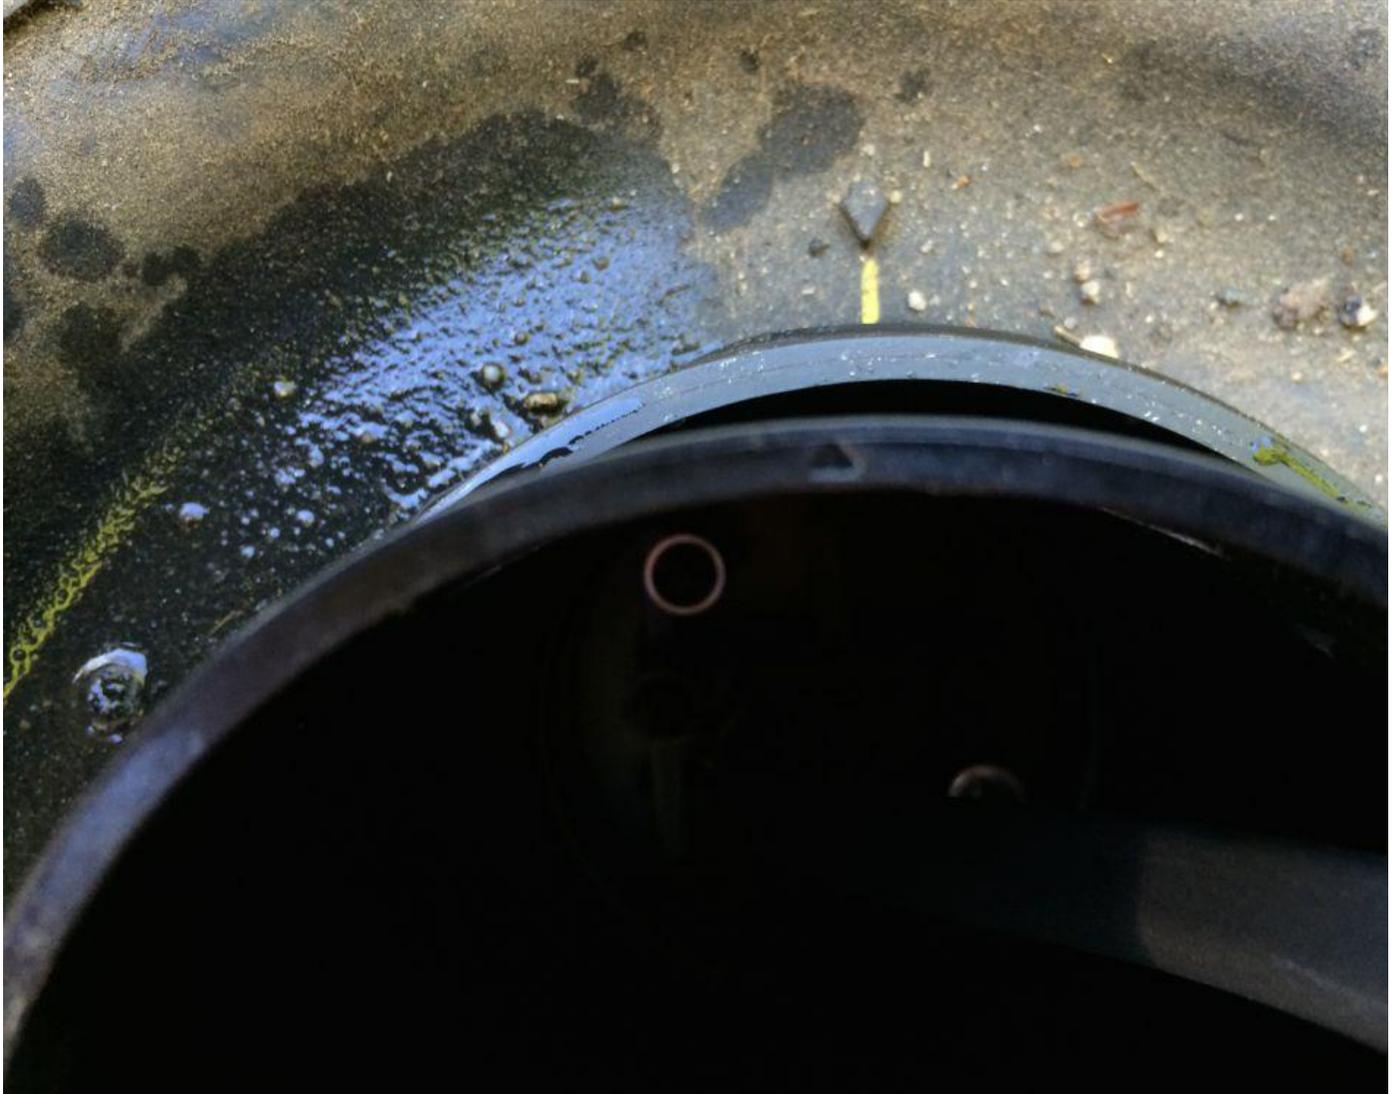
The new RS pre-heater assembly has an index arrow on the top rim, align it about 5° CCW/ACW to insert and twist clock-wise to lock in place.

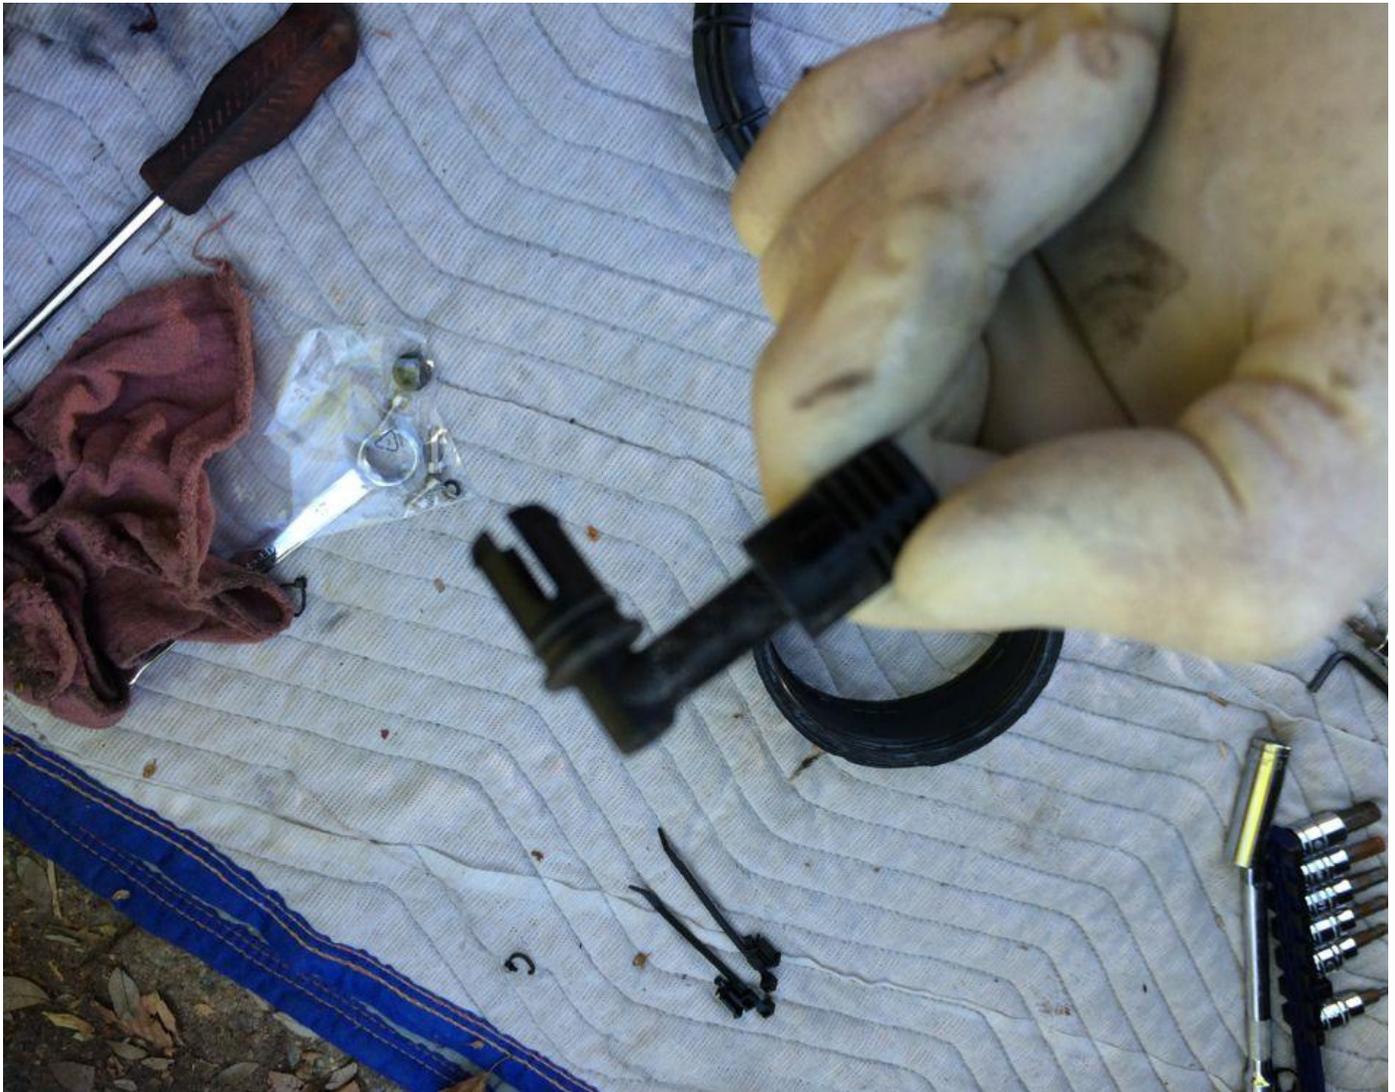
I damaged the pump after replacing the heater core because I did not prime the core chamber and the pump burned itself out trying to build pressure with the inner core empty. If you have a P20E8 low reductant pressure code, it could be your pump need to be replaced or your system has a leak that is keeping it from building pressure.

As far as I could tell, the pump works by injecting air pressure into inner core within tank, it does not actually pump the fluid itself. I think the DEF fluid is then fed to a higher-pressure pump upstream near the injectors.

My kit came with a replacement vent, so I swapped that in.

Whatever the case, I suspect you're in need of a new pump if you have low pressure code. At the point I realized this, I just threw my hands up and handed to the dealer to fix. Lesson learned for next time I need a DEF pre-heater replacement.

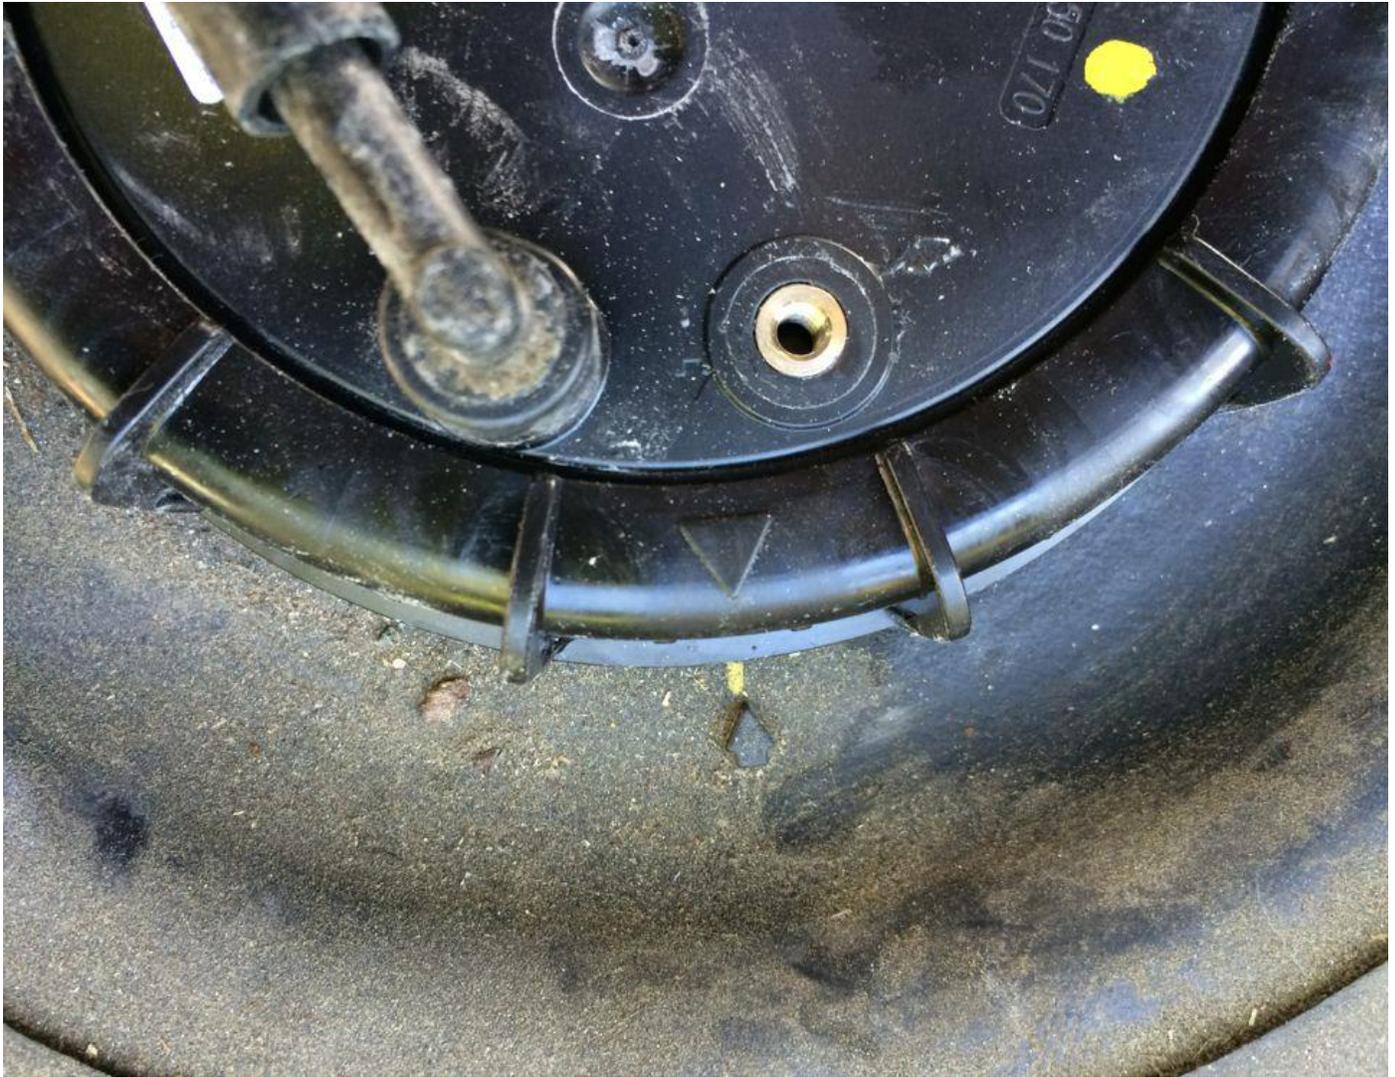
Once the new pre-heater assembly is in place, install the new gasket and make sure the skirt of the gasket smoothly surrounds the top edge of the pre-heater assembly. Install new lid locking ring and tap into alignment with index arrow if needed with rubber mallet and large flat blade screw driver.

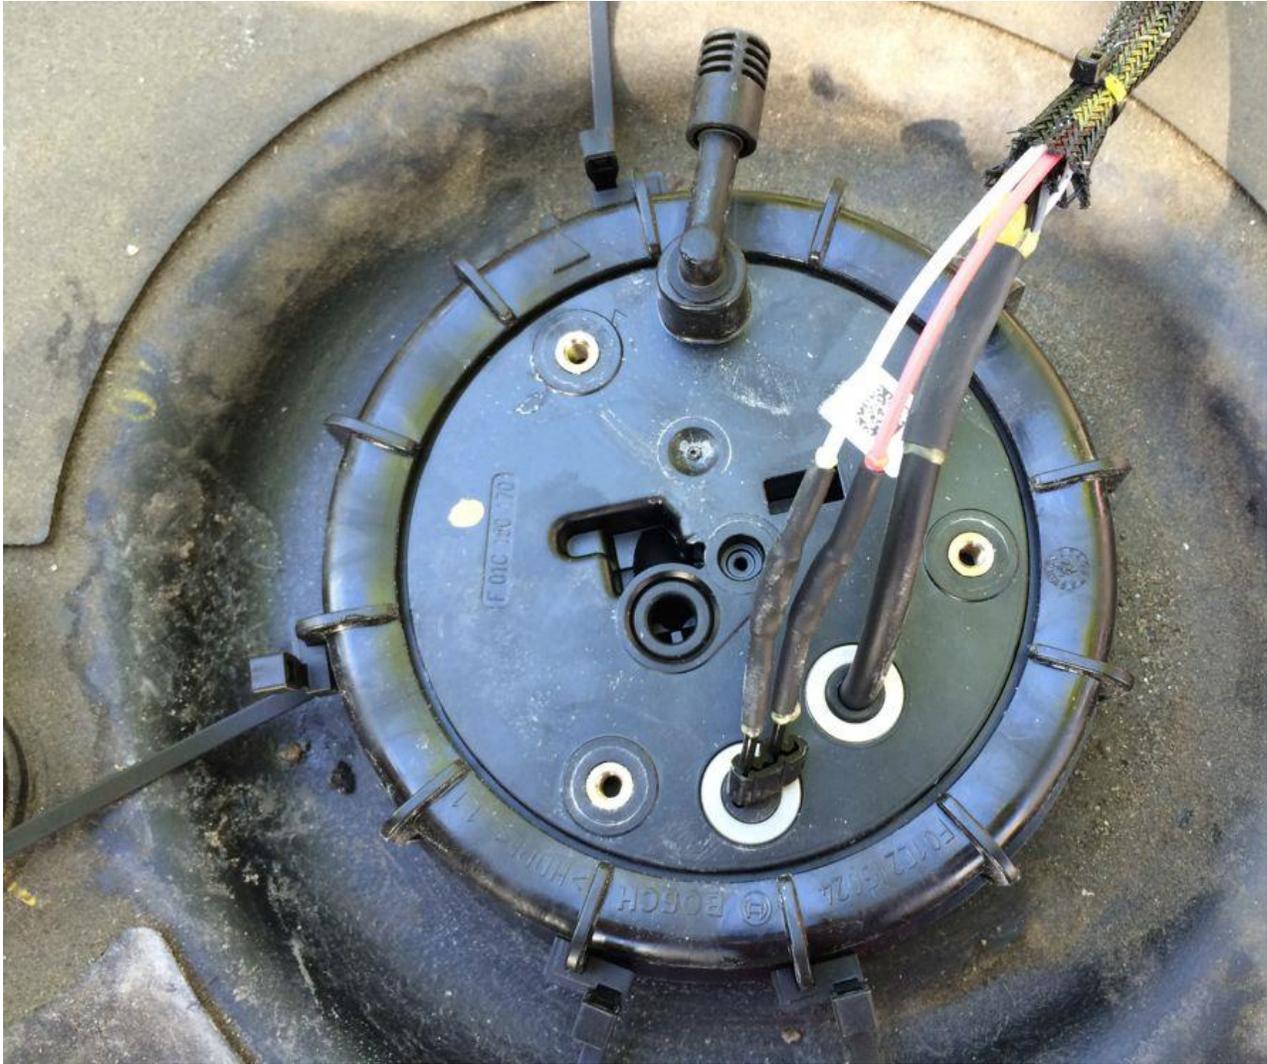
The new lid comes with a different kind of harness zip ties, so attach them to the lid at the locations indicated, roughly 12, 6, 7, and 9 o'clock starting from the index arrow.

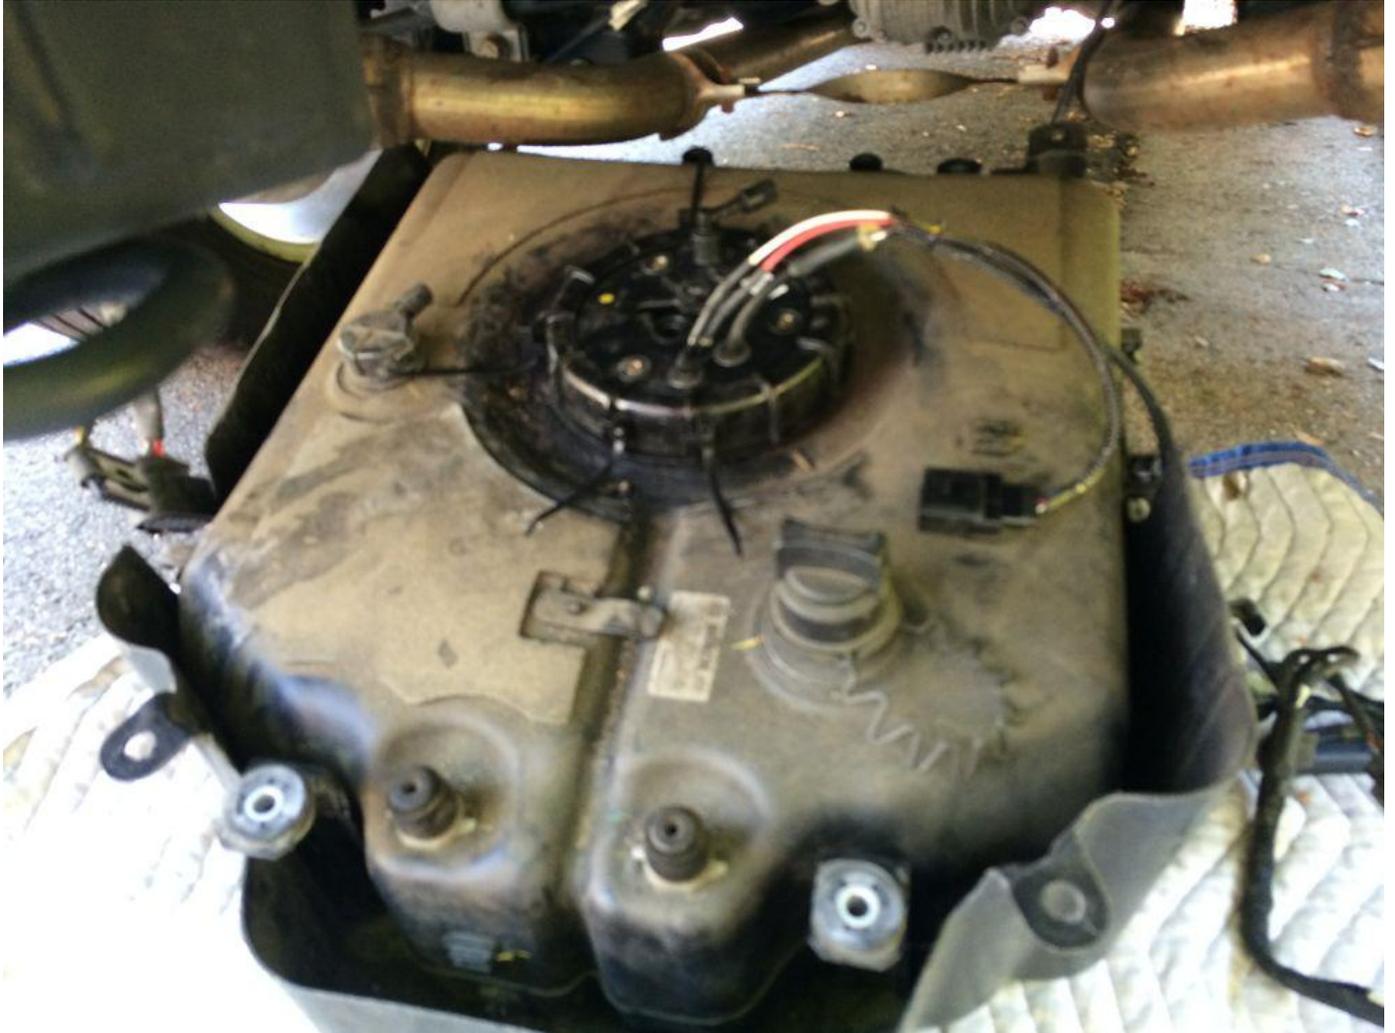
Position tank with new pre-heater back in anchor straps.

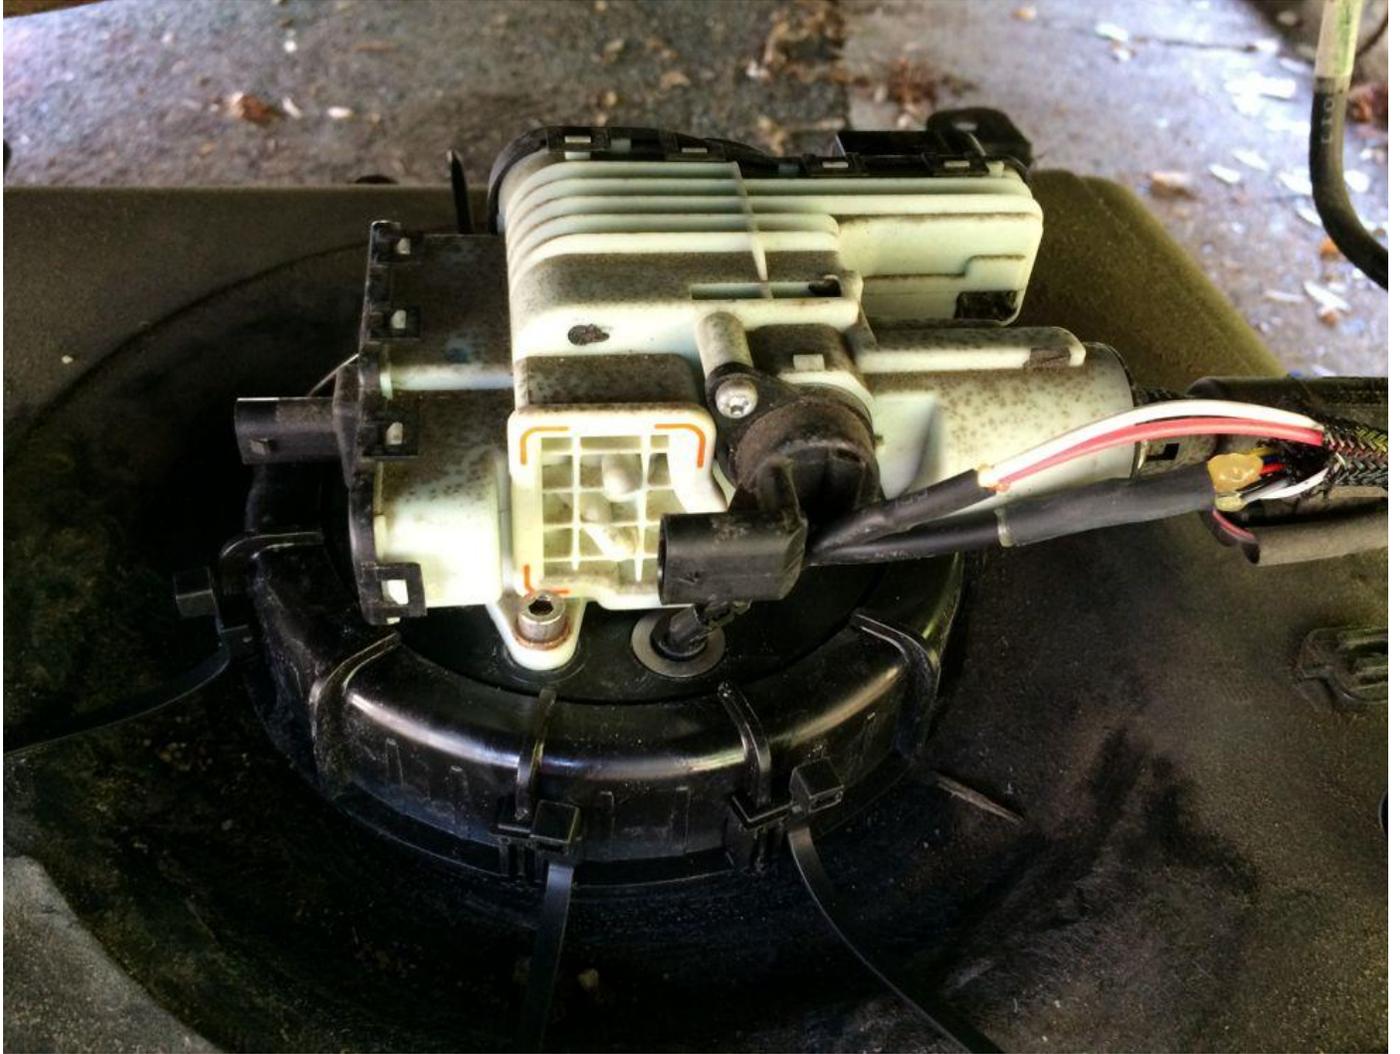
Restore pump assembly to top of additive tank lid. There are two rubber rings used to promote a seal on the pump inlet and outlet, one is a small (6mm) O-ring, the other is thick (5mm x 14mm) rubber washer. The new tank lid already had the thicker washer seal installed, I put the smaller O-ring on the smaller pressure outlet of the pump housing. I used a little petroleum jelly to lube the larger fluid inlet, so it would more easily slide into the thicker washer seal on the lid. Secure the pump with the three 4mm hex head screws.
