# DIY for Adblue Heater:

Codes are 20BD18 and 20BE1B.

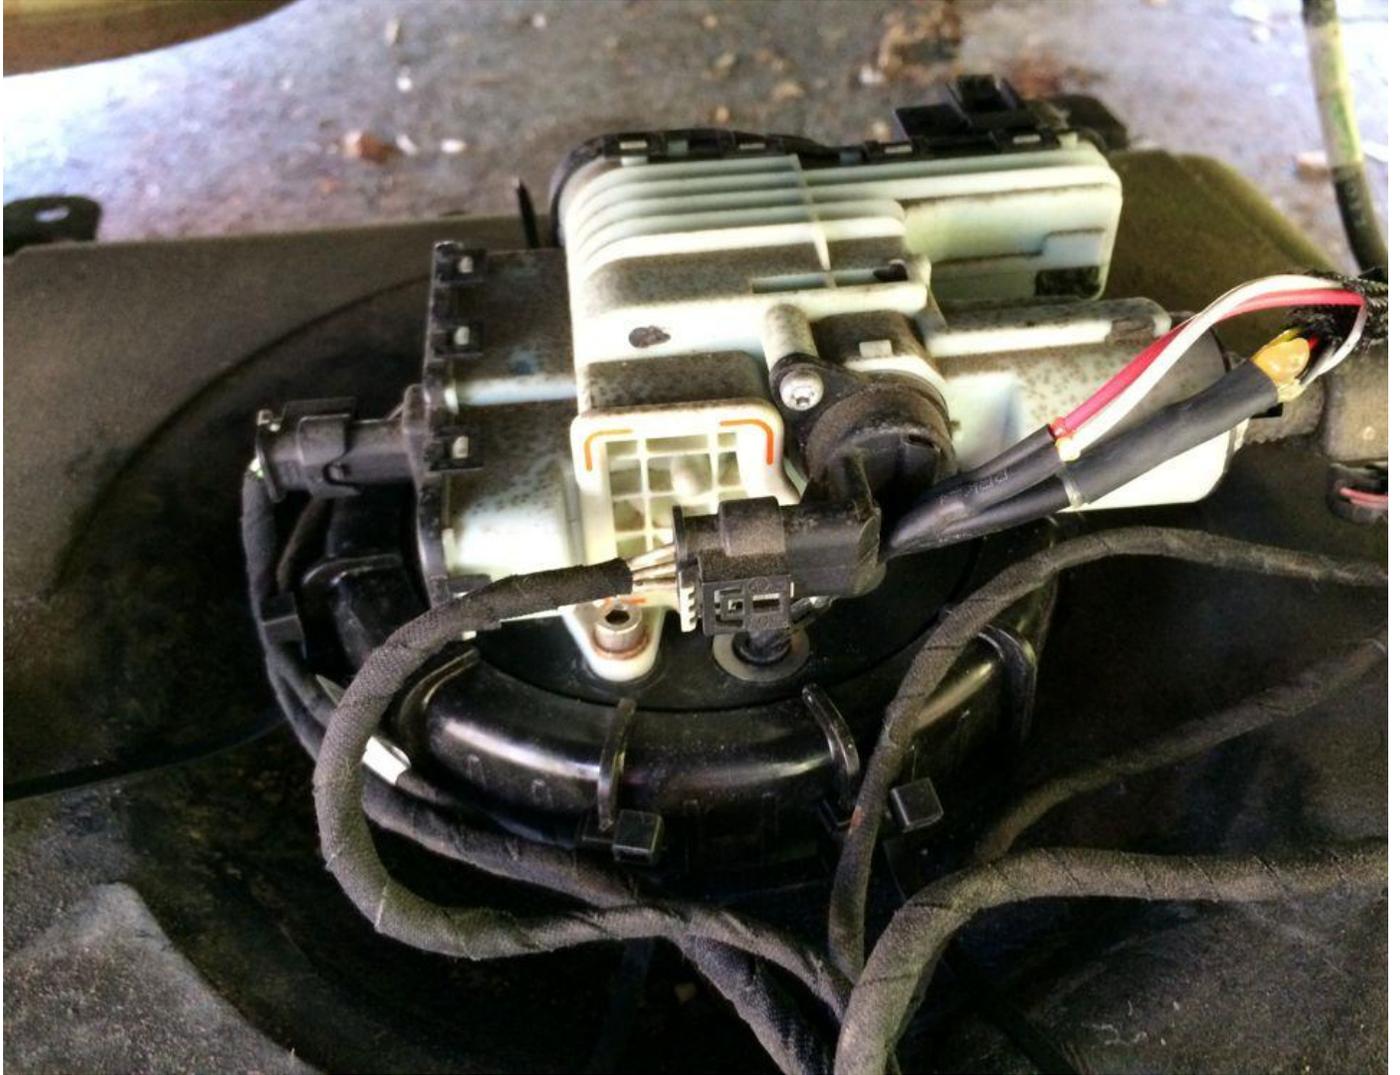
Reattach the electrical connections to the pump and the tank harness. Zip tie the cables routed around the perimeter of the lid to tidy everything up (not pictured.)

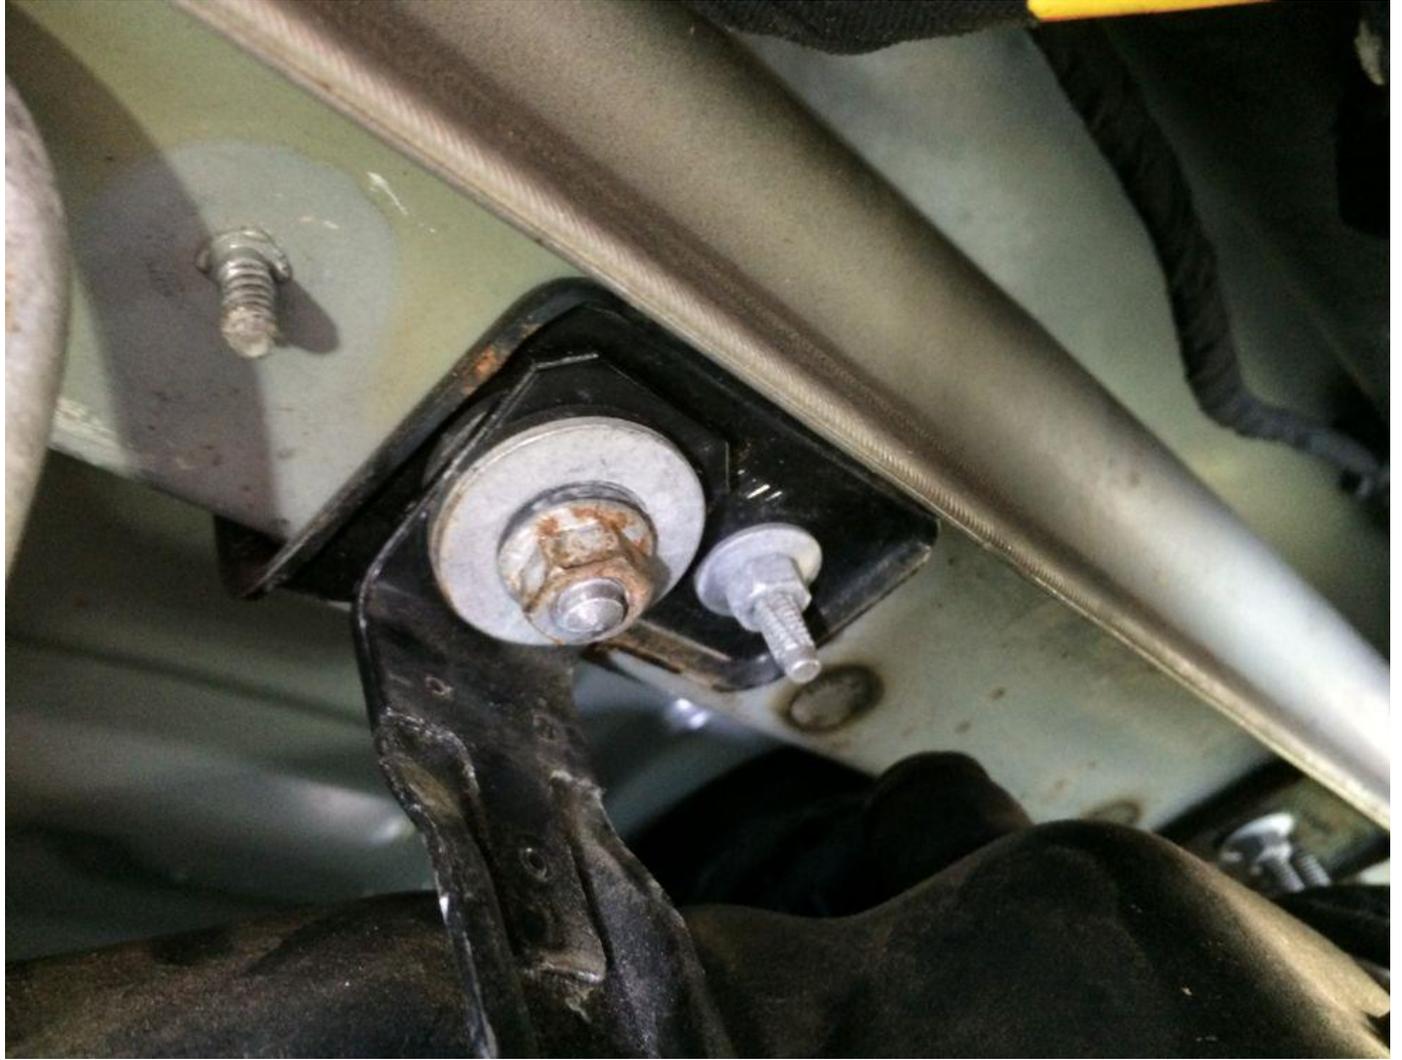
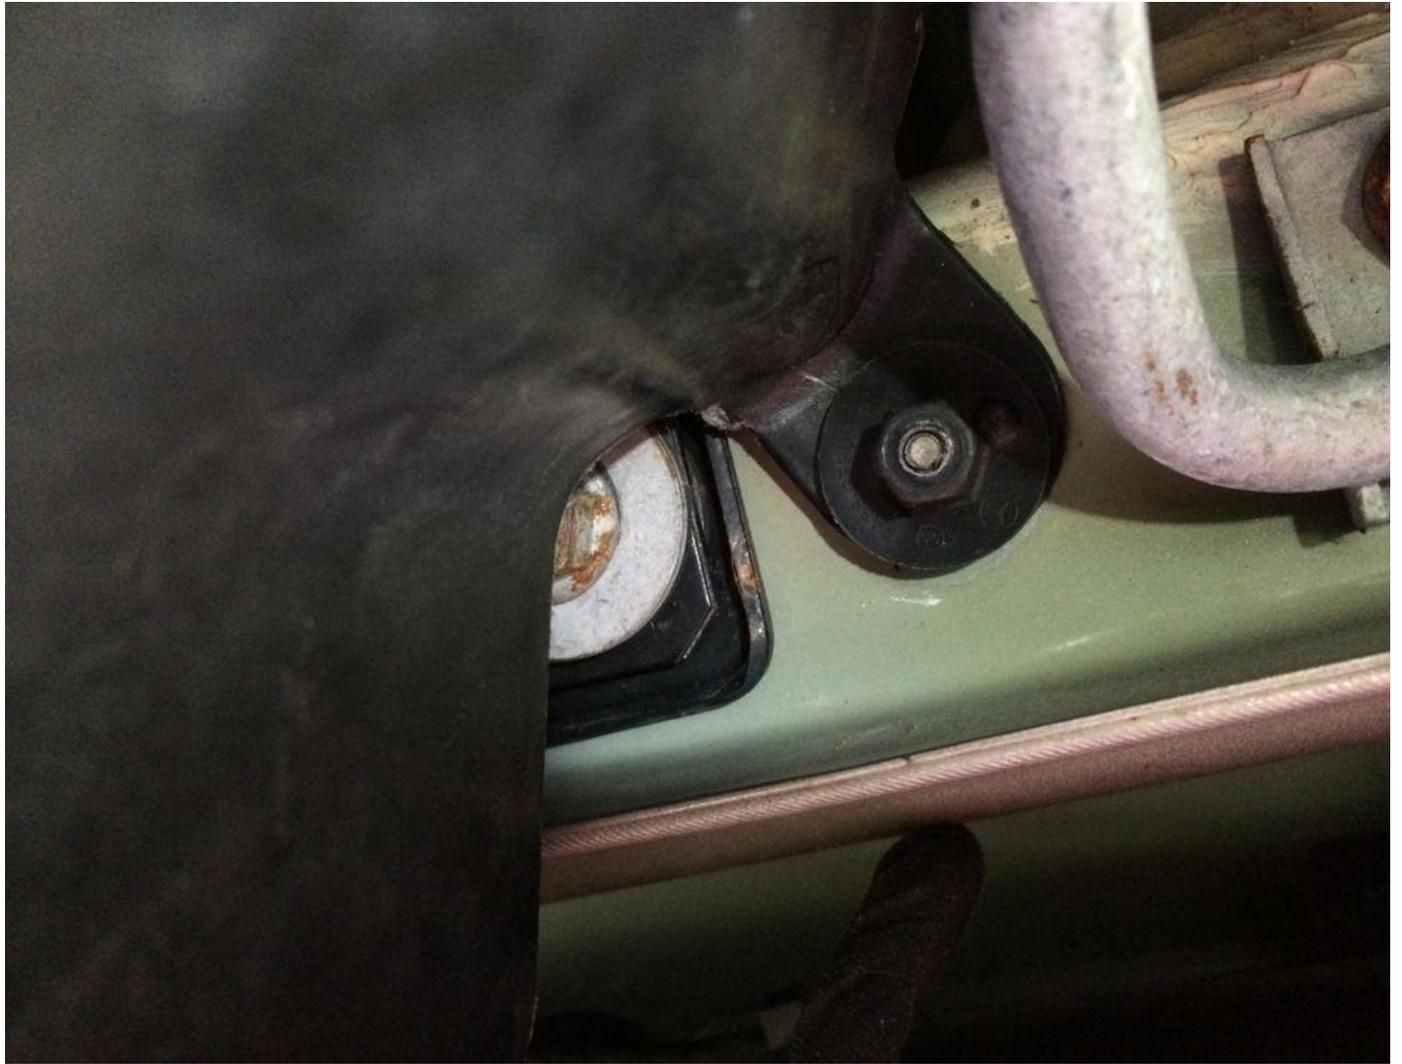
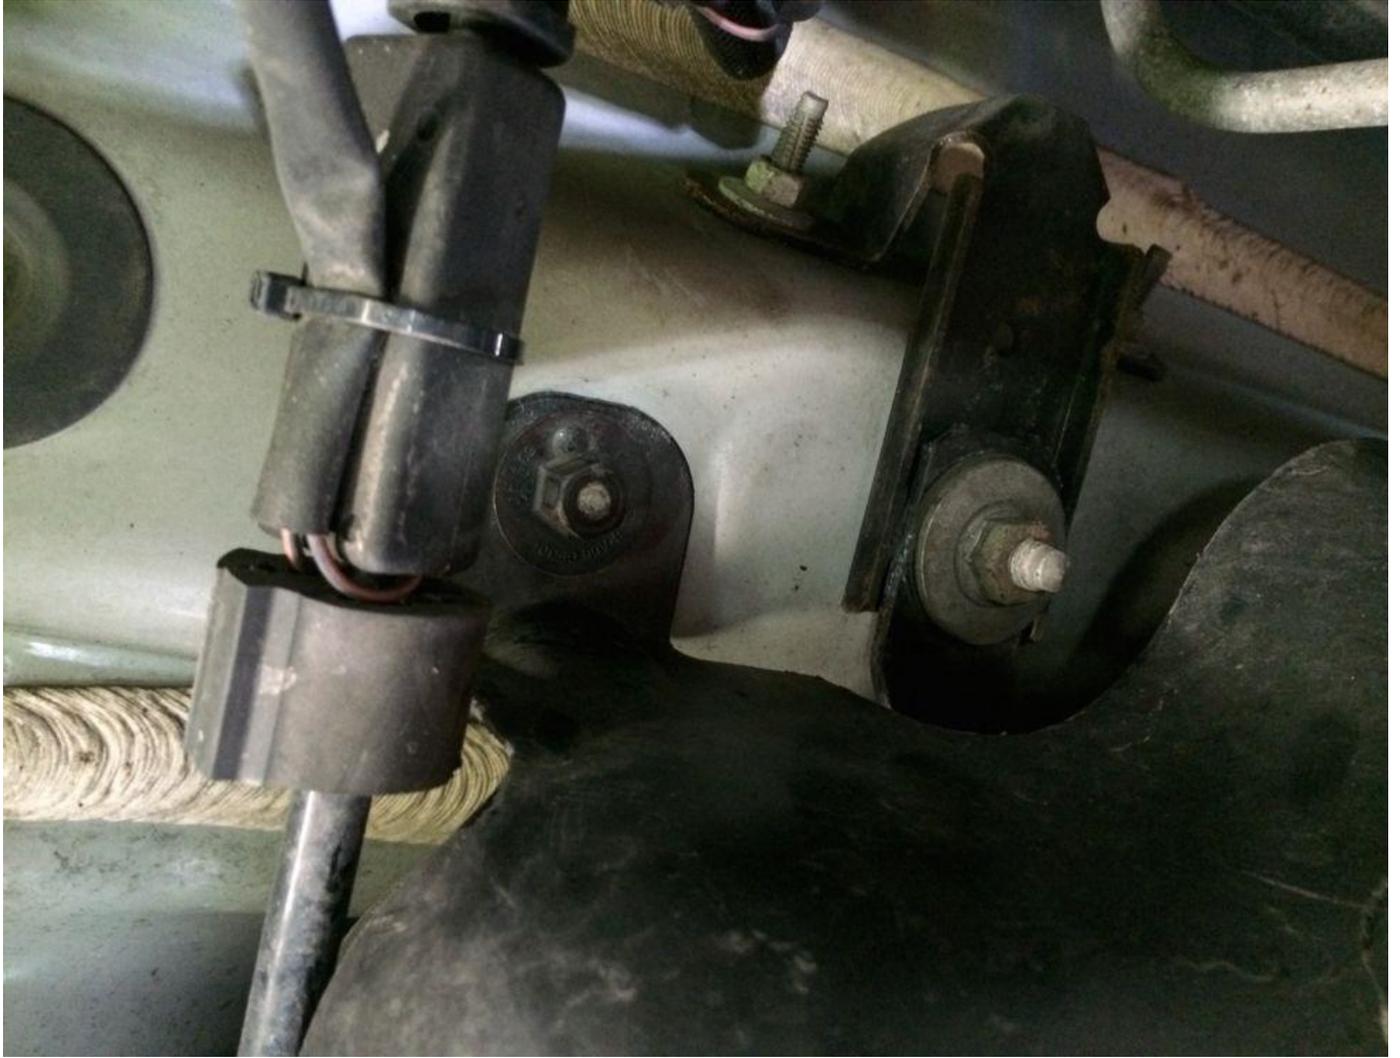
Restore the tank to the mounted position and attach the support straps and then the four plastic cover nuts.
