MODEL 204, 207, 212, 216, 221

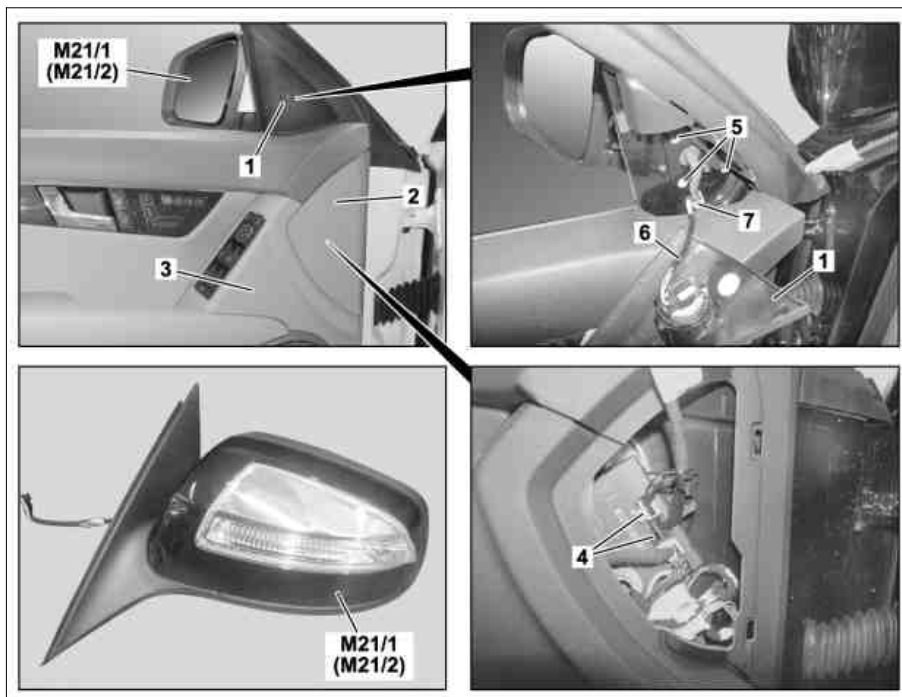
P88.70-2482-06

Shown on model 204 up to model year 2011

- 1 Mirror triangle paneling
- 2 Cover
- 3 Door lining
- 4 Electrical connections
- 5 Bolts
- 6 Electrical line
- 7 Omega clip
- M21/1 Left outside mirror
- M21/2 Right outside mirror

☒ ☒	Remove/install		
1	Unclip left and right mirror triangle paneling (1) and allow electrical line (6) to hang down	☑ Mounting wedge	*110589035900
2	Remove rear soundproofing from cover on mirror triangle (1)	MODEL 204, 216, 221	
3	Unclip window frame paneling in area of threaded connection on left outside mirror (M21/1) or right outside mirror (M21/2)	MODEL 204.9	
4	Unclip cover (2) from door lining (3) and remove	☑ Mounting wedge	*110589035900
5	Disconnect electrical connectors (4)

6	Disconnect electrical connector (8)	MODEL 212 with CODE 501 (360 degree camera)	
7	Remove omega clip (7)	MODEL 204, 212	
8	Protection door lining (3) in area of bolts (5) against damage with adhesive tape	MODEL 207	
9	Remove bolts (5) and remove left outside mirror (M21/1) or right outside mirror (M21/2)	i Prevent screws (5) from falling.	
10	Install in the reverse order		
11	Calibrate 360° camera for left outside mirror (B84/7) or 360° camera for right outside mirror (B84/8) using Star Diagnosis	MODEL 212 with CODE 501 (360 degree camera)

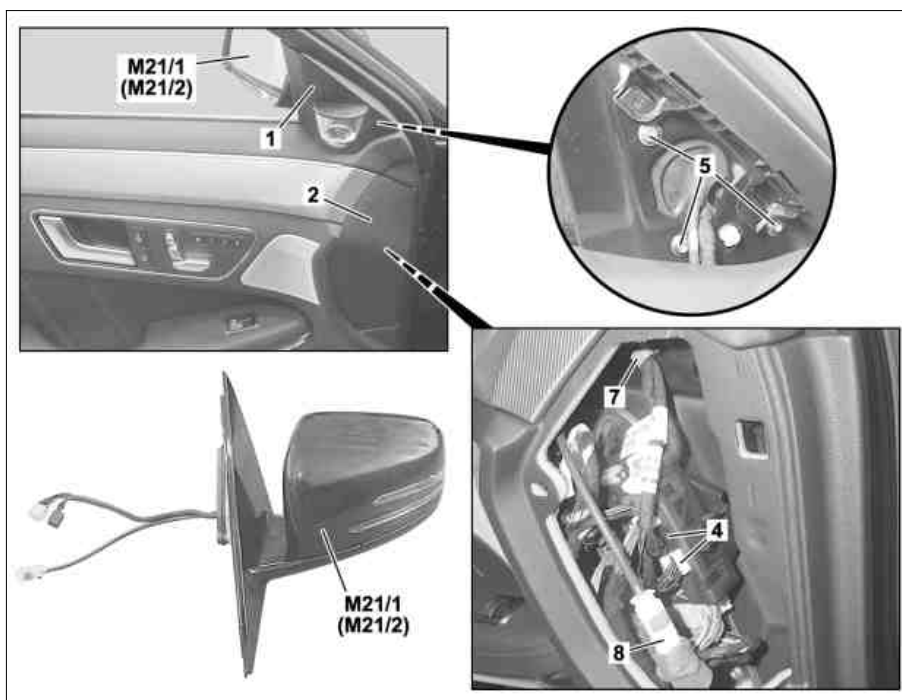
P88.70-2701-06

Shown on model 212 as of model year 2014

- 1 Mirror triangle paneling
- 2 Cover
- 4 Electrical connections
- 5 Bolts
- 7 Omega clip
- 8 Electrical connector
- M21/1 Left outside mirror
- M21/2 Right outside mirror
