MODEL	204.0/2/3 with CODE 614 (Bi-xenon headlamp unit)
MODEL	204.0/2/3 with CODE 615 (Bi-xenon headlamps with active light function)
MODEL	204.0/2/3 with CODE 616 (Bi-xenon headlamp unit with integrated asymmetric curve illumination)
MODEL	204.0/2/3 with CODE 618 (Bi-xenon headlamps)
MODEL	204.0/2/3 with CODE 621 (Intelligent Light System (left-hand traffic))
MODEL	204.0/2/3 with CODE 622 (Intelligent Light System)
MODEL	204.9 with CODE 614 (Bi-xenon headlamp unit)
MODEL	204.9 with CODE 615 (Bi-xenon headlamps with active light function)
MODEL	204.9 with CODE 616 (Bi-xenon headlamp unit with integrated asymmetric curve illumination)
MODEL	204.9 with CODE 621 (Intelligent Light System (left-hand traffic))
MODEL	204.9 with CODE 622 (Intelligent Light System)
MODEL	207, 212 with CODE 615 (Bi-xenon headlamps with active light function)
MODEL	207, 212 with CODE 616 (Bi-xenon headlamp unit with integrated asymmetric curve illumination)

Shown on model 204.0

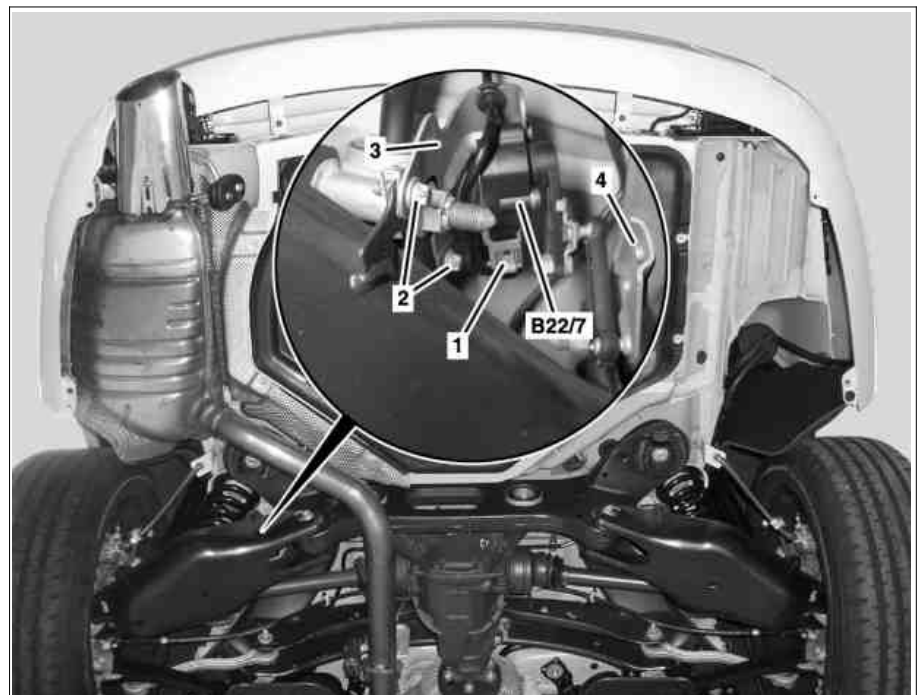
P82.10-4634-06

1	Electrical connector
2	Bolts
3	Bracket
4	Bracket
B22/7	Left rear level sensor

Remove/install		
	Risk of death caused by vehicle slipping or toppling off of the lifting platform.	Align vehicle between vehicle lift columns and position the four support plates at the vehicle lift support points specified by the vehicle manufacturer.	AS00.00-Z-0010-01A
1	Lift vehicle on vehicle lift		
2	Remove bracket (4) from underfloor		
3	Disconnect electrical connector (1)		
4	Remove electrical wiring harness from bracket (3)		
5	Remove bracket (3) from spring control arm		
6	Remove left rear level sensor (B22/7) together with brackets (3, 4)		
7	Install in the reverse order		
8	Connect diagnostic system, read out fault memory and adjust zero position of headlamps		AD00.00-P-2000-04A
