P82.62-3490-09

Remove/install		
	Information on preventing damage to electronic components due to electrostatic discharge		AH54.00-P-0001-01A
	Notes on avoiding damage to fiber optic cables during repair work		AH82.60-P-0001-05AK
1	Buffer basic data of sound system amplifier control unit (N40/3) in STAR DIAGNOSIS	When replacing the sound system amplifier control unit (N40/3). Installation: Transmit buffered basic data to new sound system amplifier control unit (N40/3).	
	Connect STAR DIAGNOSIS and read out fault memory		AD00.00-P-2000-04A
2	Switch off ignition and remove transmitter key or KEYLESS-GO start/stop button from electronic ignition lock control unit	KEYLESS-GO start/stop button only on vehicles with code (889) Keyless-Go.	
3	Remove left side paneling (1)		AR68.30-P-4600EW
4	Disconnect electrical connector (2)		
5	Disconnect electrical connector with fiber optic cable (3) and cover equipment connector at sound system amplifier control unit (N40/3)

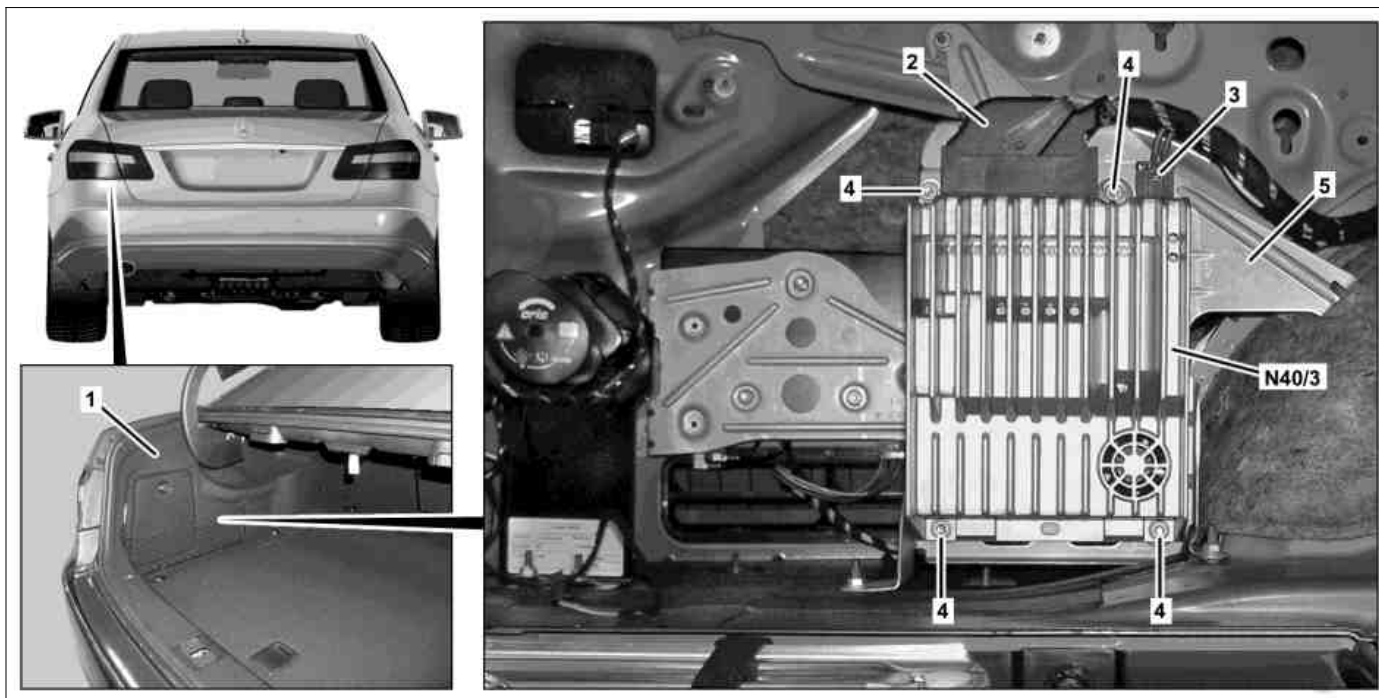
| 1 | Left side paneling | 4 | Nuts | N40/3 | Sound system amplifier control unit |
| 2 | Electrical connector | 5 | Bracket | | |
| 3 | Electrical connector with fiber optic cable | | | | |

Notes on avoiding damage to fiber optic cables during repair work	With Media Oriented System Transport (MOST)	AH82.60-P-0001-05AK
6	Unscrew nuts (4)		
7	Remove sound system amplifier control unit (N40/3) from bracket (5)		
8	Install in the reverse order
