MODEL 207, 212, 218

!	Notes on avoiding damage to optical fibers during repair work		AH82.60-P-0001-05AK
!	Information on preventing damage to electronic components due to electrostatic discharge		AH54.00-P-0001-01A
↔ ↔	Remove/install

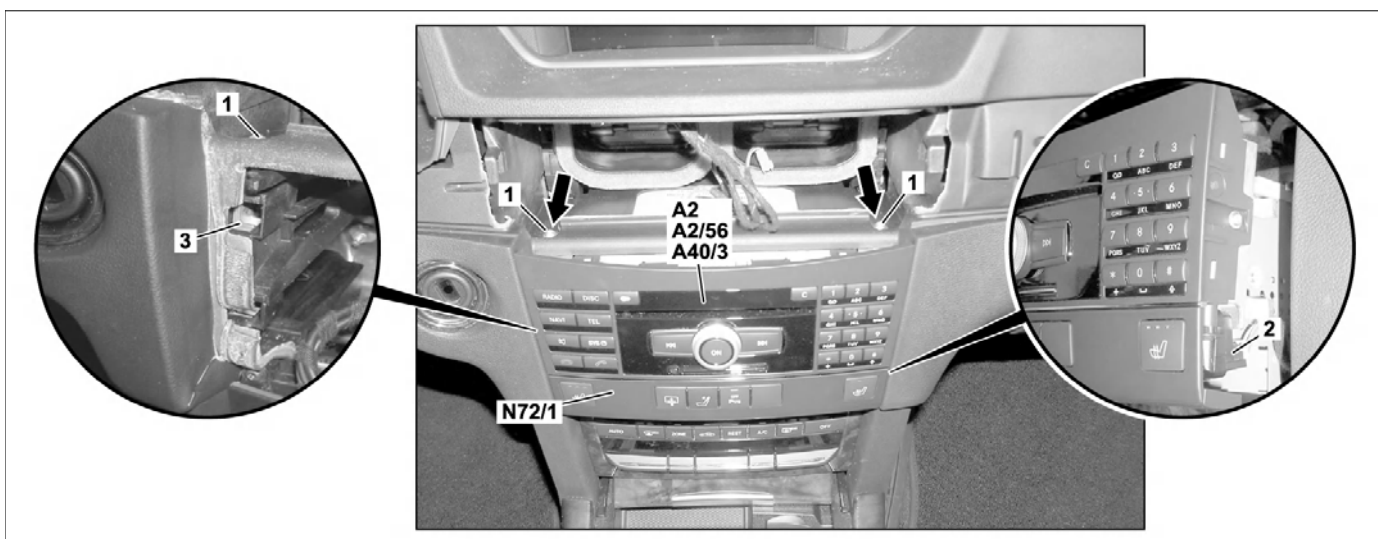
P82.60-7926-08

Shown on model 212 with open lock

1	Screw	A2	Radio (with CODE 505 (Radio 20 NTG5 without navigation capability) or with CODE 510 (Audio 20 with CD changer) or with CODE 522 (Audio 20 radio) or with CODE 523 (MB Audio 20 radio))	N72/1	Upper control panel control unit
2	Electrical connector	A2/56	Radio with auto pilot system (with CODE 511 (Audio 50 APS with DVD changer) or with CODE 525 (MB Audio 50 APS radio))		
3	Lock	A40/3	COMAND controller unit (with CODE 512 (COMAND APS with DVD changer) or with CODE 526 (COMAND (without navigation)) or with CODE 527 (COMAND APS with single DVD drive (with navigation)) or with CODE 528 (COMAND with DVD changer USA (without navigation) or with CODE 531 (COMAND APS))

2.1	Switch off ignition and remove transmitter key from electronic ignition lock control unit	MODEL 207, 212, 218 without CODE 889 (KEYLESS-GO)	
2.2	Switch off ignition and remove transmitter key or KEYLESS-GO start/stop button from electronic ignition lock control unit	MODEL 207, 212, 218 with CODE 889 (KEYLESS-GO)	
3	Remove Audio/COMAND display	MODEL 218 as of model year 2015	AR82.60-P-7722ELA
4	Remove trim piece from right instrument panel	MODEL 212, 218 MODEL 212 MODEL 218	AR68.10-P-1180EW AR68.10-P-1180EL
5	Remove center air vents	MODEL 207	AR83.10-P-4503EC
6	Unclip cover (4) from instrument panel (arrows B) and remove	MODEL 218 as of model year 2015	
7	Completely remove screws/bolts (1), position screws/bolts (1) again and press screws/bolts (1) in direction of arrow so that lock (3) is opened

The lock (3) must be completely opened. Otherwise, the radio (A2) or the radio with auto pilot system (A2/56) or the COMAND controller unit (A40/3) can be damaged.

8	Cover center console with a dry cloth and pull radio (A2) or radio with auto pilot system (A2/56) or COMAND controller unit (A40/3) far enough out of the instrument panel for the electrical connector (2) of the upper control panel control unit (N72/1) to be accessed		
9	Disconnect electrical connector (2) of upper control panel control unit (N72/1)		
10	Pull radio (A2) or radio with auto pilot system (A2/56) or COMAND controller unit (A40/3) far enough out of instrument panel until electrical connectors or optical fiber connector are accessible on the back of the unit		
11	Disconnect electrical connectors and optical fiber connector on back of radio (A2) or radio with auto pilot system (A2/56) or COMAND controller unit (A40/3), unhook retaining clip and remove radio (A2) or radio with auto pilot system (A2/56) or COMAND controller unit (A40/3)		
12	Remove upper control panel control unit (N72/1)	When replacing radio (A2) or radio with auto pilot system (A2/56) or COMAND controller unit (A40/3).	AR54.21-P-1262CY

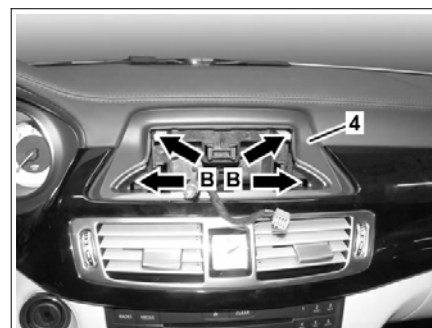
P82.60-9473-01

MODEL 218 as of model year 2015

4 Cover
