MODEL 212
with CODE 432 (Left and right dynamic multicontour seat)

MODEL 218
with CODE 432 (Left and right dynamic multicontour seat)

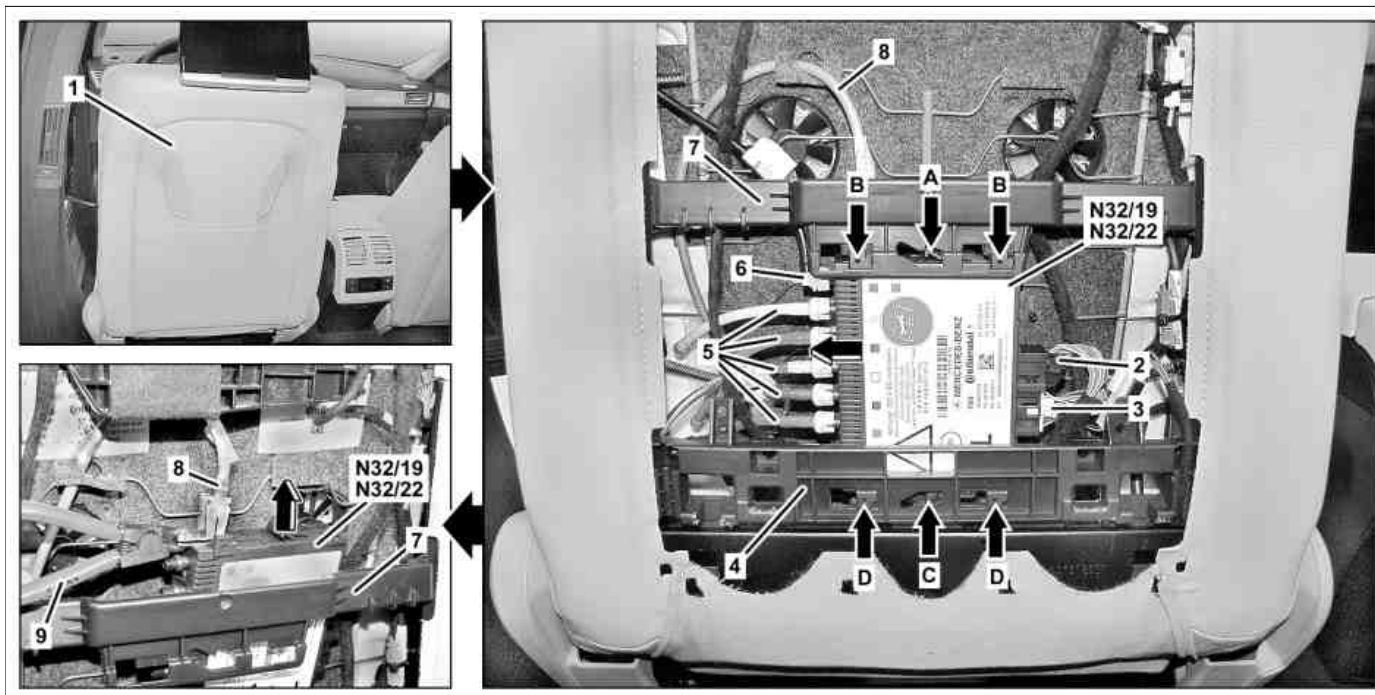
P91.25-2508-09

Shown on model 212.0

| 1 | Seat-back lining | 5 | Pneumatic lines | 9 | Pliers |
| 2 | Electrical connector | 6 | Pneumatic line | N32/19 | Left front active multicontour seat control unit |
| 3 | Electrical connector | 7 | Brace | N32/22 | Right front active multicontour seat control unit |
| 4 | Brace | 8 | Pneumatic line | | |

4	Remove seat-back lining (1)		AR91.10-P-1910CW
5	Disconnect electrical connections (2, 3)		
6	Disconnect pneumatic lines (5) with pliers (9)

Pliers	*000589043700
7	Release catch hooks (arrows A, C) and guide supports (arrows B, D) of the left front active multicontour seat control unit (N32/19) or the right front active multicontour seat control unit (N32/22) out of braces (4, 7)		
8	Disconnect pneumatic line (6) with pliers (9)

Pliers	*000589043700
9	Lift left front active multicontour seat control unit (N32/19) or right front active multicontour seat control unit (N32/22) and disconnect pneumatic line (8) with pliers (9)

Pliers	*000589043700
10	Remove left front active multicontour seat control unit (N32/19) or right front active multicontour seat control unit (N32/22) toward top		
11	Install in the reverse order
