Model 204.0/2/3, 207, 212, 218
with code 218 (Rear view camera)

**Shown on model 212.0 with code 218
(Reversing camera)**

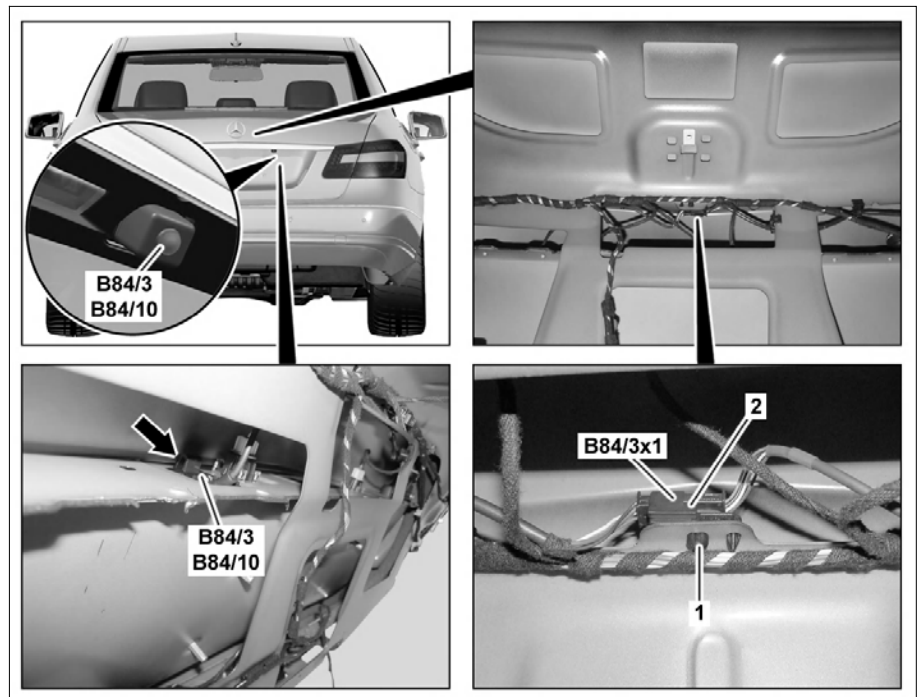
P54.65-5101-06

- 1 Bracket
2 Electrical connector (with
CODE 501 (360° camera))
B84/3 Reversing camera (with CODE
218 (Reversing camera))
B84/3x1 Electrical connection for
reversing camera (with code
218 (Reversing camera))
B84/10 Camera, rear 360° camera
(with CODE 501 (360-degree
camera))

1.2	Remove handle strip for liftgate	Model 204.2	AR72.20-P-3650CX
1.3	Pull out handle strip for liftgate using extraction hook and remove.	MODEL 212.2, 218.9 Extraction hook	*140589023300
2	Remove liftgate paneling	MODEL 212.2, 218.9 Model 212.2	AR72.20-P-3520ES
3	Disconnect electrical connection for reversing camera (B84/3x1) or electrical connection (2)		
4	Release catch hook on coupling of backup camera electrical connector (B84/3x1) and slide coupling of backup camera connector (B84/3x1) from bracket (1)	Model 204.0/2/3, 207.3/4, 212.0/1, 218 with code 218 (Reversing camera)	
5	Unlock catches (arrow) and remove reversing camera (B84/3) or rear 360° camera (B84/10) from outside	Installation: Inspect gasket for damage. If seal is damaged Replace seal ↓	
6	Install in the reverse order		
7	Perform initial startup of reversing camera (B84/3) or rear 360° camera (B84/10)	If reversing camera (B84/3) or rear 360° camera (B84/10) was replaced.
