Model 205 with transmission 722, 724, 725

Model 213 with transmission 725 Model 253 with transmission 724, 725

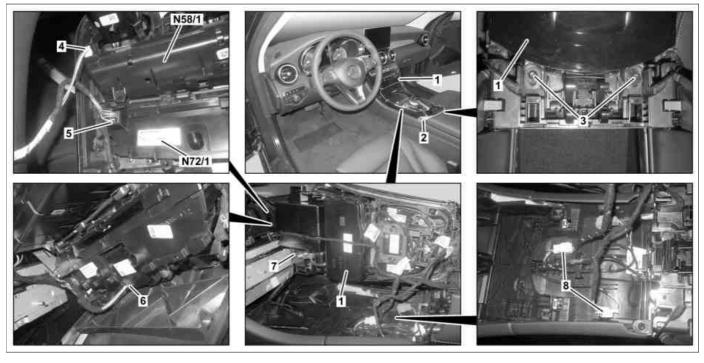
P68.20-4707-09

Shown on model 205

1	Center console cover	6	Electrical connector
2	Stowage box cover	7	Electrical connector
3	Bolts	8	Electrical connectors
4	Electrical connector (with code 581 (automatic air	N58/1	Air conditioning operating unit (with code 581 (automatic
	conditioning))		air conditioning))
5	Electrical connector	N72/1	Upper control panel control unit

(3)	Information on preventing damage to electronic components due to electrostatic discharge		AH54.00-P-0001-01A
\mathbf{X}	Remove/install		
1	Switch off ignition		
2	Remove stowage box cover (2)	Model 205 with transmission 722, 724, 725 Model 253 with transmission 724, 725	AR68.20-P-1020LW
		Model 213 with transmission 725	AR68.20-P-1020LWE
3	Unscrew bolts (3) from center console cover (1)		
4	Lift center console cover (1) at rear and move out of instrument panel at top front until electrical connectors (4, 5) are accessible	Cover center console and instrument panel with a cloth. Otherwise the center console and instrument panel may be damaged.	
5	Disconnect electrical connector (4) from air conditioning operating unit (N58/1)	Model 205 with transmission 722, 724, 725 with code 581 (Automatic air conditioning) Model 213 with transmission 725 with code 581 (Automatic air conditioning) Model 253 with transmission 724, 725 with code 581 (Automatic air conditioning)

6	Disconnect electrical connector (5) at upper control panel control unit (N72/1)		
7	Disconnect electrical connectors (6, 7, 8)	i The number can vary according to the equipment.	
8	Remove cover on center console (1)

9	Install in reverse order
