Model 213  
 Model 238

**Shown on model 213.0**

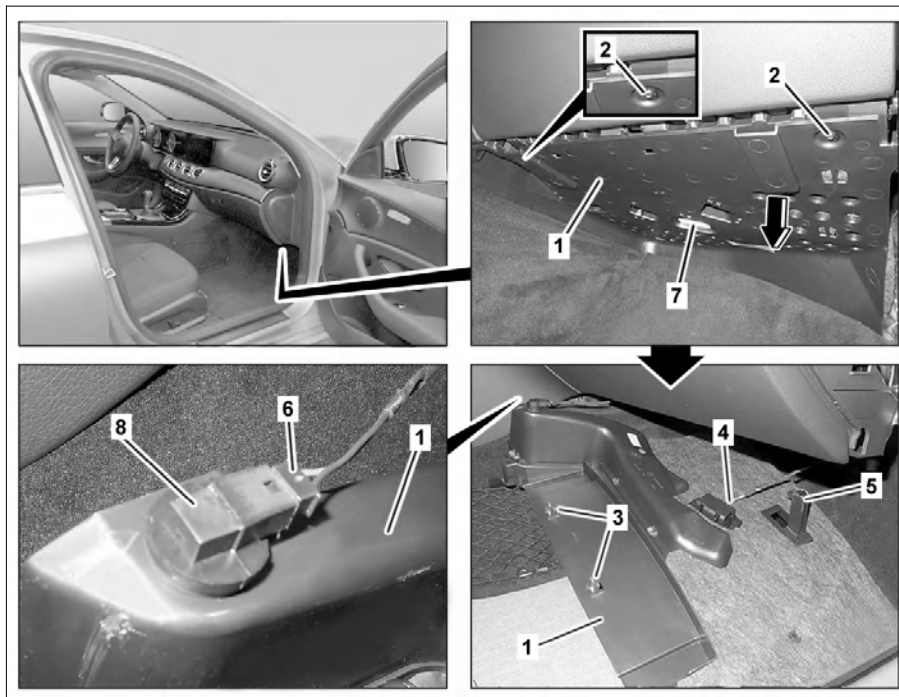
P68.10-5446-06

- 1 Cover
- 2 Screw
- 3 Retaining clips
- 4 Electrical connector
- 5 Hook
- 6 Electrical connector
- 7 Footwell lamp
- 8 Temperature sensor

Remove/install		
1	Move passenger seat to end position toward rear		
2	Remove door sill molding	Model 213 Model 238	AR68.30-P-4100LW AR68.30-P-4100CLW
3	Unscrew bolts (2)		
4	Unclip cover (1) from retaining clips (3), push outward using hook (5), unhook, and lower (arrow) until electrical connectors (4, 6) are accessible

Mounting wedge	*110589035900
5	Disconnect electrical connections (4, 6)		
6	Take off cover (1)		
7	Transfer temperature sensor (8)	When replacing cover (1).	
8	Transfer footwell lamp (7)	When replacing cover (1).	
9	Install in the reverse order
