Model 205.0/1
 Model 213.0

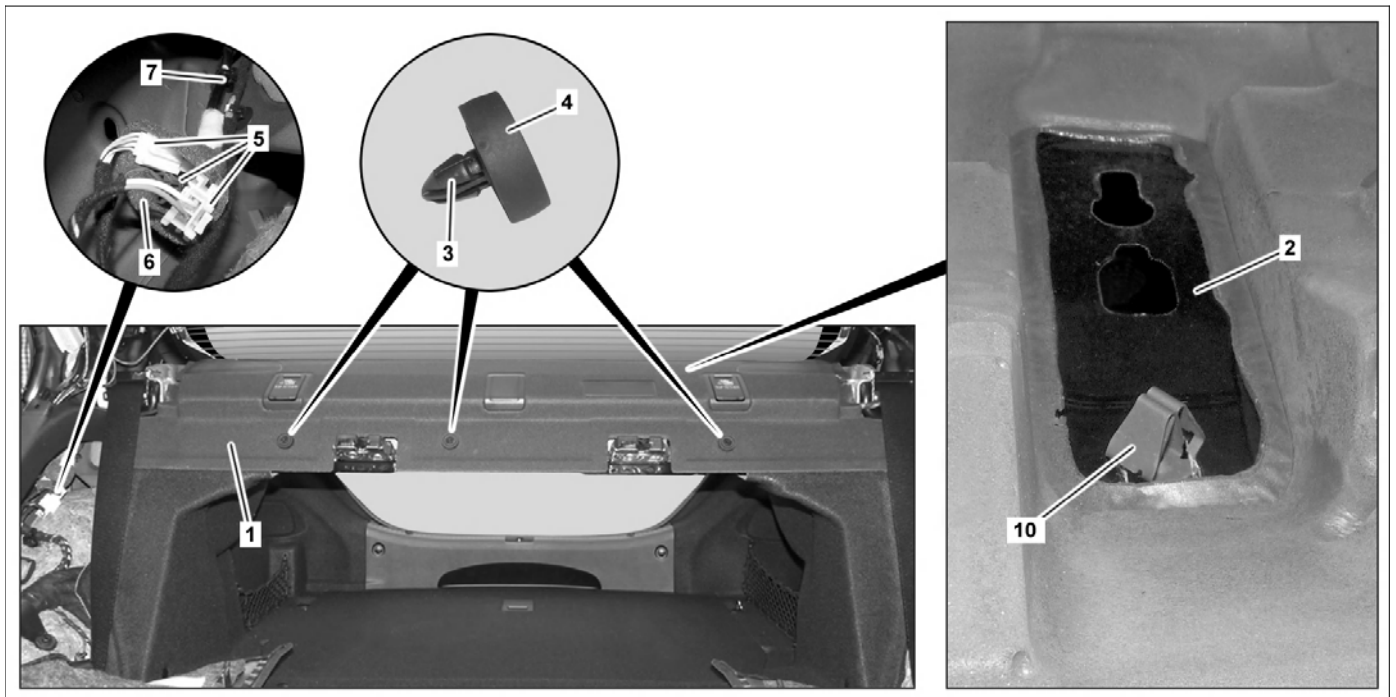
P68.30-3743-09

Shown on model 205.0 with code 287 (Folding seat backrest in rear), code 540 (Electric roller sun blind for rear window) and code 810 (Sound system)

| 1 | Rear shelf | 5 | Electrical connectors |
| 2 | Bodywork | 6 | Foam material |
| 3 | Mounting clip | 7 | Mounting clip |
| 4 | Spacer | 10 | Sheet metal clip |

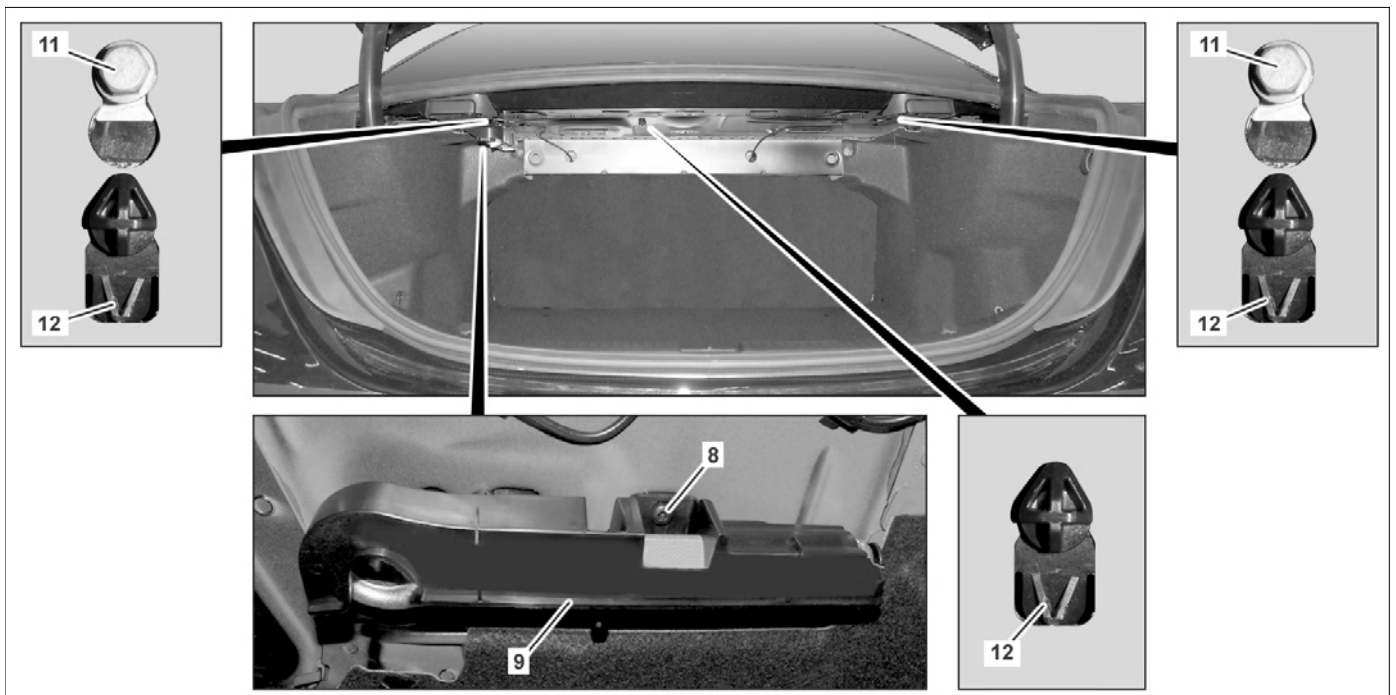
P68.30-3744-09

Shown on model 205.0 with code 287 (Folding seat backrest in rear), code 540 (Electric roller sun blind for rear window) and code 810 (Sound system)

- 8 Screw
- 9 Towing eye bracket

- 11 Screw
- 12 Catch

4	Remove anchor fitting on center seat belt	Model 205.0/1 except code 287 (Sitzlehnen im Fond klappbar) Model 213.0 except code 287 (Sitzlehnen im Fond klappbar) i Installation: Ensure bulb is correctly installed. Nm Bolt, rear belt end fitting	*BA91.40-P-1005-01U
5	Remove both C-pillar trims and guide out of working area along seat belts	Model 205.0/1 Model 213.0 i Belt end fittings must not be detached.	AR68.30-P-4490LW AR68.30-P-4490LWE
6	Remove retaining clips (3) together with spacers (4)	S Clip remover	*452589016300
7	Slightly fold back foam material (6) and disconnect electrical connectors (5)	i Installation: Completely fold back foam material (6) over electrical connectors (5). Otherwise noise may occur. i The number of electrical connectors (5) may vary depending on the equipment.	
8	Unclip retaining clip (7)	S Clip remover	*452589016300
9	Unscrew bolt (8) from towing eye bracket (9) and remove towing eye bracket (9)	Model 205.0/1 i Installation: Hook towing eye bracket (9) into body (2) together with sheet metal clip (10) and clip in.

10	Loosen screws (11)	Model 205.0/1 with code 540 (Electric sunblind for rear window) Model 213.0 with code 540 (Electric sunblind for rear window)	
11	Unlock catches (12) on rear shelf (1) and slightly push rear shelf (1) toward front	i Installation: Ensure that arrests (12) are seated correctly.	
12	Lift rear shelf (1) and guide center seat belt with anchor fitting through cover (13) of center belt guide	Model 205.0/1 except code 287 (Sitzlehnen im Fond klappbar) Model 213.0 except code 287 (Sitzlehnen im Fond klappbar)	
13	Remove rear shelf (1) from vehicle	i Helper required.	
14	Remove sheet metal clip (10) from body (2)	Model 205.0/1 i Installation: Screw sheet metal clip (10) to towing eye bracket (9) with bolt (8).	
15	Remove cover (13)	When replacing rear shelf (1).	
16	Remove Isofix coverings (14)	When replacing rear shelf (1).	
17	Disconnect electrical connectors from speakers (15)	Model 205.0/1 with code 810 (Sound system) Model 213.0 with code 810 (Sound system) Model 213.0 with code 811 (Advanced sound system) When replacing rear shelf (1).

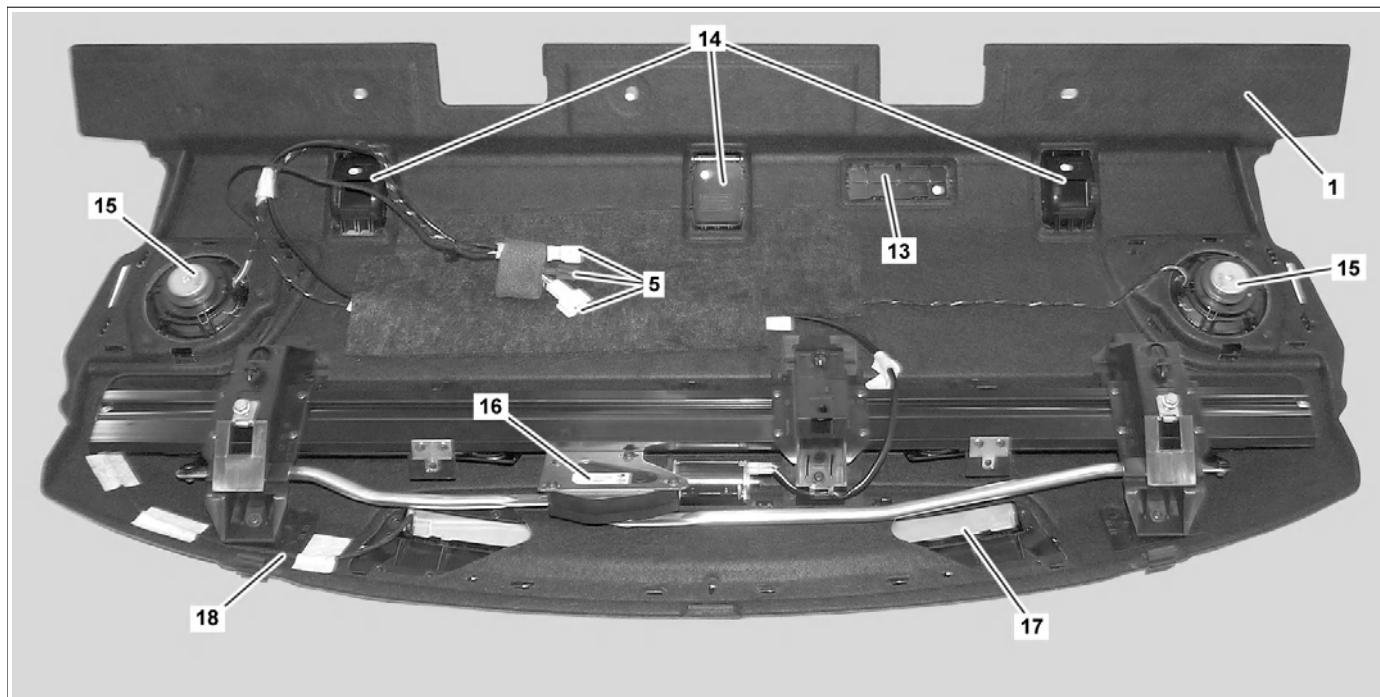
P68.30-3745-09

Shown on model 205.0 with code 287 (Folding seat backrest in rear), code 540 (Electric roller sun blind for rear window) and code 810 (Sound system)

- 1 Rear shelf
- 5 Electrical connectors
- 13 Cover
- 14 Isofix coverings

- 15 Speaker
- 16 Roller sun blind
- 17 Additional brake lamp
- 18 Electrical wiring harness

18	Remove cover above speakers (15)	Model 205.0/1 with code 810 (Sound system) Model 213.0 with code 810 (Sound system) Model 213.0 with code 811 (Advanced sound system) When replacing rear shelf (1).	
19	Remove speakers (15)	Model 205.0/1 with code 810 (Sound system) Model 213.0 with code 810 (Sound system) Model 213.0 with code 811 (Advanced sound system) When replacing rear shelf (1).	
20	Remove tweeters	Model 213.0 with code 811 (Advanced sound system)	
21	Remove roller sun blind (16)	When replacing rear shelf (1). Model 205.0/1 with code 540 (Electric sunblind for rear window) Model 213.0 with code 540 (Electric sunblind for rear window)	AR68.50-P-3400LW AR68.50-P-3400LWV

22	Remove additional brake lamp (17)	When replacing rear shelf (1). i Installation: Replace adhesive strips for fastening electrical wiring harness (18) on additional brake lamp (17).	
23	Install in the reverse order
