Model 213.0/1 Model 238.3

P68.30-3885-09

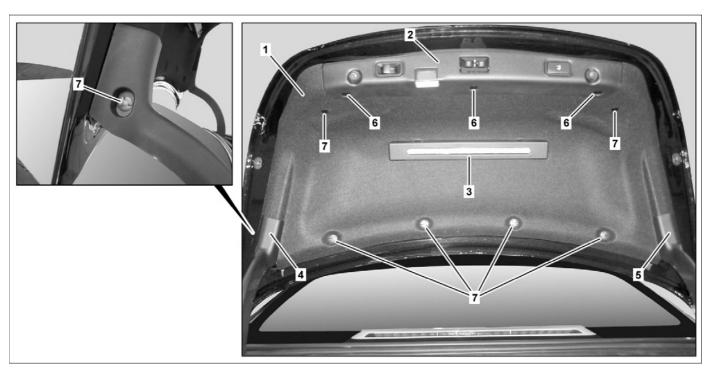
Shown on model 213.0

- 1 Cover
- 2 Cover
- 3 Hazard warning triangle bracket
- 4 Hinge cover

- 5 Hinge cover
- 6 Mounting clip
- 7 Retaining clips

Risk of injury caused by fingers being jammed or pinched when removing, installing or aligning hoods, doors, trunk lid/rear-end door or sliding roof.	No parts of the body or limbs should be within the operating area when the components are moving.	AS00.00-Z-0011-01A
i	Notes on sensor system for trunk lid opening/closing	Model 213.0/1, 238.3 with code P17 (KEYLESS-GO package)	AH80.61-P-0001-01A
XX	Remove/install		
1	Remove warning triangle (3) from warning triangle bracket		
2	Remove rear hazard warning triangle (3)	S Clip remover	*452589016300
3	Unclip retaining clips (6)	Clip remover	*452589016300
4	Unclip paneling (2) and disconnect electrical connector	i The number of electrical connectors may vary depending on the equipment.	
5	Remove trim panel (2)		
6	Unclip retaining clips (7) from hinge covers (4, 5)	S Clip remover	*452589016300
7	Unclip remaining retaining clips (7)		
8	Remove paneling (1) upward from hinge covers (4, 5)

9	Install in the reverse order
