- Model 205.2
with code 890 (EASY-PACK-tailgate)
- Model 213.2
with code 890 (EASY-PACK-tailgate)
- Model 253.1/9
with code 890 (EASY-PACK-tailgate)
- Model 293
with code 890 (EASY-PACK-tailgate)

P72.20-3367-09

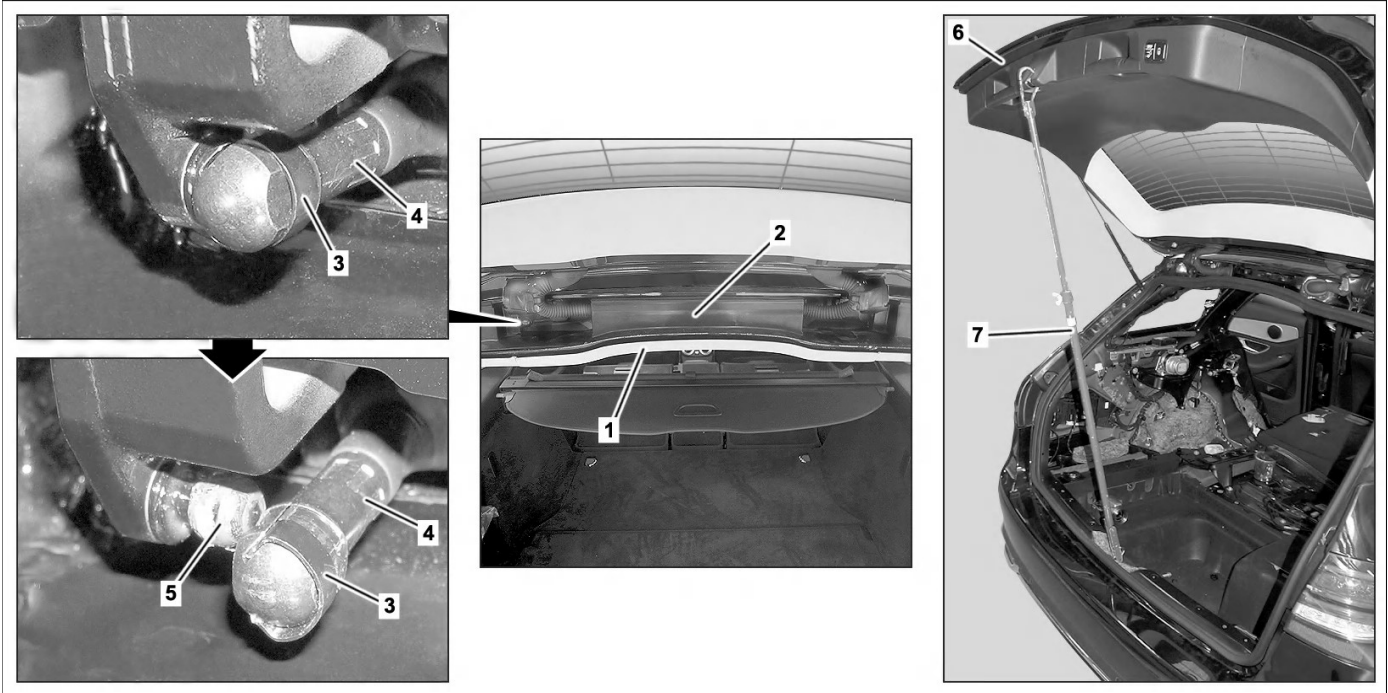
Shown on MODEL 205.2

| 1 Headliner | 5 Ball head |
| 2 Cover | 6 Liftgate |
| 3 Fuse | 7 Support |
| 4 Tappet | |

Remove/install		
1	Remove roof lining (1).		AR68.30-P-4300LWS
2	Unclip cover (2) and remove.		
3	Secure liftgate (6) with support (7).

Support	*170589046300
4	Lift retainer (3) with suitable screwdriver and remove tappet (4) of the trunk lid/liftgate control drive unit (M51/3) from the ball head (5).

Do not remove locking device (3). Otherwise, the retainer (3) preload can be lost.

Installation: Install plunger (4) on trunk lid/liftgate control drive unit (M51/3) with installed retainer (3) on ball head (5).

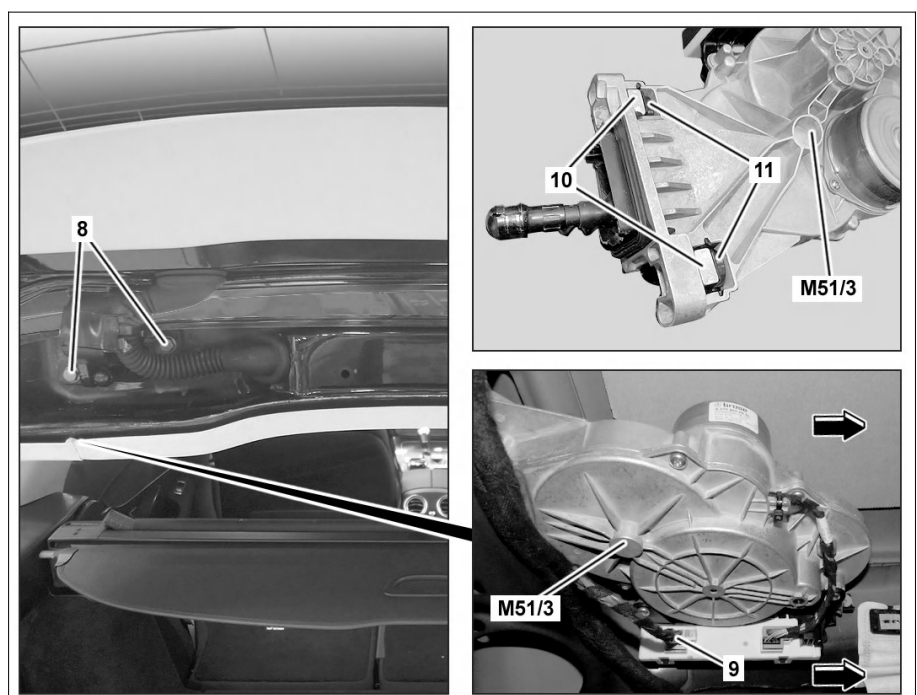
Shown on MODEL 205.2

| 8 Bolts |
| 9 Electrical connector |
| 10 Square nuts |
| 11 Plastic clips |
| M51/3 Trunk lid/liftgate control drive unit |

5	Remove screws (8).

Bolt, drive for automatic liftgate to roof frame	*BA72.20-P-1006-02N
6	Detach electrical connection (9).		
7	Remove trunk lid/liftgate control drive unit (M51/3) in the direction of the arrow.

Installation: Ensure that square nuts (10) and plastic clips (11) are seated correctly in trunk lid/liftgate control drive unit (M51/3).	
8	Install in the reverse order.		
9	Normalize trunk lid/liftgate control drive unit (M51/3) with vehicle diagnosis system.	When replacing trunk lid/liftgate control drive unit (M51/3). Model 205.2, 213.2, 253.1/9 with code 890 (EASY-PACK-tailgate) Model 293 with code 890 (EASY-PACK-tailgate)	AD00.00-P-2000-04B AD00.00-P-2000-06FR
