Service Campaign Bulletin

Campaign No. 2019080019, November 2019

SUBJECT: **Various Models**
Model Years 2012-2017

Replace Steering Gear Bolts

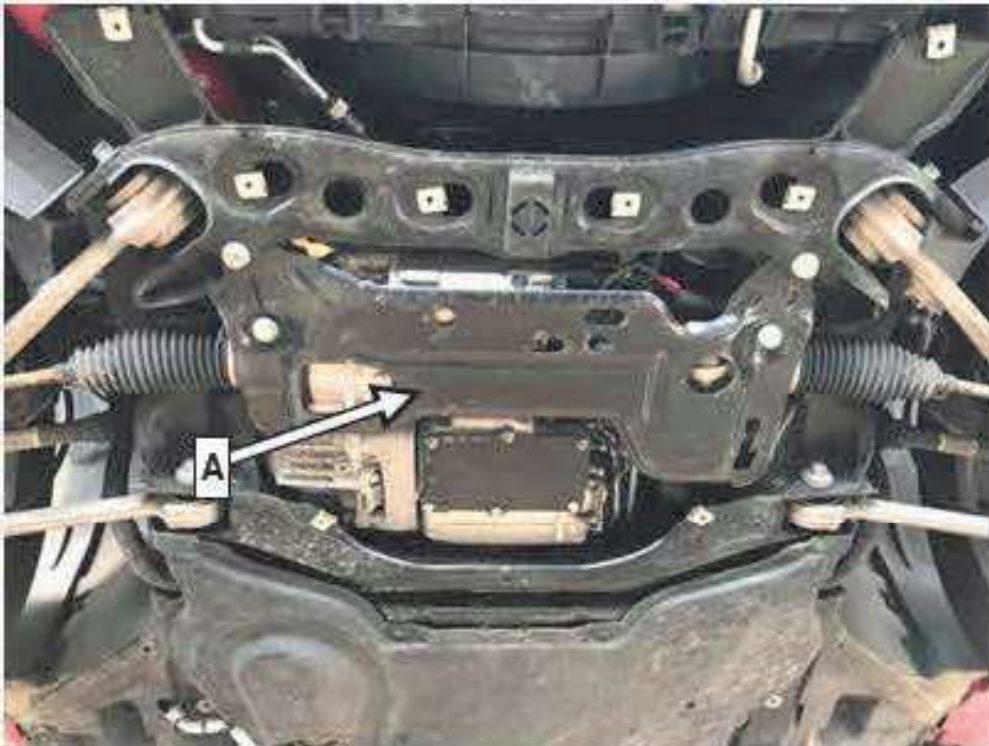
Figure 1

1. Remove center section of lower engine compartment lining.
2. Remove mounting plate (A, Figure 1) for steering gear.
 - i** For basic data, see AR46.20P-0600EL.
 - i** For basic data, see AR46.20-P-0600LF.

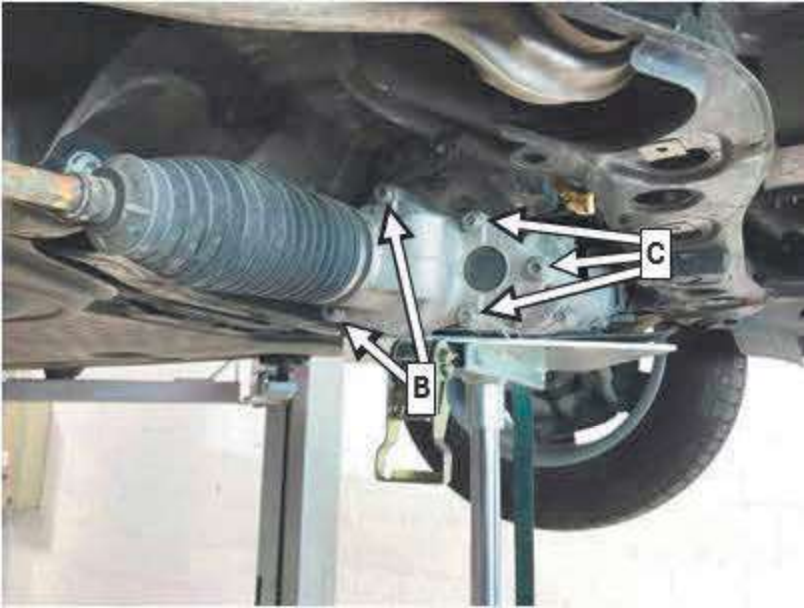
Figure 2

4. Remove screws (B and C, Figure 2), making **absolutely sure** to do so **individually and one after the other**, replace with new steel screws and tighten with the specified torque incl. tightening angle.

- i** The procedure must be completed so that the power-pack does not twist away from its set position thus resulting in consequential damage.
 - Hm** Power-pack screw on steering gear: **5 Nm and 90°** tightening angle.

- i** If a **screw** should **break off** or have already broken off, **replace the electric power steering rack.**
 - i** For basic data, **see AR46.20-P-0600EL and AR46.20-P-0600EF.**

1. Remove center section of lower engine compartment lining.
2. Remove screws (B and C, Figure 2), making **absolutely sure** to do so **individually and one after the other**, replace with new steel screws and tighten with the specified torque incl. tightening angle.

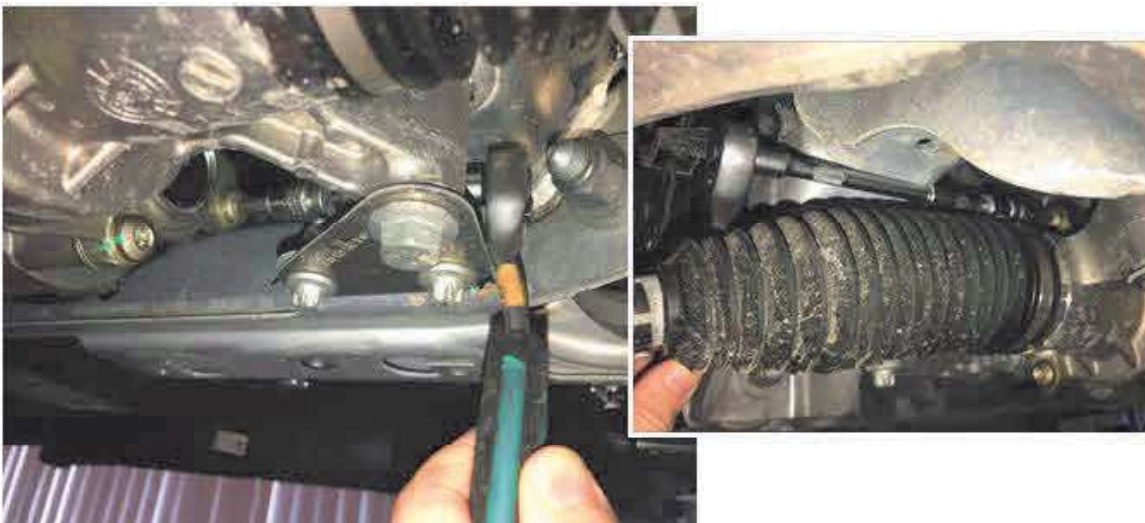
Figure 4

- i** The procedure must be complied with so that the power-pack does not twist away from its set position thus resulting in consequential damage.
 - i** For models 205, 213, 238, and 253, the steering **does not have** to be released from the front axle carrier.

- Nm** Power-pack screw on steering gear: **5 Nm and 90°** tightening angle.
 - i** If a **screw** should **break off** or have already broken off, **replace the electric power steering rack**.

3. After replacing the screws, apply a generous coat of wax to the area (**D, Figure 3**) around the threaded connections and around the gap between the power-pack and the steering.
 - i** Wax gap between power-pack and steering **all-round**.
4. Assemble in reverse order.

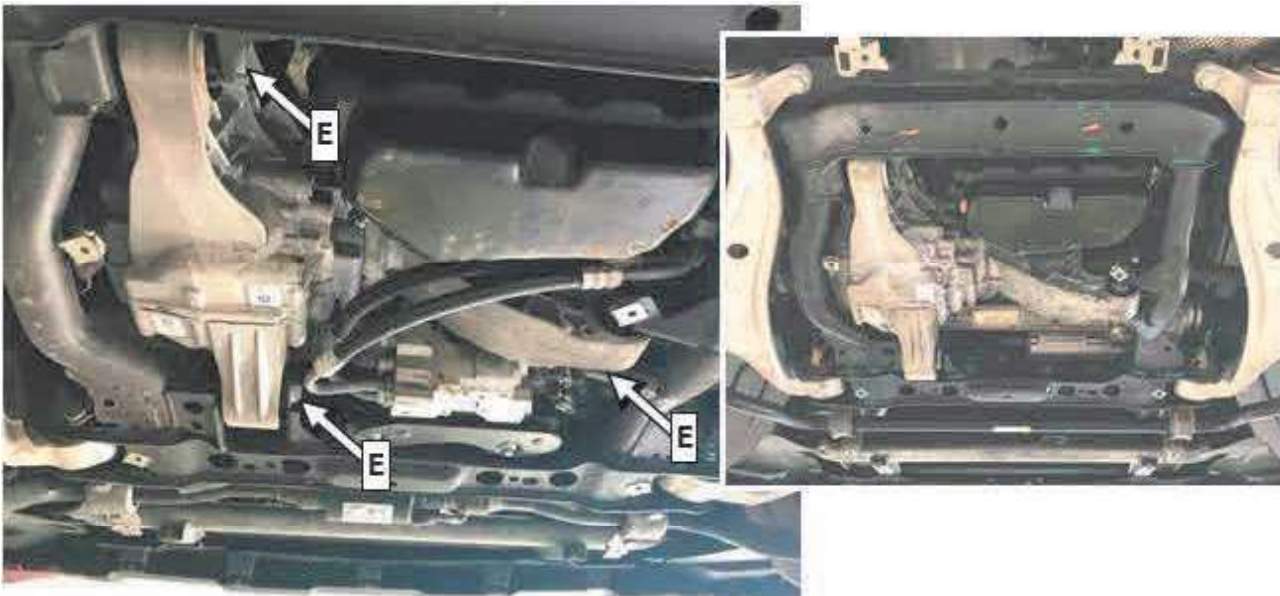
Figure 5

1. Remove center section of lower engine compartment lining.
2. Remove screws (E, Figure 5) connecting the front axle differential to the front axle carrier.
 - i** Front axle differential remains lying in front axle carrier. It is only slightly lowered.
 - i** **No further** threaded connections are released at front axle differential.
 - i** For basic data, see **AR33.30-P-0525GQ**.

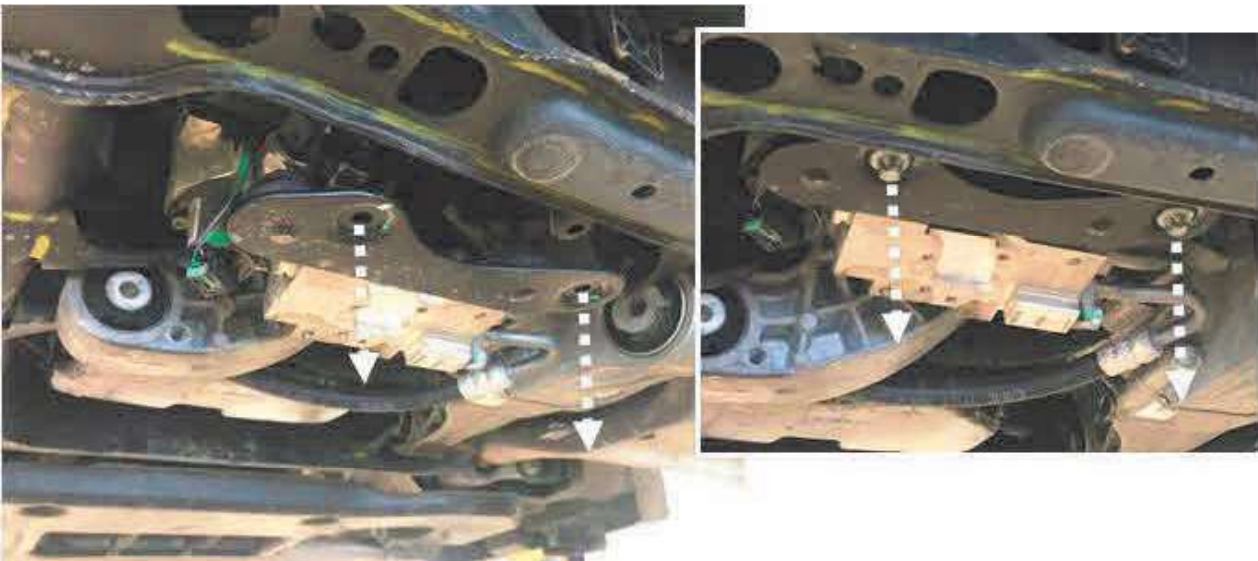
Figure 7

4. For vehicles **with code 468 (Active Curve System)**, unscrew the hydraulics block (**Figure 7**) and slightly press downwards with lines connected.

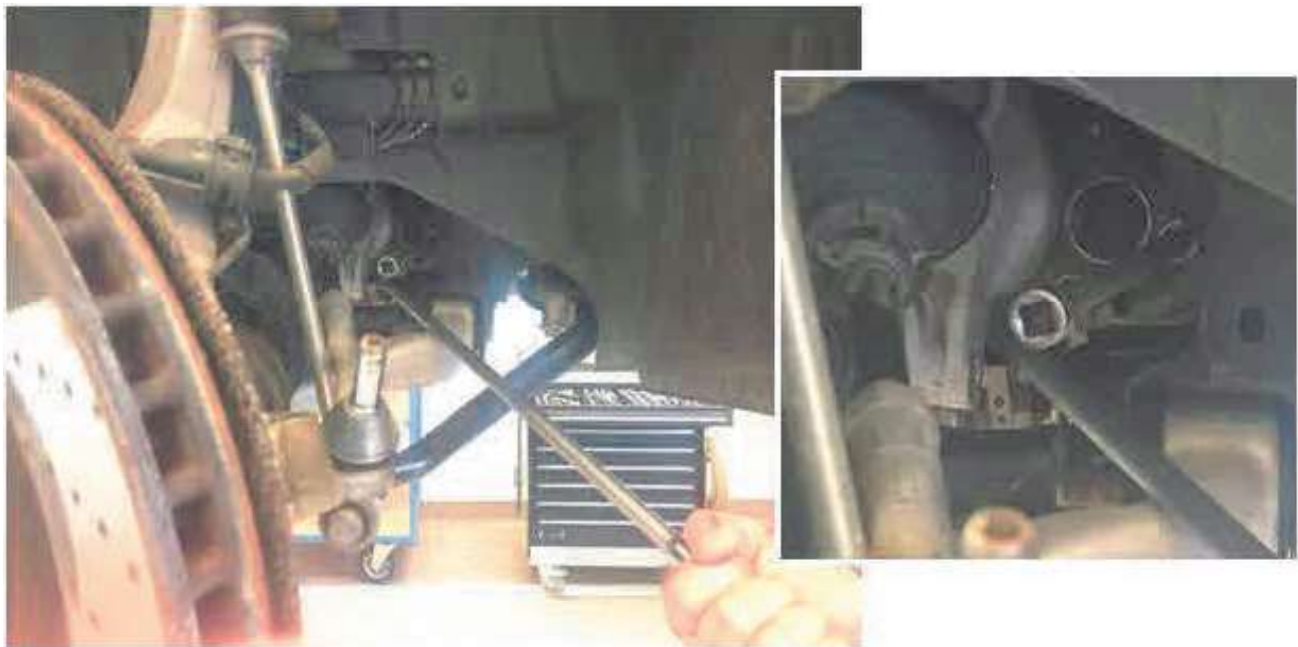
Figure 9

i Keep the steering pressed towards the rear with the aid of a helper as shown (Figure 9).
