TRANSMISSION 722.9 as of 21.6.10 with ENGINE 113, 156, 157, 271, 272, 273, 275, 276, 278, 642, 651

New transmission oil pan (1) version, as of 21.6.2010

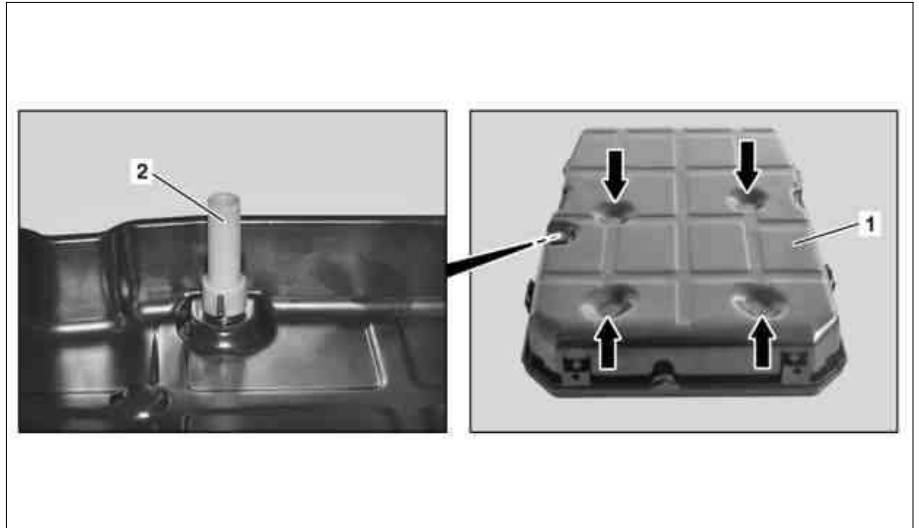
P27.10-2368-05

The transmission oil pan (1) and the overflow pipe (2) have been redesigned to optimize the oil feed of the transmission.

The new transmission oil pan version (1) is recognizable by its oval forms (see arrows). This transmission oil pan (1) may only be installed with the **green** overflow pipe (2).

ⓘ In order to avoid damage to the transmission, always observe the **various Specifications for Operating Fluids**. In the event of a repair the old and new transmission oil pan (1) versions must **never** be interchanged when replacing them.

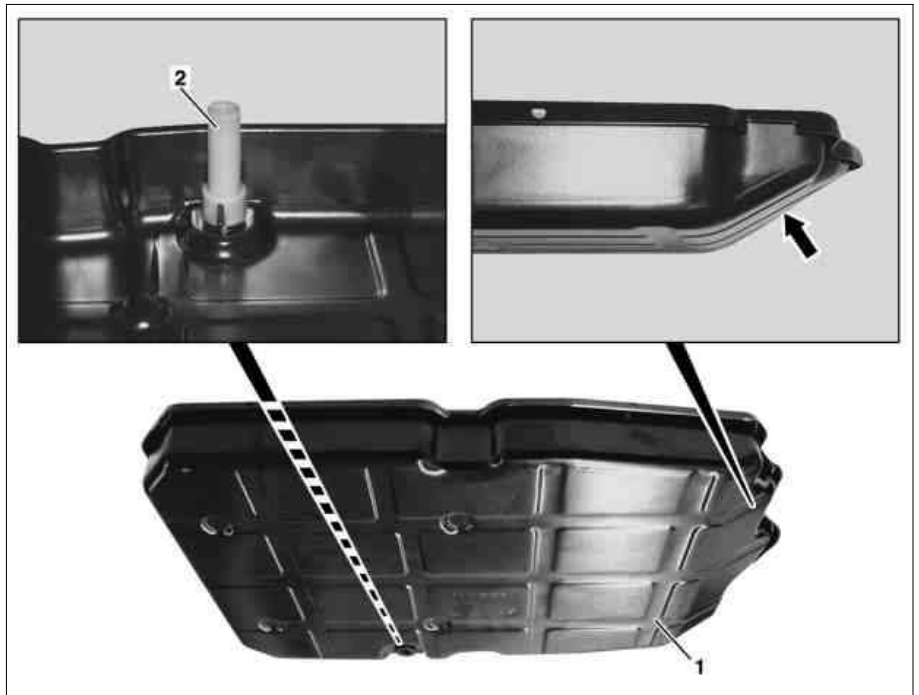
P27.10-2139-06

Old transmission oil pan (1) version, up to 18.6.2010

The old transmission oil pan (1) version can be recognized by the chamfer (arrow). This transmission oil pan (1) may only be installed with the **white** overflow pipe (2).
