Dashboard / Instrument Panel: Service and Repair

AR68.10-P-1030GH Remove/Install Center Section of Instrument Panel

Remove/Install Center Section Of Instrument Panel

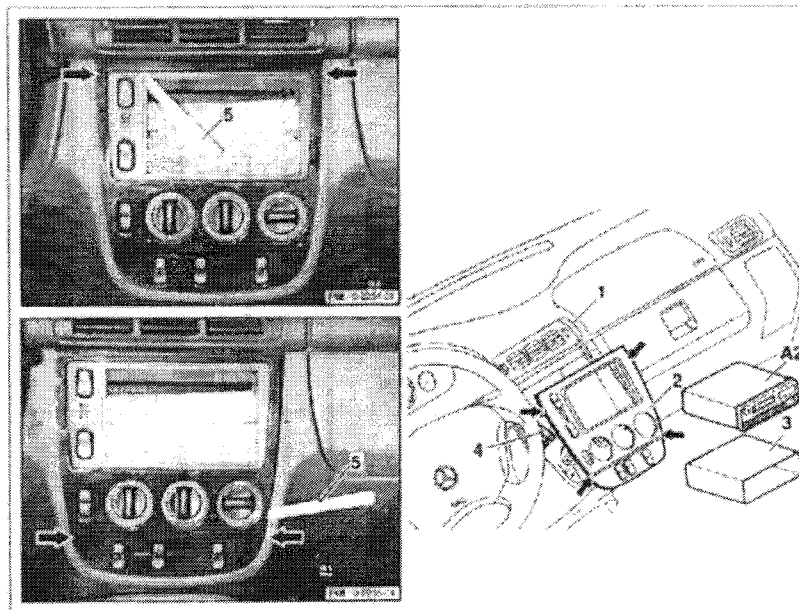
P68.10-2358-06

Illustrated on Model 163 up to VIN
A289564, X754619

- 1 Instrument panel
- 2 Instrument panel center section
- 3 Stowage compartment
- 4 In-car temperature sensor intake hose
- 5 Long wedge
- A2 Radio
- Arrows Retaining clips

- 1 Remove radio (A2)
- 2.1 Remove stowage compartment (3)

- 3 Pry off top retaining clips (arrows) at center section of instrument panel (2) out of instrument panel (1)

- Risk of cracks and fracture!
- Put long wedge (5) behind center section of instrument panel (2) on the top edges of the opening and carefully pry off top retaining clips (arrows).
- Long Wedge: See **Special Tools** below.

- 4 Insert long wedge (5) into gap between instrument panel center section (2) and instrument panel (1) and pull down to rotary switches
 - Long Wedge: See **Special Tools** below.

- 5 Carefully pry off bottom retaining clips (arrows) at center section of instrument panel (2) out of instrument panel (1)

- 6.1 Pull off interior temperature sensor intake hose (4)

- 7 Unplug all connectors from center section of instrument panel (2)
- 8.1 Separate connectors from AAC pushbutton control module

- 9 Remove instrument panel center section (2)
- 10 Install in the reverse order
