AR27.19-P-0230A	Replace pilot bushing in electrohydraulic control unit	3.2.05
-----------------	--	--------

TRANSMISSION 722.6

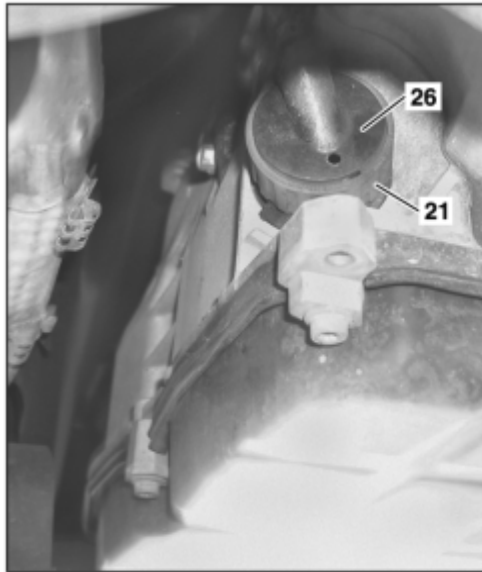
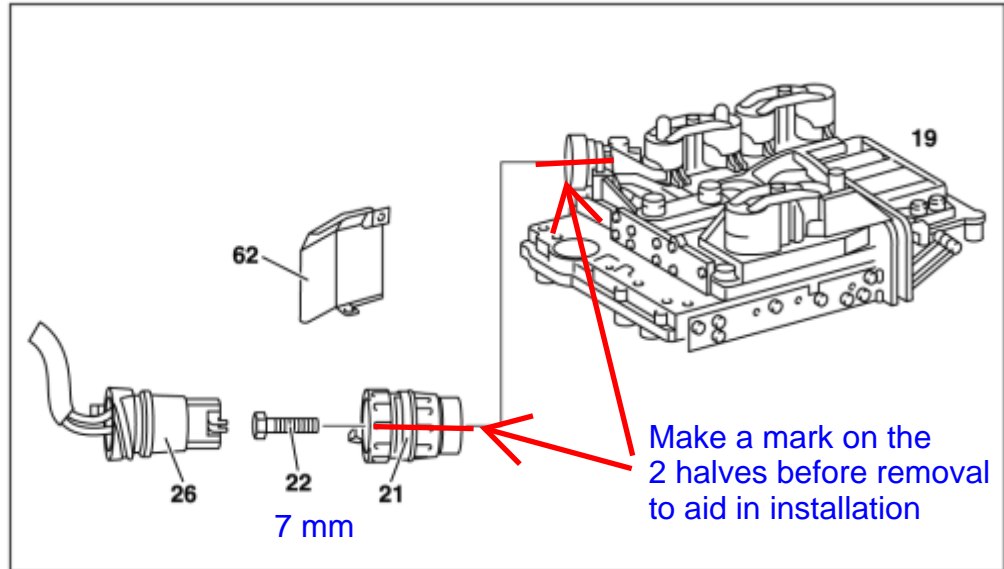
P27.19-2286-08

19 Electrohydraulic control unit
21 Pilot bushing

22 Bolt
26 Plug socket

62 Heat shield

Remove/Install		
1.1	Switch off the ignition, remove the ignition key from the EIS control unit	Vehicles without Keyless Go	
1.2	Remove the Keyless Go transmitter (ignition key/card) from the vehicle and store beyond transmission range	Vehicles with Keyless Go Code 889 Switch off engine.	
2.1	Remove the rear section of the engine compartment paneling	Model 163	AR61.20-P-1105GH
3.1	Disconnect plug connector (26)	Model 163	
			BA27.40-P-1014-01A
4	Unscrew bolt (22) and remove pilot bushing (21) from the electrohydraulic control unit (19)	When removing pilot bushing (21) watch for transmission oil run off.	
		If there is a green dot on the pilot bushing (21), only the sealing rings have to be replaced and not the entire pilot bushing.	
			BA27.19-P-1003-01A
5	Install in the reverse order		
6	Pour ATF into automatic transmission and inspect ATF level	Model 163	AR27.00-P-0101A
