AR68.10-P-1030GH	Remove/install center section of instrument panel	11.4.97
------------------	---	---------

MODEL 163

## Illustrated on Model 163 up to VIN A289564, X754619

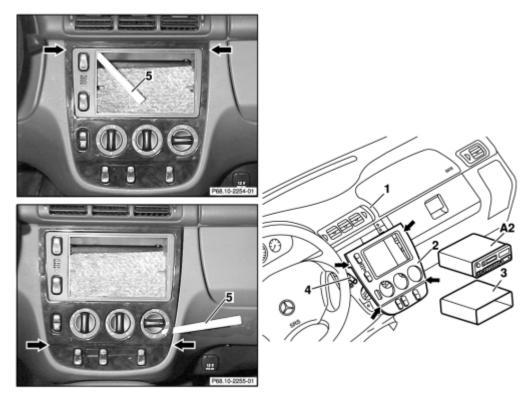
P68.10-2358-06

Instrument panel
Instrument panel center section
Stowage compartment
In-car temperature sensor intake hose
Long wedge
Radio
Arrows Retaining clips

XX	Remove/install		
1	Remove radio (A2)		AR82.60-P-7502EA
2.1	Remove stowage compartment (3)	i Only if present	
3	Pry off top retaining clips (arrows) at	I Risk of cracks and fracture!

center section of instrument panel (2) out of instrument panel (1)	<b>i</b> Put long wedge (5) behind center section of instrument panel (2) on the top edges of the opening and carefully pry off top retaining clips (arrows).	
		S Long wedge Plastic	<u>115 589 03 59 00</u>
4	Insert long wedge (5) into gap between instrument panel center section (2) and instrument panel (1) and pull down to rotary switches	S Long wedge	<u>115 589 03 59 00</u>
5	Carefully pry off bottom retaining clips (arrows) at center section of instrument panel (2) out of instrument panel (1)	I Risk of cracks and fracture!	
		S Long wedge	<u>115 589 03 59 00</u>

6.1	Pull off interior temperature sensor intake hose (4)	<b>i</b> Up to VIN A289564, X754619.	
7	Unplug all connectors from center section of instrument panel (2).

8.1	Separate connectors from AAC pushbutton control module	<b>i</b> As of VIN A289565, X754620.	
9	Remove instrument panel center section (2)		
10	Install in the reverse order
