P72.12-2061-09

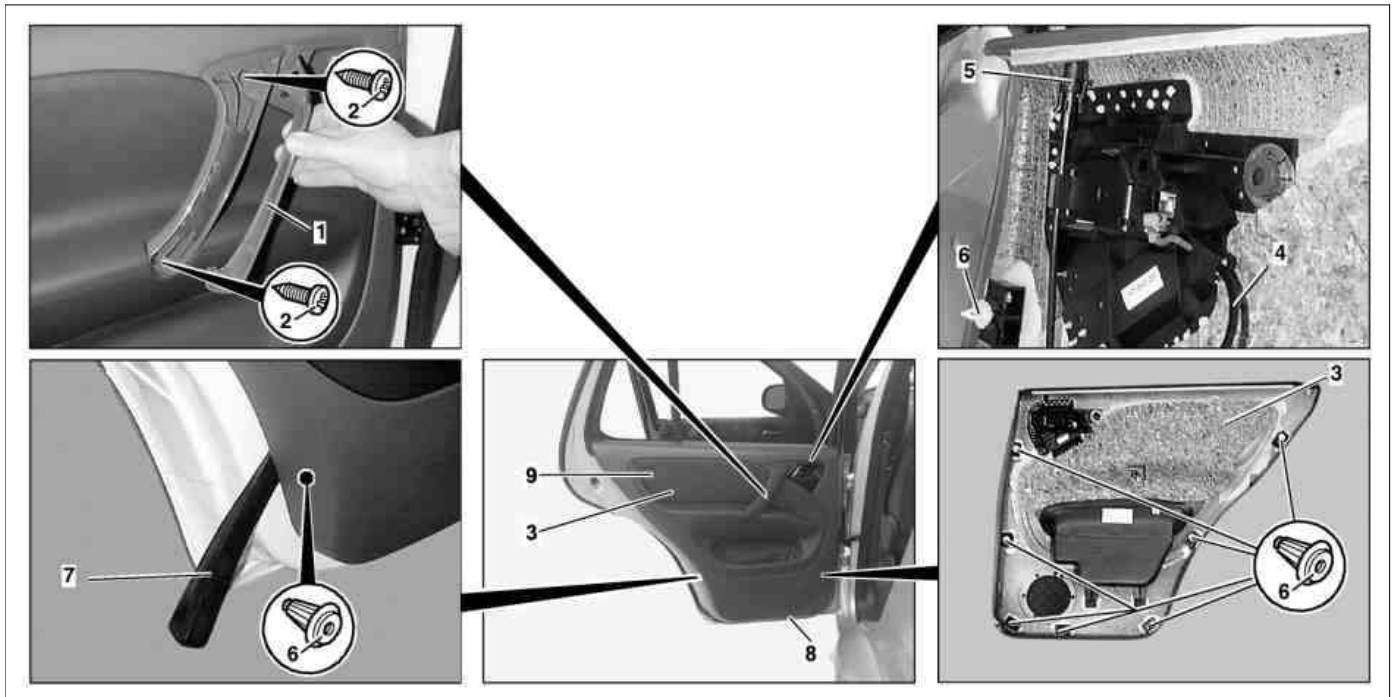
- 1 Door handle cover
- 2 Bolt
- 3 Door liner

- 4 Bowden cable
- 5 Inner lock
- 6 Clips

- 7 Assembly wedge
- 8 Entrance lamp
- 9 Bolt

Remove/install		
1	Open crank window		
2	Remove cover for door handle (1)		
3	Unscrew screw (2)		
4.1	Unclip SRS panel and unscrew screw (9)

As of vehicle identification number A145273, X708319.	
5	Press door liner (3) off of bottom, front and rear inner door panel with assembly wedge (7)

Assembly wedge	*110589035900
6	Lift door liner (3) up and out		
7	Unhook control cable (4) on inner door actuating mechanism		
8	Unclip inner lock (5) on door liner (3)		
9.1	Remove entrance lamp (8)

As of vehicle identification number A145273, X708319.	
10	Lay down door liner		
11	Check foil and sheet metal clip nuts on inner door panel

Replace damaged foil. Replace all clips.	
12	Install in the reverse order
