P54.65-2918-07

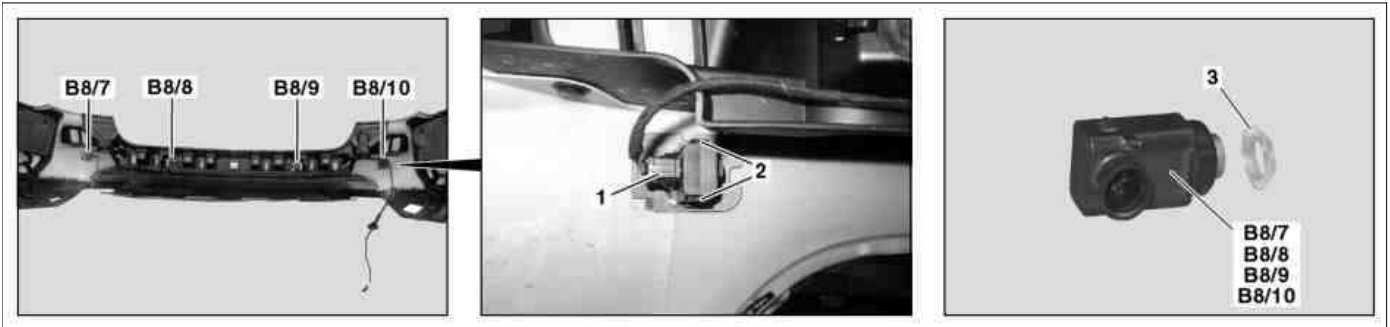
- 1 Electrical connector
- 2 Circlip
- 3 Sealing ring

- B8/7 Outer right rear PTS ultrasonic sensor
- B8/8 Inner right rear PTS ultrasonic sensor
- B8/9 Inner left rear PTS ultrasonic sensor
- B8/10 Outer left rear PTS ultrasonic sensor

Remove/install		
1	Remove rear bumper		AR88.20-P-2200GZ
2	Disconnect electrical connector (1)		
3	Unlock the corresponding circlip (2) using the unlocking tool	Unlocking tool	*168589023100
4	Remove the outer right rear PTS ultrasonic sensor (B8/7) or inner right rear PTS ultrasonic sensor (B8/8) or inner left rear PTS ultrasonic sensor (B8/9) or outer left rear PTS ultrasonic sensor (B8/10) from the bumper	Installation: Check sealing ring (3) and replace if damaged.	
5	Install in the reverse order
