DTB

Date: April 23, 2009
 Order No.: S-B-03.30/08i
 Supersedes: S-B-03.30/08h dated October 24, 2008
 Group: 03

SUBJECT: Model 164.156/172/186/871/886
Model 171.454/456
Model 203.052/054/056/087/092
Model 204.054/056/081/987
Model 209.356/372/456/472
Model 211.056/072/087/090/256/287
Model 216.371/386
Model 219.372
Model 221.171/186
Model 230.471
Model 251.156/165
Equipped with M272 or M273 Engine
Check Engine Light On / Fault Codes Current and/or Stored in ME-SFI Control
Module / Oil Leaking at Camshaft Adjustment Solenoid

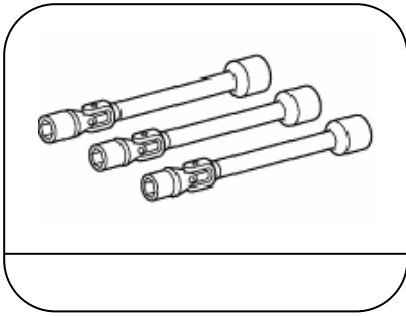
- a) Perform a visual inspection for any wear of the teeth (damage profile) on the sprocket of the balance shaft (M272) or of the guide (idler) gear for timing chain (M273) by removing the timing case cover on the engine. Refer to WIS instructions AR01.40-P-8000* (* - applies to a specific model designation e.g. AR01.40-P-8000SX – models 221, 216). Ensure the use of the Special Tool W001 589 81 09 00 when removing / installing timing case cover.
