P05.10-2269-09

Nm Timing chain, chain tensioner

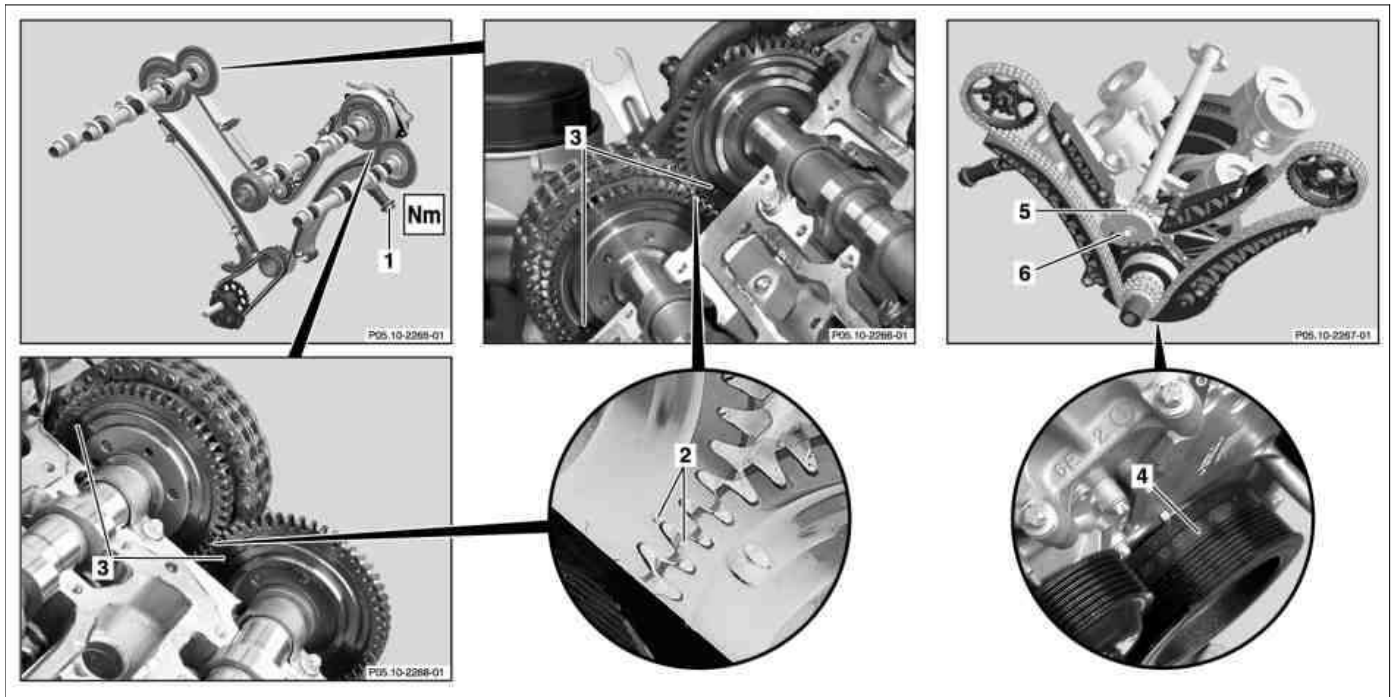
- 1 Chain tensioner
- 2 Markings
- 3 Markings
- 4 TDC marking
- 5 Marking
- 6 Balance shaft drive gear

✕	Removing		
1	Remove cylinder head covers		AR01.20-P-5014GZB
2	Remove mixing chamber		AR09.20-P-1320GZB
◀	Checking		
3	Check timing chain		AR05.10-P-7600GZB
4	Check tightening torque of chain tensioner (1)	i The chain tensioner (1) must be installed and tightened at the correct tightening torque. Nm	*BA05.10-P-1001-01L
5	Position piston of cylinder 1 to ignition TDC	i Rotate engine at crankshaft in the running direction. The markings (2) on camshaft sprockets must be positioned opposite each other. The markings (3) at the camshaft sprockets must be aligned with the cylinder head and lie on the left side. i The TDC marking (4) on belt pulley must be aligned with bar of timing case cover.	
6	Inspect basic position of balancing shaft	i Only in the case of damage i The marking (5) at the balance shaft drive wheel (6) must stand at the vertical center line.	AR03.20-P-3637OM
✕	Install		
7	Install mixing chamber		AR09.20-P-1320GZB
