AR32.22-P-8100GZ Check AlRmatic for leaks. 16.08.2016

# Model 164, 166, 292 with code 489 (AIRMATIC)

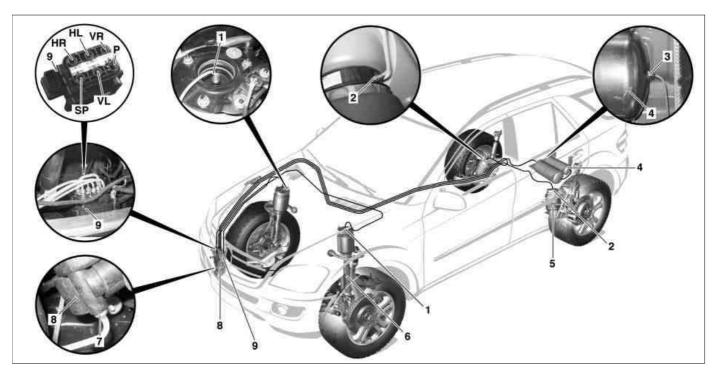
P32.22-2590-09

#### Show on model 164.1

- 1 Pressure line connection
- 2 Pressure line connection
- 3 Pressure line connection

| i | Notes on AIRmatic | | AH32.22-P-1000-02G2 |
|---|--|--|---|
| } | Check pressure line connections (1) on front suspension struts (6) | Wait for approximately 10 to 15 minutes after spraying the leakage detection spray. | |
| 5 | Check pressure line connections (2) on rear air springs (5) | Leakage detection spray for USA | *BR00.45-Z-1004-03A |

| | | | AR68.30-P-4800GQC |
|---|--|--|---|
| 7 | Check pressure line connections (3) on central reservoirs (4) | Leakage detection spray for USA | *BR00.45-Z-1004-03A |
| 9 | Check pressure line connection (7) to AIRmatic compressor unit (8) | Leakage detection spray for USA | *BR00.45-Z-1004-03A |
| 11 | Check pressure line connections to AIRmatic valve unit (9) | | *BR00.45-Z-1004-03A |

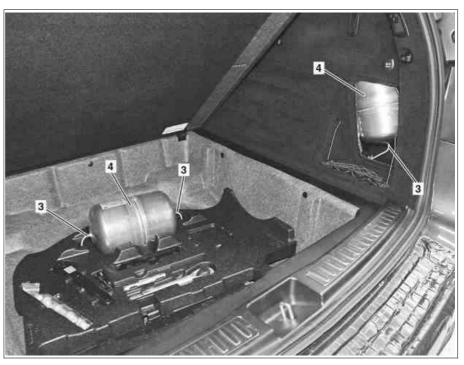
P32.22-2498-06

### Shown on model 166.057

- 3 Pressure line connection
- 4 Central reservoir

- 4 Central reservoir
- 5 Rear air spring
- 6 Front suspension strut
- 7 Pressure line connection
- 8 AIRmatic compressor
- 9 AIRmatic valve unit

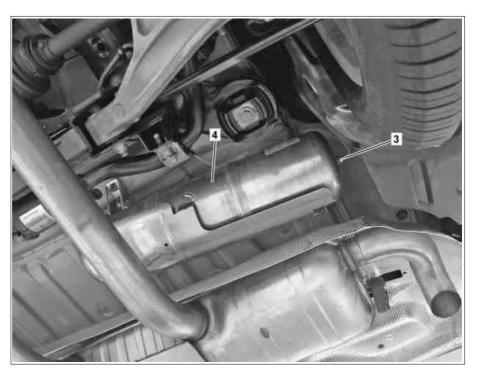
P32.22-2517-06

### Shown on model 166.873

- 3 Pressure line connection
- 4 Central reservoir
