AR82.60-P-7502GZ Remove/install radio 23.2.11

MODEL 164

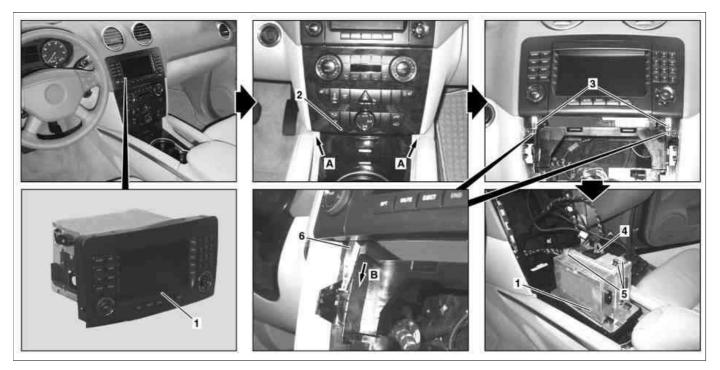
P82.60-4772-09

Shown on model 164.1, with USA version, code 494

- Radio
- 2 Instrument panel center section
- Bolts

- Electrical connector
- 5 Antenna cable connectors
- Latch

X	Remove/install		
③	Information on preventing damage to electronic components due to electrostatic discharge		AH54.00-P-0001-01A
1	Read out coding of radio (1)	i Only when replacing radio and if it can still be read out using STAR DIAGNOSIS.	
A D	Connect STAR DIAGNOSIS and read out fault memory	CTAD DIA CNOCIC dia managia avatama	AD00.00-P-2000-04A
2	Switch off ignition and remove transmitter key from EIS control unit	STAR DIAGNOSIS diagnosis system i On vehicles with code (889) Keyless-Go: Press Keyless-Go start/stop button repeatedly until ignition is switched off. Remove transmitter key from vehicle and store it in a location beyond its transmission range (at least 2 m).	
3	Disengage dashboard center part (2) at bottom edge (arrows A) and pull forward out of dashboard use plastic pry tool	i Protect trim parts of the instrument panel and center console from scratches.	
4	Remove bolts (3) and slide latches (6) on both sides downwards (arrow B)

5	Pull radio (1) out of installation opening and detach electrical connector (4) along with antenna cable connectors (5)	i Protect dashboard, center console trim parts and the radio from scratches.	
6	Install in the reverse order		
7	Code radio (1)	i Only after installing a new radio.	
A D	Connect STAR DIAGNOSIS and read out fault memory	· ·	AD00.00-P-2000-04A
		STAR DIAGNOSIS diagnosis system
