MODEL 164

Shown on model 164.1, with USA version, code 494

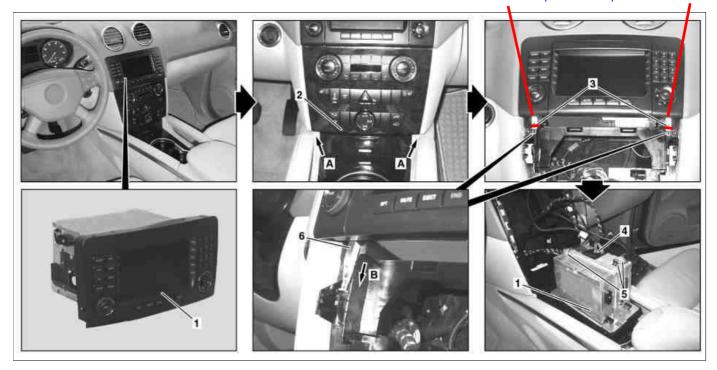
P82.60-4772-09

- Radio
- 2 Instrument panel center section
- Bolts

- Electrical connector
- 5 Antenna cable connectors
- 6 Latch

Remove/install		
(1)		Information on preventing damage to electronic components due to electrostatic discharge		AH54.00-P-0001-01A
1		Read out coding of radio (1)	i Only when replacing radio and if it can still be read out using STAR DIAGNOSIS.	
Α	VD.	Connect STAR DIAGNOSIS and read out fault memory		AD00.00-P-2000-04A
			STAR DIAGNOSIS diagnosis system	
2		Switch off ignition and remove transmitter key from EIS control unit	i On vehicles with code (889) Keyless-Go: Press Keyless-Go start/stop button repeatedly until ignition is switched off. Remove transmitter key from vehicle and store it in a location beyond its transmission range (at least 2 m).	
3		Disengage dashboard center part (2) at bottom edge (arrows A) and pull forward out of dashboard use plastic pry tool	i Protect trim parts of the instrument panel and center console from scratches.	
4		Remove bolts (3) and slide latches (6) on both sides downwards (arrow B)

5		Pull radio (1) out of installation opening and detach electrical connector (4) along with antenna cable connectors (5)	i Protect dashboard, center console trim parts and the radio from scratches.	
6		Install in the reverse order		
7		Code radio (1)	i Only after installing a new radio.	
ÞΦA	\D	Connect STAR DIAGNOSIS and read out fault memory	, Ç	AD00.00-P-2000-04A
			STAR DIAGNOSIS diagnosis system
