MODEL 164

## Shown on vehicle with automatic rear-end door, code 890

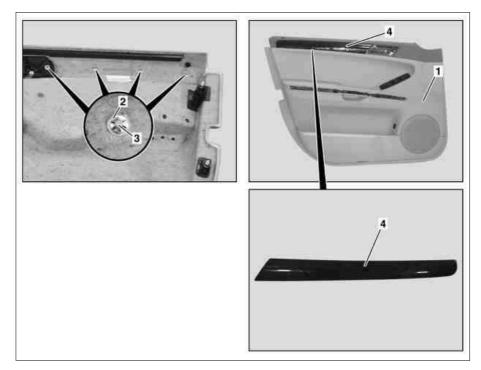
P72.10-3042-06

- Door lining
- Clamping plates
- 2 3 4 Pins
- Trim strip

| $\mathbf{X}$ | Remove | | |
|---|--|---|---|
| 2 | Bend open clamping plates (2) with suitable screwdriver and remove from pins (3) | | |
| 3 | Lift door lining (1) and remove trim strip (4) | | |
| 4 | Insert trim strip (4) in door lining (1) | i Ensure that trim strip (4) is seated correctly on door lining (1). | |
| 5 | Press clamping plates (2) over pins (3) of trim strip (4) | Replace clamping plates (2) Use 11 mm socket with suitable handle Clamping plates (2) should make contact with door lining (1). | |
