N40/3 Amplifier for sound system

Remove/install

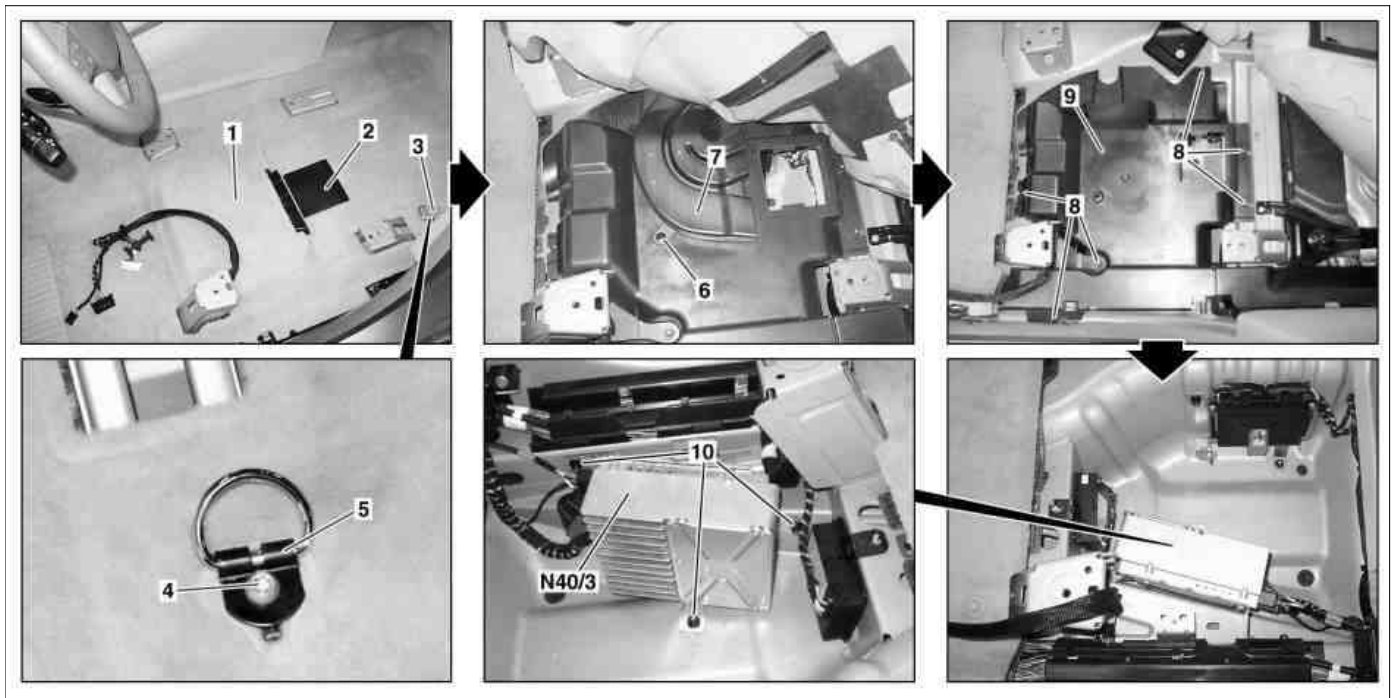
P82.62-2731-09

- 1 Rear floor covering
- 2 Cover
- 3 Anchoring lug cover
- 4 Bolt

- 5 Anchoring lug
- 6 Clip
- 7 Air duct
- 8 Nuts

- 9 Left intermediate bottom
- 10 Nuts

N40/3 Amplifier for sound system

AD			
2	Remove left front seat		AR91.10-P-1000GZ
3	Remove left front door sill molding		AR68.30-P-4100GZ
4	Remove left rear door sill molding		AR68.30-P-4100GZ
5	Remove B-pillar paneling at bottom left		AR68.30-P-4700GZ
6	Remove cover (2).		
7	Remove anchoring lug cover (3)		
8	Remove bolt (4) and remove anchoring lug (5)	<p>

Installation: Insert anchoring lug with its positioning tab properly aligned.</p> <p>

</p>	*BA68.50-P-1001-03F
9	Fold over left rear floor covering (1)

10	Remove clip (6) and remove air duct (7)		
11	Remove nuts (8) and remove left intermediate bottom (9)		
12	Disconnect electrical connectors from amplifier for sound system (N40/3)

Cover fiber optic cable using suitable means.	
13	Remove nuts (10) and remove amplifier for sound system (N40/3) together with bracket		
14	Remove bolts (11) and remove bracket (12) from amplifier for sound system (N40/3)		
15	Install in the reverse order		
16	<p>Code amplifier for sound system (N40/3)</p> <p>Connect STAR DIAGNOSIS and read out fault memory</p>	<p>Only when installing new amplifier for sound system (N40/3).</p> <p>STAR DIAGNOSIS diagnosis system</p>	<p>AD00.00-P-2000-04A</p> <p>*WH58.30-Z-1048-13A</p>

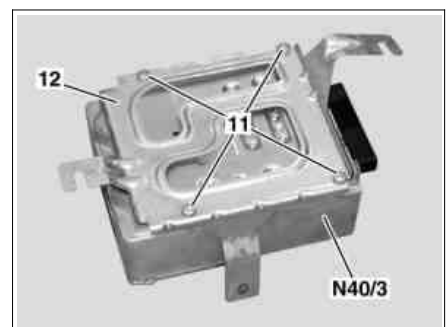
P82.62-2732-01

- 11 Bolts
- 12 Bracket

N40/3 Amplifier for sound system
