Model 164, 166, 292
with code 489 (AIRMATIC)

Notes on AIRmatic		AH32.22-P-1000-02GZ
	Remove/install		
1	Open engine hood and raise to vertical position	Model 164 Model 166	AR88.40-P-1000GZ AR88.40-P-1000GQ
2	Remove covers over suspension strut towers	Model 166, 292 with code 489 (AIRMATIC)	
	Check		
3	Check pressure line connections (1) on front suspension struts (6)	Wait for approximately 10 to 15 minutes after spraying the leakage detection spray. This allows smaller leaks to be detected (bubbles form). Larger leaks are visible immediately. Leakage detection spray for USA Leak detection spray Socket wrench bit Knife If necessary, use leakage detection spray to check for leakages ↓ Repair AIRmatic pressure line connection	*BR00.45-Z-1004-03A *BR00.45-Z-1002-03A *211589000900 *000589122800 AR32.22-P-2001-02GZ
Danger !	Risk of death caused by vehicle slipping or toppling off of the lifting platform.	Align vehicle between vehicle lift columns and position the four support plates at the vehicle lift support points specified by the vehicle manufacturer.	AS00.00-Z-0010-01A

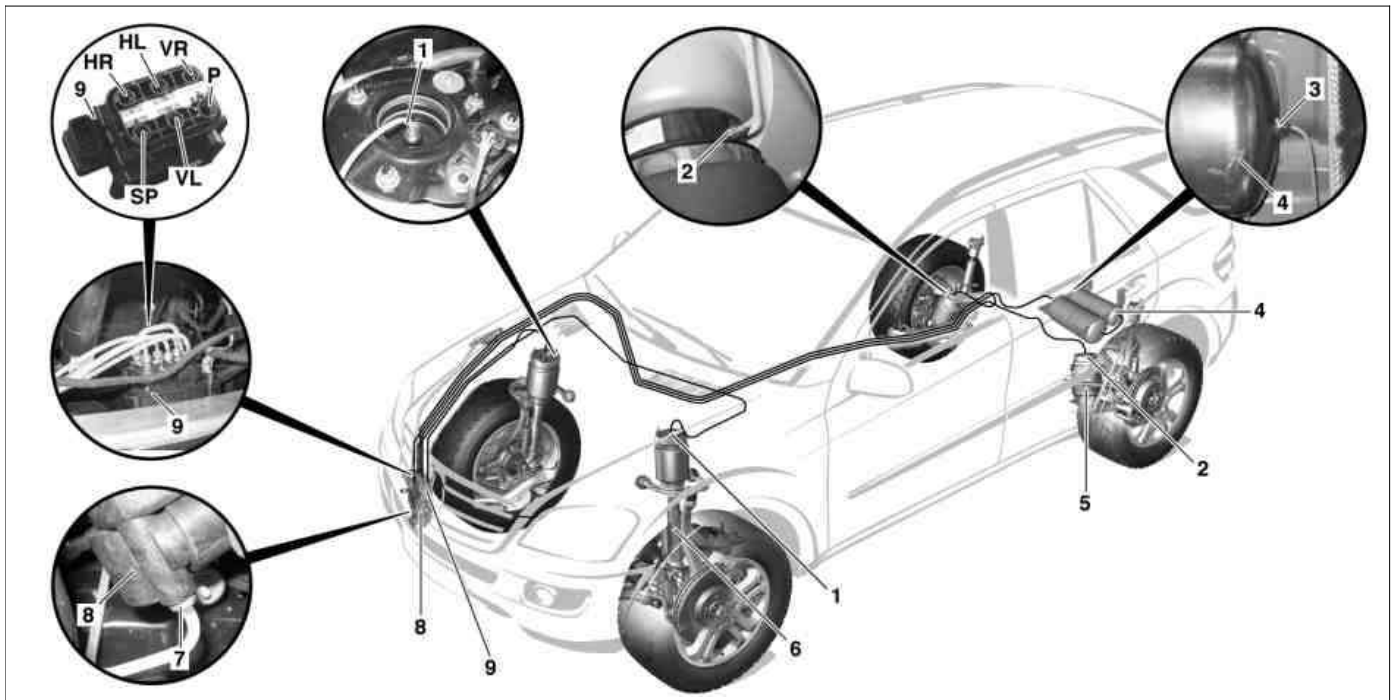
P32.22-2590-09

Show on model 164.1

| 1 | Pressure line connection | 4 | Central reservoir | 7 | Pressure line connection |
| 2 | Pressure line connection | 5 | Rear air spring | 8 | AIRmatic compressor |
| 3 | Pressure line connection | 6 | Front suspension strut | 9 | AIRmatic valve unit |

4	Lift vehicle on vehicle lift		AR00.60-P-1000GZ
5	Check pressure line connections (2) on rear air springs (5)	Leakage detection spray for USA Leak detection spray Socket wrench bit Knife If necessary, use leakage detection spray to check for leakages ↓ Repair AIRmatic pressure line connection	*BR00.45-Z-1004-03A *BR00.45-Z-1002-03A *211589000900 *000589122800 AR32.22-P-2001-02GZ

7	Check pressure line connections (3) on central reservoirs (4)	<p>Leakage detection spray for USA</p> <p>Leak detection spray</p> <p>

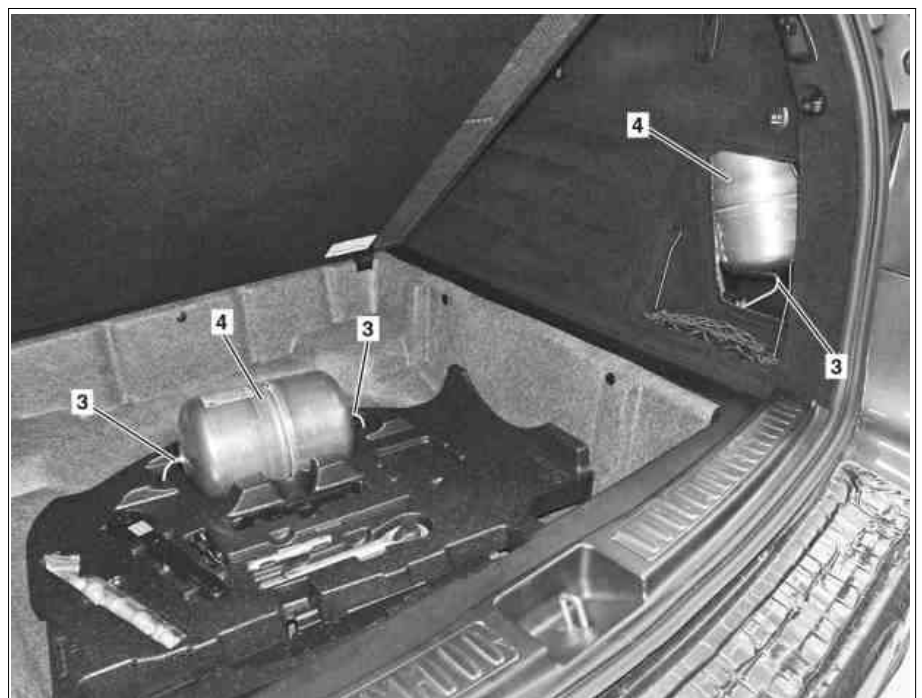
P32.22-2498-06

Shown on model 166.057

| 3 | Pressure line connection |
| 4 | Central reservoir |

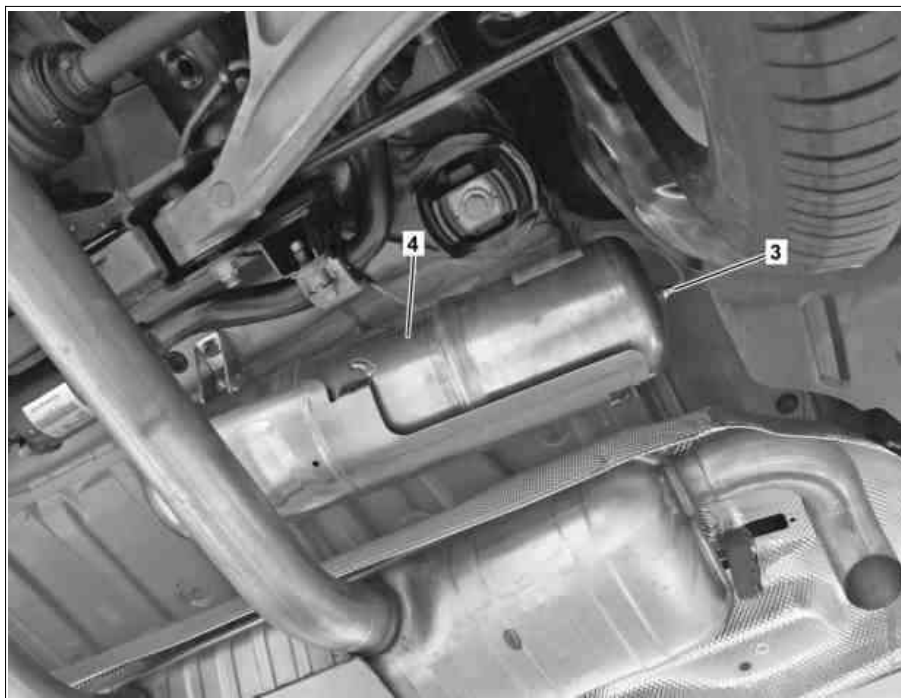
P32.22-2517-06

Shown on model 166.873

- 3 Pressure line connection
- 4 Central reservoir
