## AR27.60-P-0931GZ Remove/install DIRECT SELECT selector lever TRANSMISSION 722.9 in MODEL 164

Shown on vehicle with electrically adjustable steering column, code 441

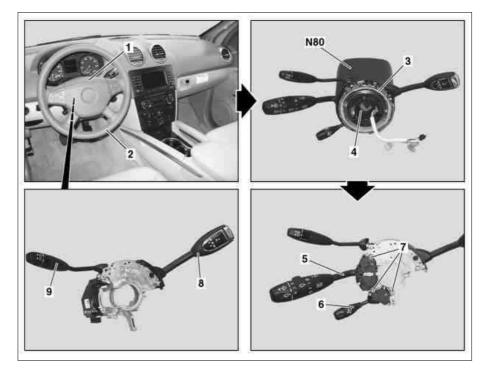
P27.60-2652-06

- 1 Driver airbag unit
- 2 Steering wheel
- 3 Clock spring contact
- 4 Steering angle sensor
- 5 Combination switch
- 6 Steering column adjustment switch
- 7 Bolts
- 8 DIRECT SELECT selector lever
- 9 CC [TPM] switch
- N80 Steering column module

XX	Remove/install		
⚠ Danger!	<b>Risk of injury</b> caused by performing testing or repair work on airbag or emergency tensioning retractor units.	Store airbag units with deployment side facing up; do not expose to temperatures greater than 100 °C. When working on these units, disconnect the power supply.	AS91.00-Z-0001-01A
1	Remove driver airbag unit (1)		AR91.60-P-0660GZ
2	Remove steering wheel (2)		AR46.10-P-0100GZ
3	Removing jacket tube module (N80)		AR54.25-P-2802GZ
4	Remove clock spring contact (3)		AR46.10-P-0200GZ
5	Remove steering angle sensor (4)		AR46.10-P-0300GZ
6	Remove bolts (7)	<b>i</b> The number of bolts (7) is dependent on the equipment.	
7	Detach steering column adjustment switch (6)	<ul> <li>Donly on vehicles with electrically adjustable steering column, code 441.</li> <li>Do not damage electrical connector.</li> </ul>	
8	Remove combination switch (5).	i Do not damage electrical connector.

9	Install in the reverse order	<b>i</b> DIRECT SELECT selector lever (8) and cruise control pushbutton switch (9) form a unit which cannot be disassembled.	
10	Perform basic programming		AR00.19-P-0200GZ
11	Carry out function check
