## Illustrated on model 164.1

## Steering wheel

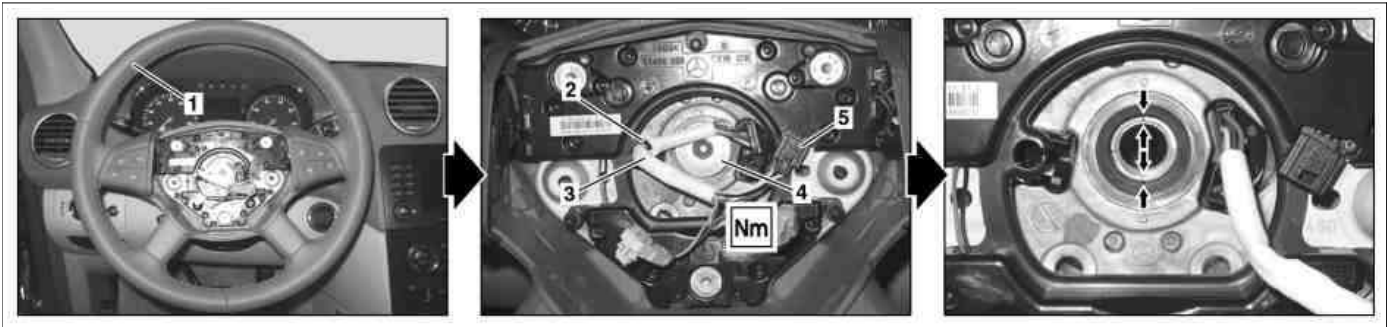
P46.10-2588-07

- 1 Steering wheel  
2 Bracket  
3 Wiring harness

- 4 Countersunk screw  
5 Electrical connector

1	Move steering wheel (1) to horizontal position	Front wheels in straight-ahead position.	
2	Disconnect battery ground cable		AR54.10-P-0003GZ
3	Remove driver airbag unit		AR91.60-P-0660GZ
4	Separate electrical connector (5)		
5	Detach wiring harness (3) from the bracket (2)		
6	Remove countersunk screw (4); counterhold steering wheel (1) when doing so	<b>Installation:</b> Replace countersunk screw. 	*BA46.10-P-1001-02G
7	Remove steering wheel (1), in the process guide the wiring harness (3) through the opening in the steering wheel (1)	<b>Installation:</b> Assign the cutouts of the serrations in the steering wheel to the markings on the steering shaft (arrows).	
8	Clock spring contact for damage	When the steering wheel (1) is removed the clock spring contact must not be twisted otherwise it will be damaged. Visual inspection, replace clock spring contact if necessary: ↓ Remove/install clock spring contact	AR46.10-P-0200GZ

9	Install in the reverse order		
10	Conduct a road test	Tests during the road test: <b>Turn signal reset</b> If the steering wheel (1) is offset by more than one tooth, perfect turn signal indicator reset is no longer guaranteed. <b>Airbag indicator lamp</b> The SRS indicator lamp must not light up on full steering lock in both directions. <b>Position of steering wheel (1)</b> If the steering wheel (1) is crooked, adjust it by max. one tooth.
