Engine	272
Engine	273

## Oil pan bottom section for engine with front sump without code M005

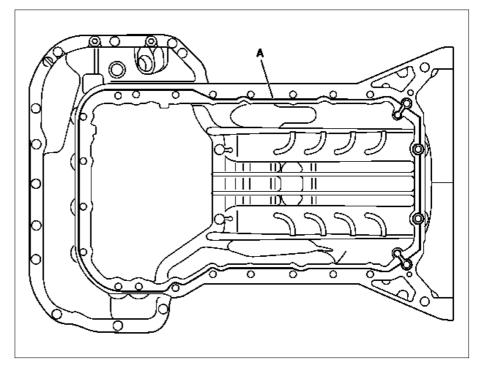
P01.45-2272-06

Oil pan top section on engine 272 with front sump without code  $M005\,$

**i** The sealing surface must be cleaned. The sealant must only be applied to the specified surface in the form of a bead with a height and width of 2.0 mm ( $\pm$ 0.5 mm). The sealant must be processed within 10 min. The sealant bead must not be spread. Use only the sealant indicated in the repair materials.

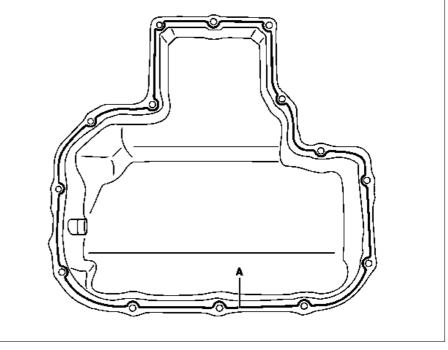
P01.45-2193-06

Oil pan bottom section for engine with front sump with code M005

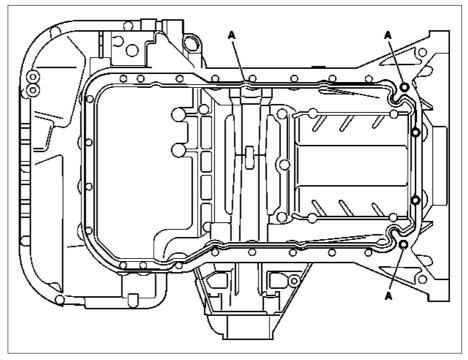
P01.45-2275-06

Oil pan top section on engine 272 with front sump with code M005

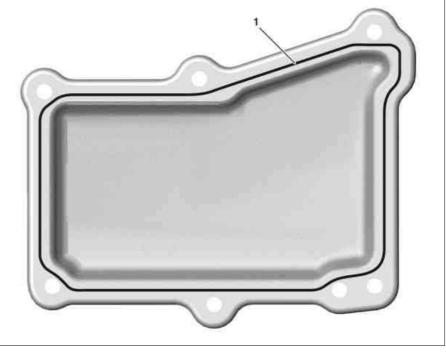
P01.45-2283-06

Oil pan bottom section for engine with middle sump

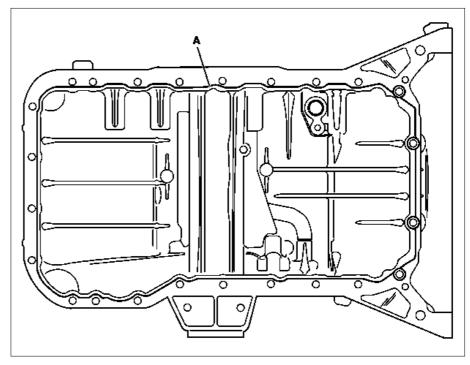
P01.45-2269-06

Oil pan top section on engine 272 with middle sump

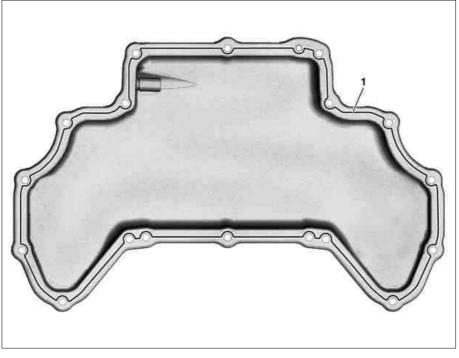
P01.45-2138-06

Oil pan bottom section for engine with rear sump

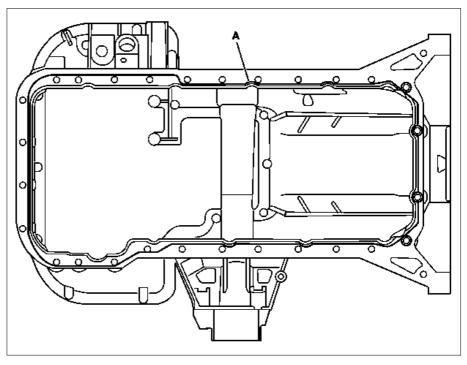
P01.45-2270-06

Oil pan top section on engine 272 with rear sump

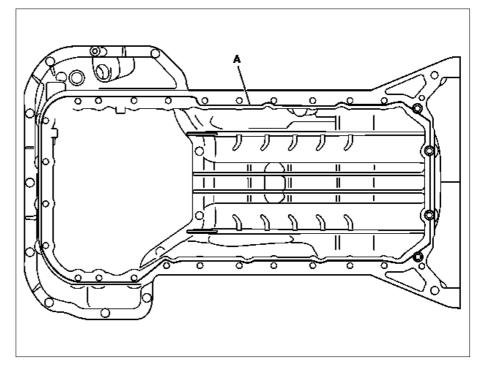
P01.45-2274-06

Oil pan in engine 273 with front sump

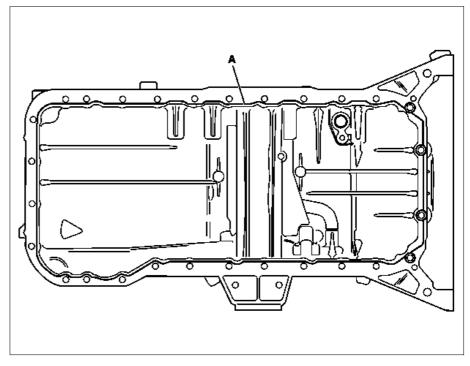
P01.45-2271-06

Oil pan in engine 273 with middle sump
