MODEL 164

P54.21-2516-07

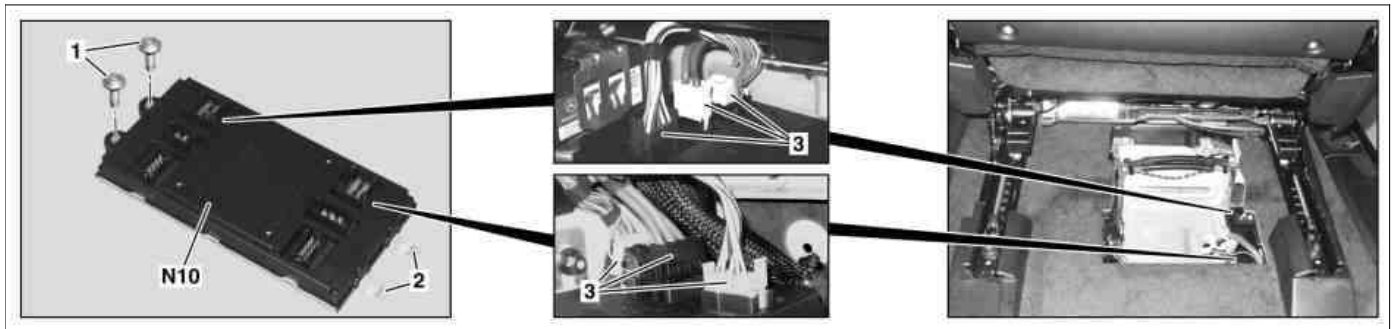
1 Bolts
2 Retaining clips

3 Connector

N10 Front SAM control unit

9	Unlock all plugs (3) and disconnect from front SAM control unit (N10)		
10	Undo bolts (1), remove front SAM control unit (N10)	Installation: Insert retaining clamps (2) into corresponding openings, then fasten the front SAM control unit (N10) using bolts (1).	
11	Install in the reverse order		
12	Code front SAM control unit (N10)	Only when installing a new front SAM control unit (N10).
