Engine diagnosis warning lamp lights up, fault codes 1200 and 1208 stored in motor electronics control unit.

Topic number	LI03.30-P-050027
Version	2
Design group	03.30 Flywheel, driving disk, vibration damper, starter ring gear
Date	05-31-2011
Validity	Engine 272 in model 164, 171, 203, 209, 211, 219, 221, 230, 251 Engine 273 in model 164, 209, 211, 216, 219, 221, 230 Implementation of series measure changing material for balance shaft sprocket as of engine 2729xx30 468993 as of October 2006 production Implementation of series measure changing material for timing chain guide wheel as of engine 2739xx30 088611 as of September 2006 production
Reason for change	Supersedes DTB S-B-03.30/08

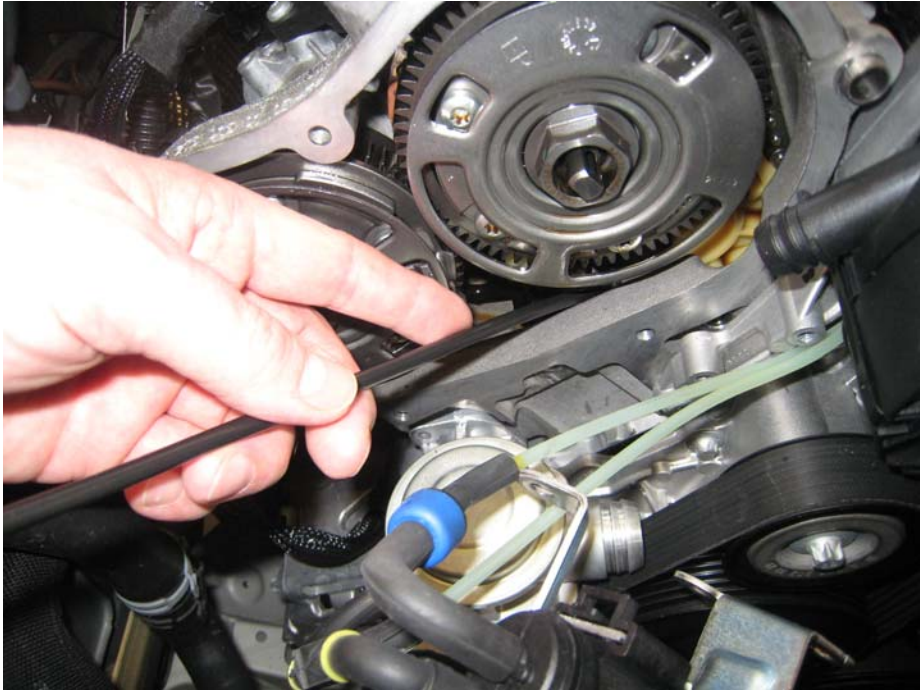
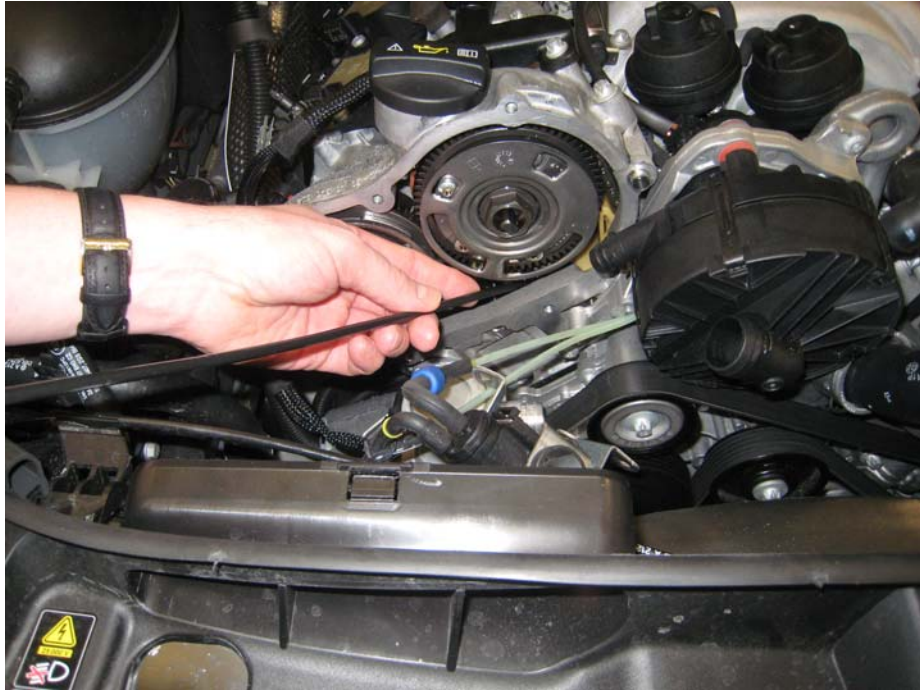
Balance shaft sprocket (engine 272) or timing chain guide wheel (engine 273) worn (sprocket damage profile).

The position of the camshafts of the right cylinder bank relative to the crankshaft is impaired by a worn sprocket on the balance shaft (engine 272) or by a worn guide wheel for the timing chain (engine 273).

Attachments	
File	Designation
balance shaft.jpg	Damage profile of sprocket
Anwendung Endoskop.pdf	Check for wear with borescope. (Insert borescope over the right-hand chain slide rail as far as the balance shaft / guide wheel)
Beispielbilder Endoskop Kettenrad.pdf	Example images of balance shaft sprocket (sprocket OK)

1. Remove right front camshaft adjuster cover.
2. Check balance shaft sprocket (engine 272) or timing chain guide wheel (engine 273) for wear using flexible borescope (see attachment sprocket damage profile/ borescope "endoscope" image of sprocket).
3. If worn as in the sprocket damage profile: Continue with step 4.

4. Replace balance shaft (engine 272) or timing chain guide wheel (engine 273)
5. Install a new chain tensioner (only renew chain tensioner A272 050 01 11 when required).
6. Engine oil and filter change. (Only use engine oils as per Specification 229.1 and 229.3 - use the cheapest engine oil available in the workshop)
7. Drive with engine at high load and rpm for a distance of at least 20 km.
