- Model 217, 222**
with code 233 (DISTRONIC PLUS)
- Model 217, 222**
with code 234 (Blind Spot Monitoring)
- Model 217, 222**
with code 237 (Active Blind Spot Assist)

Shown on model 222 as of model year 2018

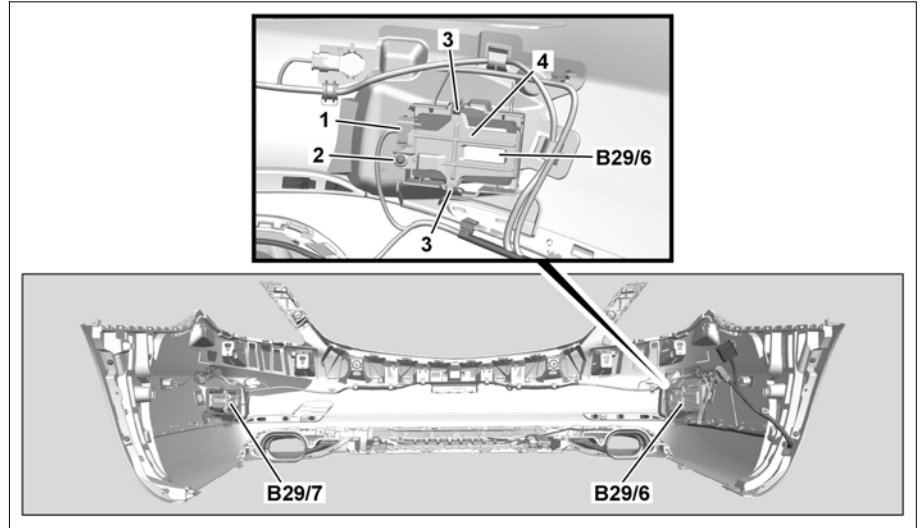
P54.71-2705-05

- 1 Electrical connector
2 Screw
3 Retaining lug
4 Bracket
B29/6 Left rear bumper radar sensor
B29/7 Right rear bumper radar sensor

Notes on preventing damage to electronic components due to a magnetic tool		AH54.00-P-0002-01A
	Information on preventing damage to electronic components due to electrostatic discharge		AH54.00-P-0001-01A
	Remove/install		
1	Commission rear left bumper radar sensor (B29/6) or rear right bumper radar sensor (B29/7)	When replacing the left rear bumper radar sensor (B29/6) or the right rear bumper radar sensor (B29/7).	AD00.00-P-2000-04B
	2 Remove rear bumper	Model 217 Model 222	AR88.20-P-2200LC AR88.20-P-2200LF
3	Disconnect electrical connector (1)		
4	Unscrew bolt (2)	Model 217, 222 as of model year 2018

5.1	Unlock retaining lug and remove left rear bumper radar sensor (B29/6) or right rear bumper radar sensor (B29/7) from bracket (4)	Model 217, 222 up to model year 2018

5.2	Release retaining lugs(3) and remove rear left bumper radar sensor(B29/6) or rear right bumper radar sensor(B29/7) from holder(4)	Model 217, 222 as of model year 2018	
6	Install in the reverse order
