P32.22-2080-09

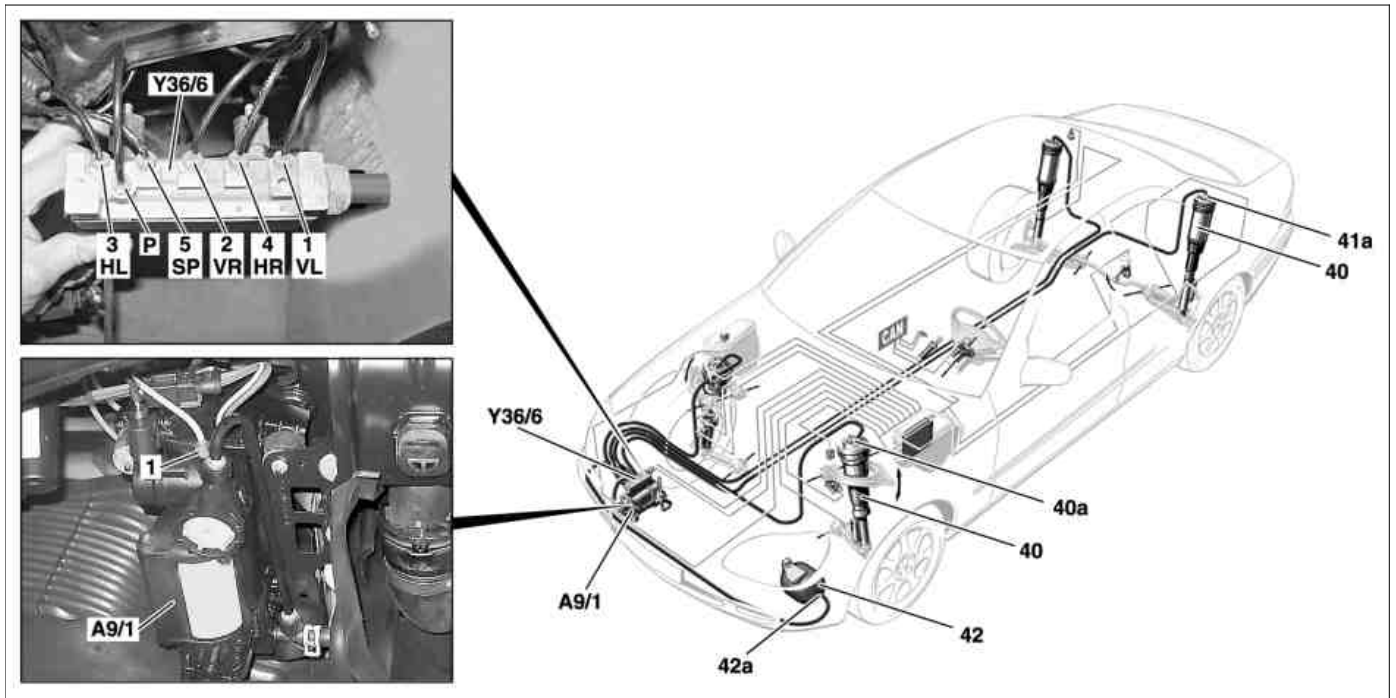
Pressure line connections:

- 1 to AIRmatic compressor unit
- 1VL to left front spring strut
- 2VL to right front spring strut
- 3HL to left rear spring strut

- 4HR to right rear spring strut
- 5SP to central reservoir
- P to AIRmatic compressor unit
- 40a on front spring strut
- 41a on rear spring strut
- 42a on central reservoir

- 40 Front spring strut
- 41 Rear spring strut
- 42 Central reservoir
- A9/1 AIRmatic compressor unit
- Y36/6 Level control valve unit

◀	Checking		
i	Notes on AIRmatic		AH32.22-P-1000-02I
1	Remove engine compartment lining	i Only on the right-hand side of the vehicle for testing the AIRmatic compressor unit (A9/1)	AR61.20-P-1105M
2	Remove part of the wheel house inner panel in front fender	i Only on the right-hand side of the vehicle for testing the level control valve unit (Y36/6)	
3	Spray the pressure line connections (1VL, 2VR, 3HL, 4HR, 5SP,P) of the level control valve unit (Y36/6), the pressure line connection of the AIRmatic compressor unit (A9/1) and the pressure line connection (42a) of the central reservoir (42) with leak detecting spray	i Wait for approx. 10-15 minutes after spraying. This means that minor leaks can be recognized (forming a white cap). Severe leaks are evident immediately. i Use leak detecting spray	
4	Spray the area of the casting compound and pressure line connections (40a, 41a) on the spring struts (40, 41) with leak detecting spray	i Wait for approx. 10-15 minutes after spraying. This means that minor leaks can be recognized (forming a foam crown). Severe leaks are evident immediately. i Use leak detecting spray
