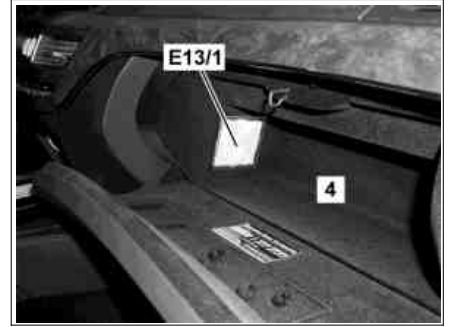
P82.60-5468-01

- 1 Remove glove compartment lamp (E13/1) from glove compartment (4).

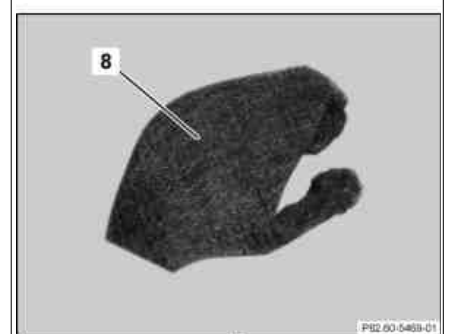
P82.60-5469-01

- 2 Remove damping material (8) in the area (A) from rear of glove compartment (4).
- 3 Check whether no other components or wiring harnesses are installed in area (A) on rear of glove compartment (4).

i Drill hole in area (A).

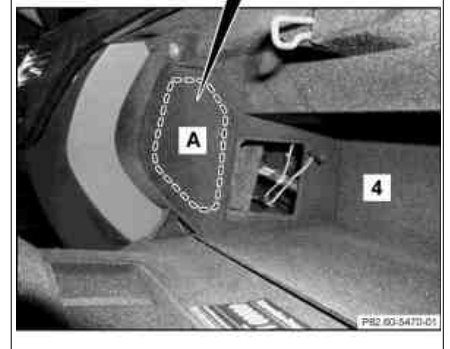
P82.60-5470-01

- 4 Drill hole (C) with $\varnothing = 20$ mm into glove compartment (4) as per the dimensioning.

! Ensure that no other components are damaged when drilling hole (C).

$B=15\text{mm}$

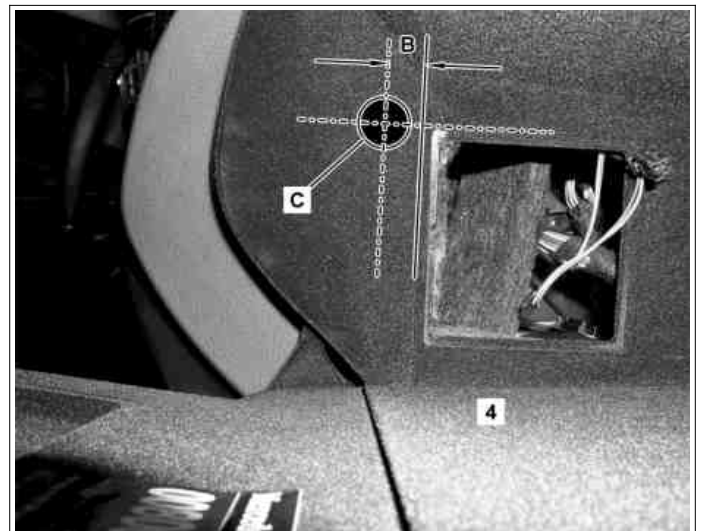
P82.60-5472-11

- 1 iPod wiring harness
- 2 iPod connector
- 5 Coupling for interface
- 6 Grommet

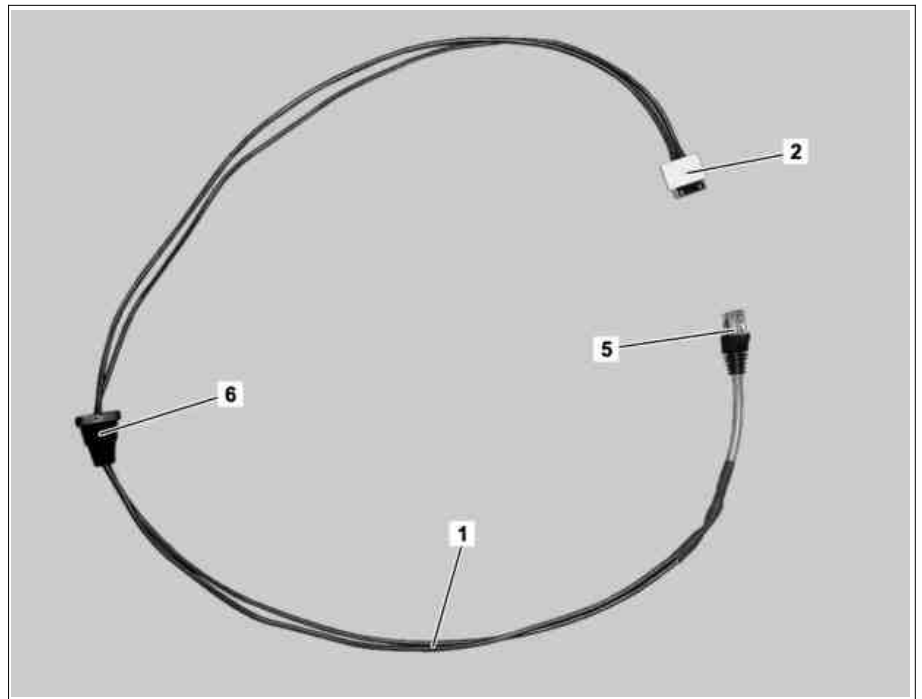
P82.60-4980-06

- 5 Route interface coupling (5) of iPod wiring harness (1) through drilled hole in glove compartment (4) into COMAND installation opening.
- 6 Seal hole with grommet (6).

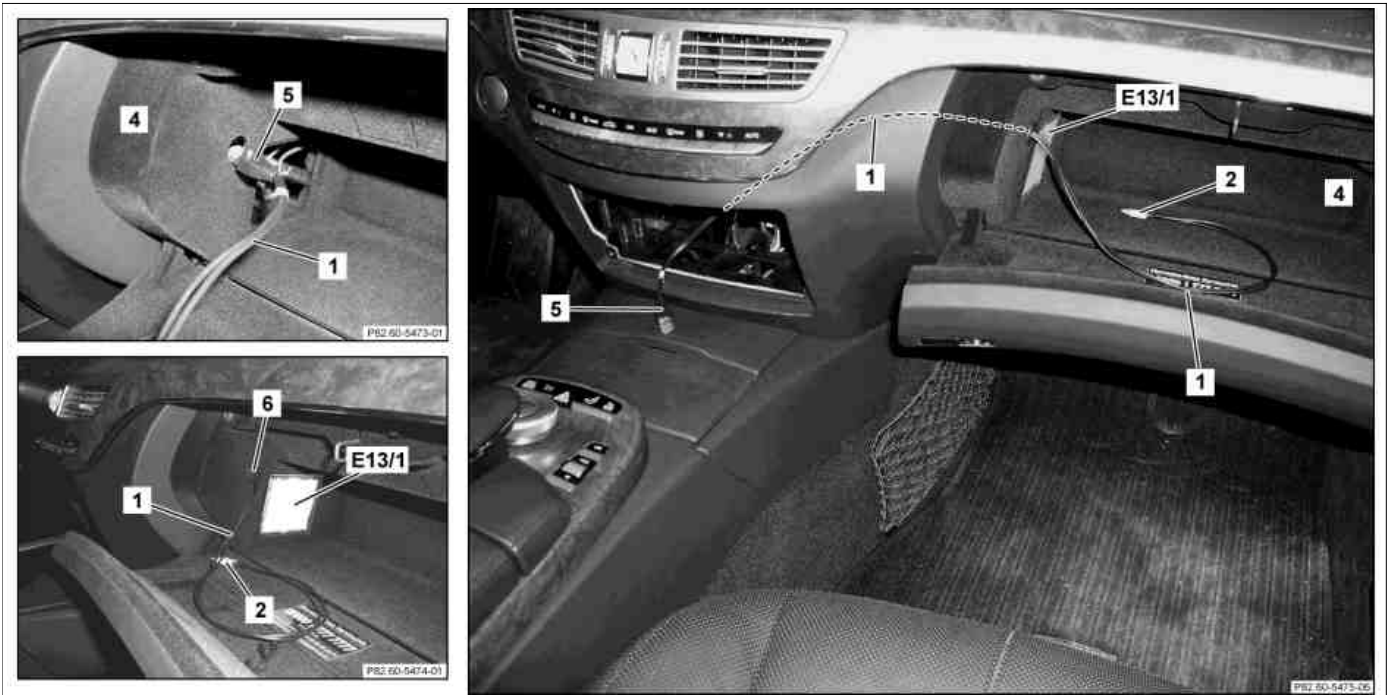
P82.60-5476-09

- 7 Reinstall glove compartment lamp (E13/1) in glove compartment (4).

i The iPod coupling (2) is later connected to the iPod. The interface connector (5) can be connected to the iPod interface later.
