MODEL 221.0 /1 as of 1.6.09

MODEL 221.0 /1 with CODE (800) Model year 2010

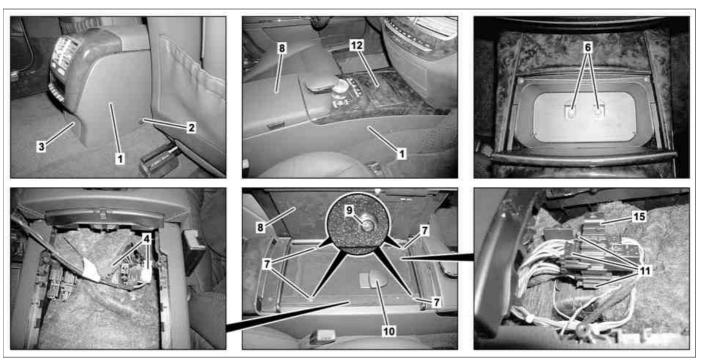
P68.20-4191-09

Shown on vehicle with code (582) Rear air conditioning

- Center console
- 2 Cap
- 3 Housing
- 4 Electrical connectors (with code (386) Preinstallation for cell phone telephone, UPCI system or with code (388) Cell phone telephone, UPCI system)
- 6 Bolts
- 7 Cover plug
- 8 Armrest lid
- 9 Screw

- 10 Contact plate
- 11 Electrical connectors
- 12 Front stowage compartment lid
- 15 Bracket

Shown on vehicle without code (582) Rear air conditioning

- 11 Electrical connectors
- 14 Maintenance flap

X	Remove/install		
1	Move front seats toward front to end position		
2	Remove rear paneling from center console		AR68.20-P-5169SX
3	Remove housing (3) for 12 V socket or rear ashtray		AR68.20-P-2420SX
4	Unclip cap (2) on both sides and unscrew bolts below	i Installation: Check mechanism of front ashtray for proper function, if necessary loosen threaded connection of center console (1) and tighten center console (1) without tension.	
5	Adjust front seats toward rear to end position		
6	Switch off ignition and withdraw transmitter key or Keyless Go start/stop button from the EIS [EZS] control unit	i Keyless Go start/stop button only for vehicles with code (889) Keyless Go.	
7	Open front stowage compartment lid (12)

Remove cupholder	On vehicles with code (310) Double front cup holder.	
Remove inserting device		
Remove bolts (6)	i Installation: Ensure that center console (1) is installed without tension.	
Open armrest lid (8) and unclip maintenance flap (14)	For vehicles without code (582) AC in rear.	
Open armrest cover (8) and remove cover plug (7) in stowage compartment and remove bolts (9)	For vehicles with code (582) Rear air conditioner.	
Lift up armrest lid (8) and disconnect electrical connector (4)	On vehicles with code (582) Air conditioning system in rear and code (386) Preinstallation for telephone "Cell phone" UHI system or code (388) Telephone "Cell phone" UHI [Universal Portable Cell Phone Interface system].	
Remove armrest lid (8)	For vehicles with code (582) Rear air conditioner.	
Unlock bracket (15) of electrical wiring harness and pull out upwards	For vehicles with code (582) Rear air conditioner.

Expose electric wiring harness in center console (1) and disconnect electrical connectors (11)	i Number of electrical connectors (11), if equipped.	
Lift up rear center console (1) and remove from vehicle	i Aid of helper required.	
Install in the reverse order		
	Remove inserting device Remove bolts (6) Open armrest lid (8) and unclip maintenance flap (14) Open armrest cover (8) and remove cover plug (7) in stowage compartment and remove bolts (9) Lift up armrest lid (8) and disconnect electrical connector (4) Remove armrest lid (8) Unlock bracket (15) of electrical wiring harness and pull out upwards Expose electric wiring harness in center console (1) and disconnect electrical connectors (11) Lift up rear center console (1) and remove from vehicle	Remove inserting device Remove bolts (6) Den armrest lid (8) and unclip maintenance flap (14) Open armrest cover (8) and remove cover plug (7) in stowage compartment and remove bolts (9) Lift up armrest lid (8) and disconnect electrical connector (4) Remove armrest lid (8) Children arms lid (8) For vehicles with code (582) Air conditioning system in rear and code (386) Preinstallation for telephone "Cell phone" UHI system or code (388) Telephone "Cell phone" UHI [Universal Portable Cell Phone Interface system]. Remove armrest lid (8) For vehicles with code (582) Rear air conditioner. Conditioner. For vehicles with code (582) Rear air conditioner.
