MODEL 221.0

**Front door**

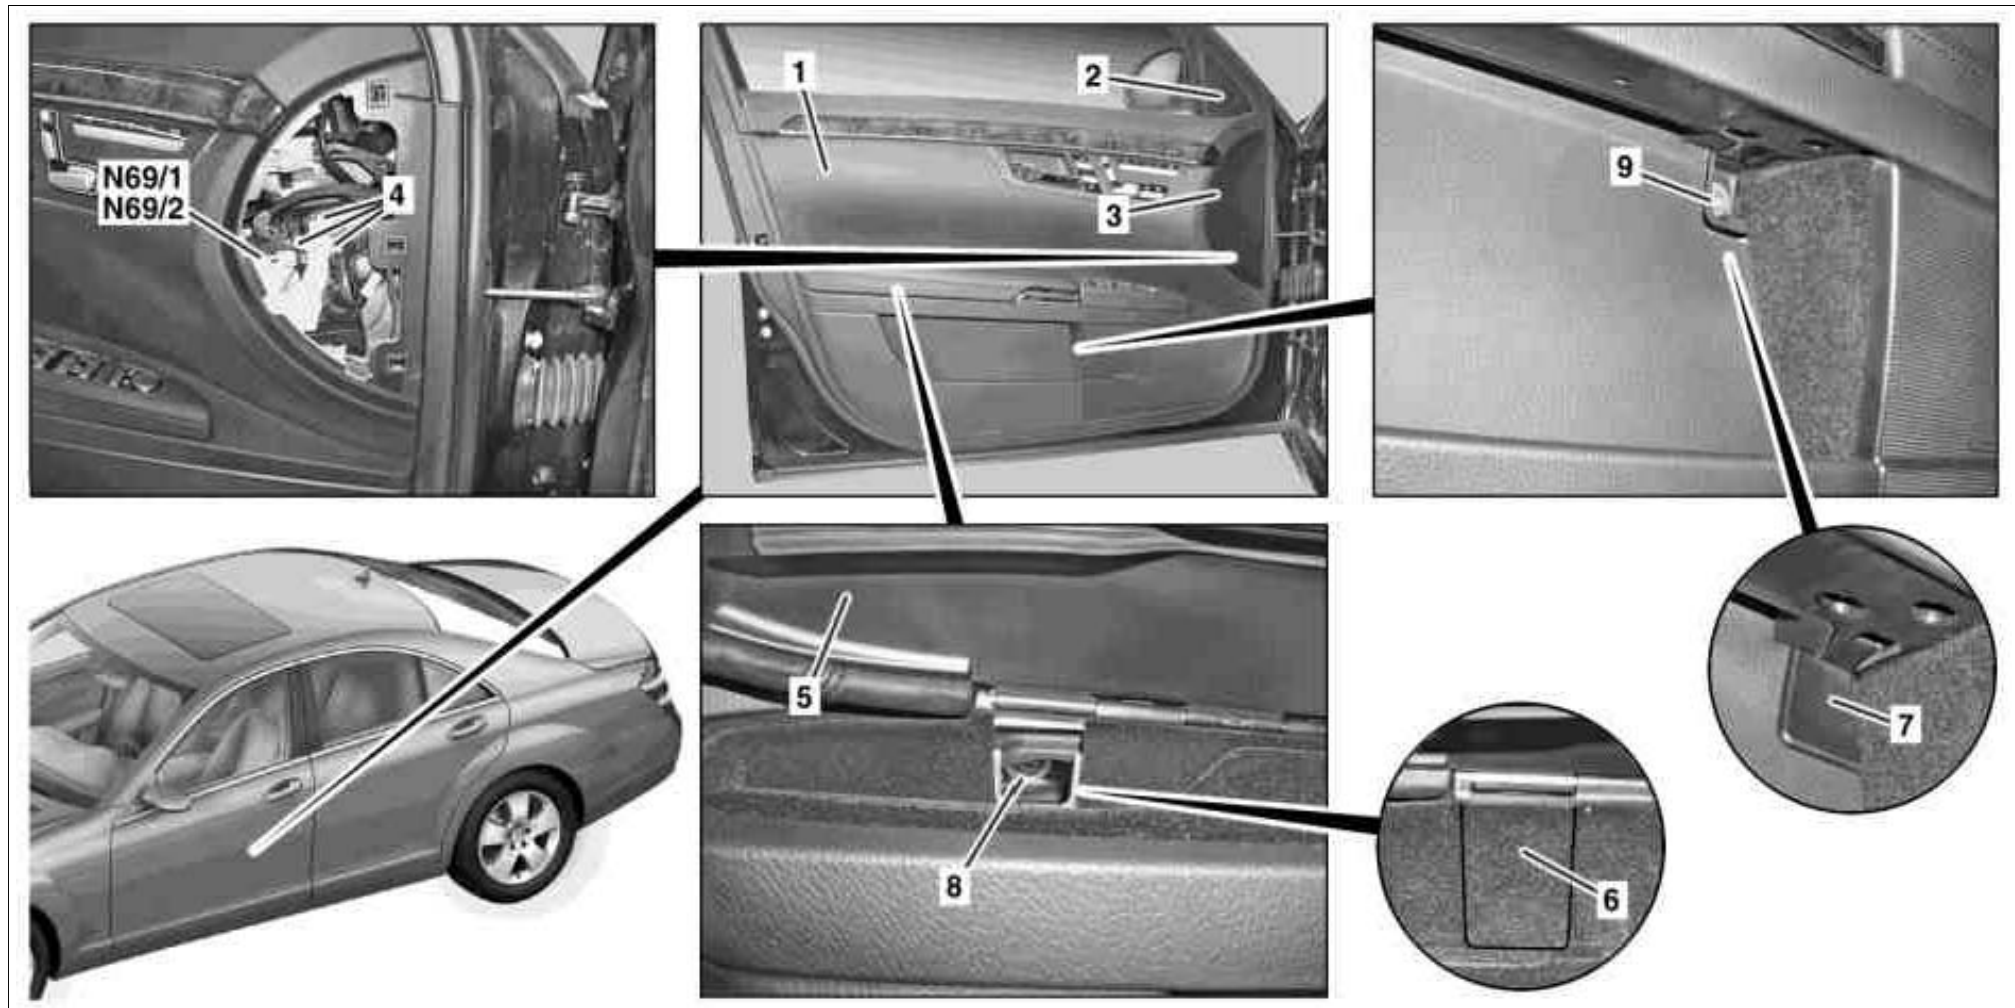
P72.10-3240-09

- 1 Door lining
 2 Mirror triangle cover
 3 Cover
 4 Connector

- 5 Armrest
 6 Cap
 7 Cap
 8 Bolt

- 9 Bolt

- N69/1 Door control unit front left
 N69/2 Door control unit front right

Remove/install		
1	Wind crank window fully down		
2	Loosen mirror triangle cover (2) and lay down to side with line connected.

*115589035900
3	Remove cover (3) from door lining (2)

*115589035900
4	Disconnect connector (4) from left front door control module (N69/1) or right front door control module (N69/2)		
5	Open armrest (5).		
6	Slide cover (6) upward and remove		
7	Unclip covering (7)		
8	Unscrew bolts (8, 9)

Installation: Apply screw securing agent to bolt threads (8, 9).

9	Press door lining (1) on mounting clips off of inner door panel

Move long wedge directly onto each mounting clips and ensure that retaining lugs on mounting clips do not tear out of door lining (1).

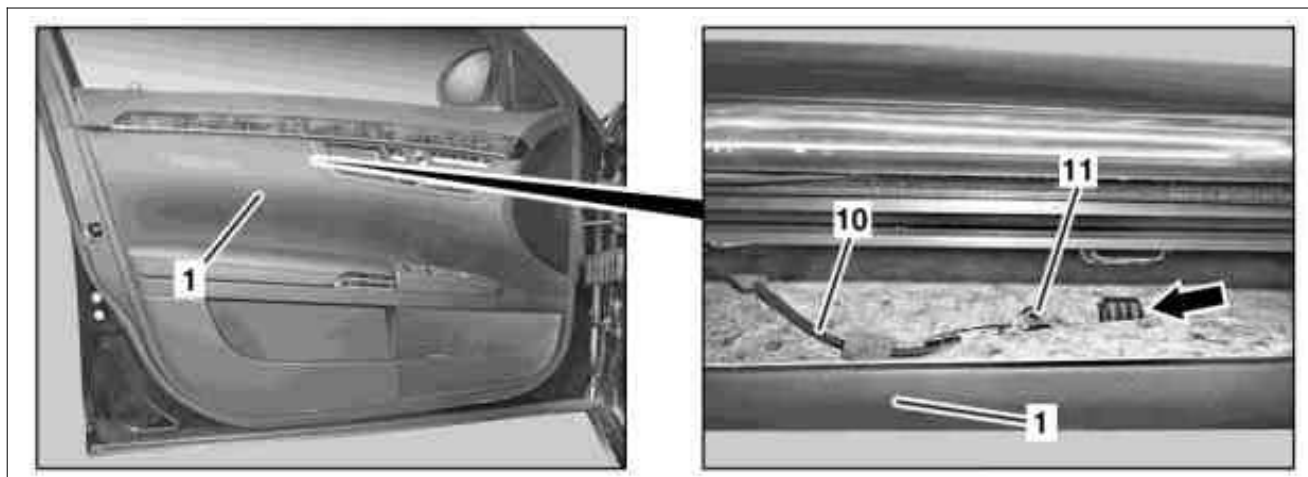
P72.10-3241-04

- 1 Door lining
- 10 Bowden cable
- 11 Door opener

*115589035900
10	Remove door lining (1) upward out of guide (arrow) until Bowden cable (10) is accessible.		
11	Unhook Bowden cable (10) from inner door opener (11)		
12	Remove door lining (1)		
13	Install in the reverse order
