MODEL 221.0

MODEL 221.1 except CODE (Z07) Top protection

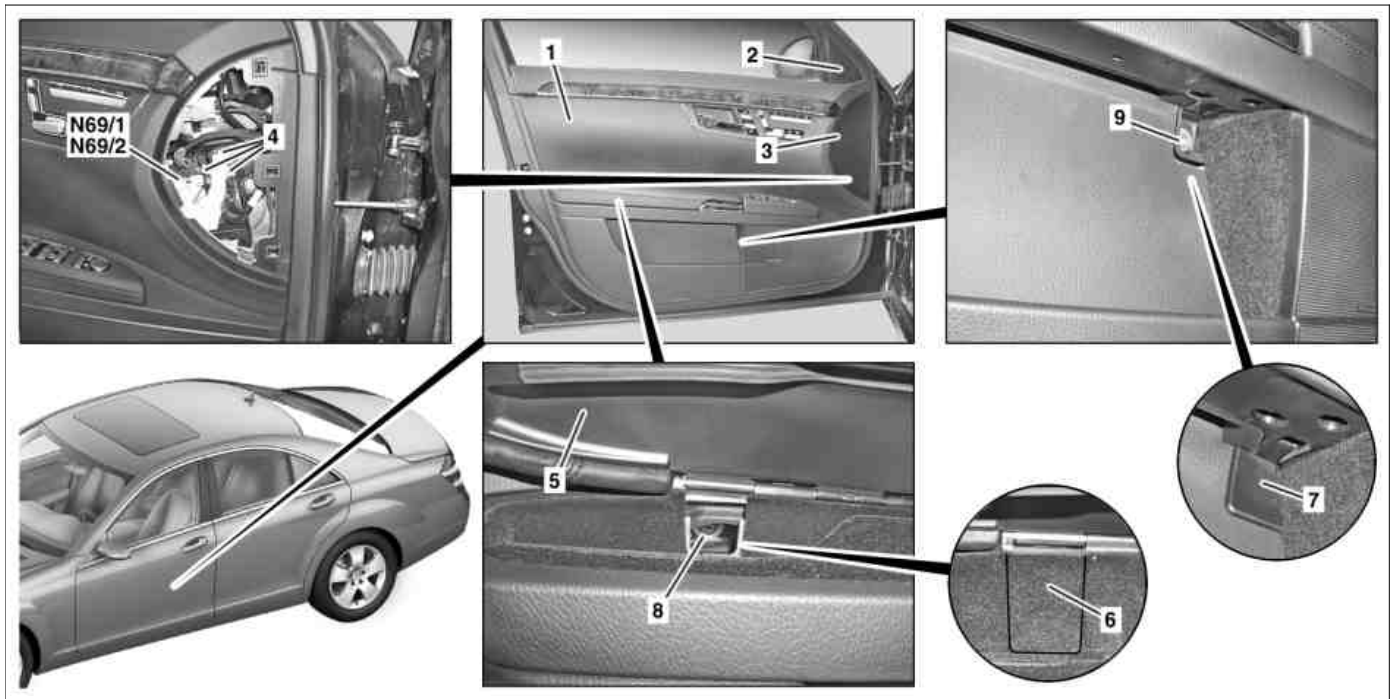
P72.10-3240-09

- 1 Door lining
- 2 Mirror triangle cover
- 3 Cover
- 4 Connector

- 5 Armrest
- 6 Cap
- 7 Cap
- 8 Bolt

- 9 Bolt
- N69/1 Door control unit front left
- N69/2 Door control unit front right

Remove/install		
1	Wind crank window fully down		
2	Loosen mirror triangle cover (2) and lay down to side with line connected.

*115589035900
3	Remove cover (3) from door lining (2)

*115589035900
4	Disconnect connector (4) from left front door control module (N69/1) or right front door control module (N69/2)		
5	Open armrest (5).		
6	Slide cover (6) upward and remove		
7	Unclip covering (7)		
8	Unscrew bolts (8, 9)

Installation: Apply screw securing agent to bolt threads (8, 9).

Loctite 262	*115589035900 *BA72.10-P-1009-01Q *BR00.45-Z-1059-02A
9	Press door lining (1) on mounting clips off of inner door panel

Move long wedge directly onto each mounting clips and ensure that retaining lugs on mounting clips do not tear out of door lining (1).

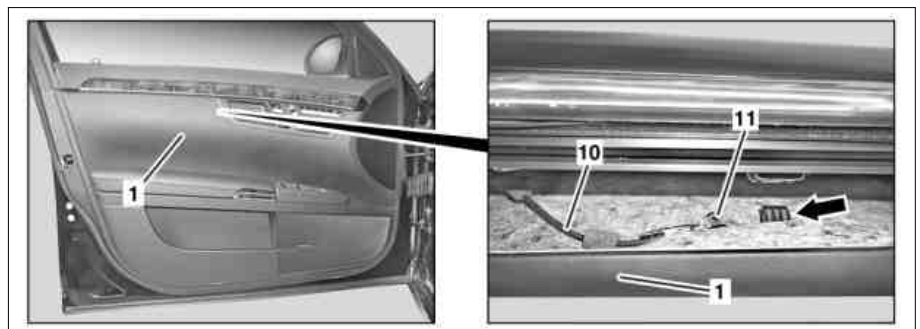
P72.10-3241-04

- 1 Door lining
- 10 Bowden cable
- 11 Door opener

10	Remove door lining (1) upward out of guide (arrow) until Bowden cable (10) is accessible.		
11	Unhook Bowden cable (10) from inner door opener (11)		
12	Remove door lining (1)		
13	Install in the reverse order
