#### Model 222.0/1

#### **Modification notes**

24.08.2017 Remove speaker cover and seat belt guide/trim.

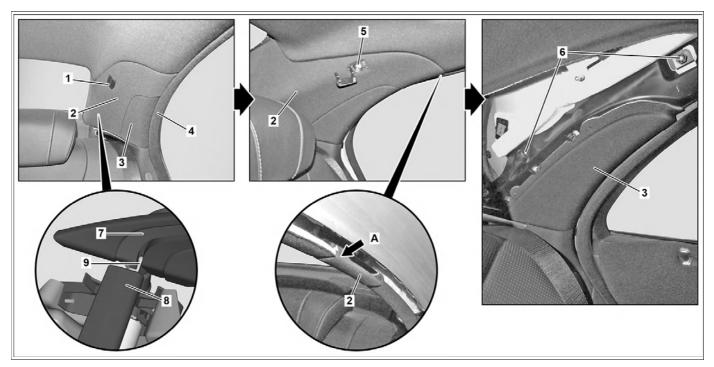
P68.30-3684-09

## Shown on model 222.1 with code Z07 (Top protection)

- 1 Cover
- 2 C-pillar paneling top section
- 3 C-pillar paneling bottom section
- 4 Edge guard
- 5 Nut

- 6 Buckle clamp
- 7 Guide rail
- 8 Roller sun blind
- 9 Pin

Note on functional reliability of windowbag		AH91.60-P-0693-01A
XX	Remove/install		
1	Remove edge guard (4) in area of C-pillar trim		
2	(2, 3) Unclip cover (1)

3.1	Unscrew nut (5)	Model 222.0/1	
3.1	Onsciew nut (3)	except code Z07 (Top protection)	
		Nml Nut/screw, trim bracket to C-pillar	*BA68.30-P-1002-01E
3.2	Remove screw (14) under cover (1)	Model 222.0/1 with code Z07 (Top protection)	
		Nm Nut/screw, trim bracket to C-pillar	*BA68.30-P-1002-01E
4	Unclip guide rail (7) from C-pillar paneling top section (2)	Model 222.0/1	
		with code 540 (Electric sunblind for rear window) except code Z07 (Top protection)	
		(arrow B), turn 90° and unclip guide rail (7) from top downward. Guide rail (7) is hooked	
		into C-pillar paneling top section (2) at bottom.	
		li Installation: Ensure that pin (9) on roller blind (8) is seated correctly in guide rail (7). Ensure that guide rail (7) is seated correctly.	
		S Extraction hook	*140589023300
5	Lever retainer (arrow A) of C-pillar trim upper section (2) over roof lining (10)		
6	from C-pillar trim upper section (2)	Model 222.0/1 with code Z07 (Top protection)  Slightly press in spring clip (13), guide rive

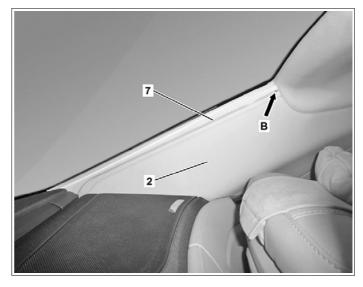
P68.30-3722-11

## Shown on model 222.1 without code Z07 (Highest protection)

- 2 C-pillar paneling top section
- 7 Guide rail

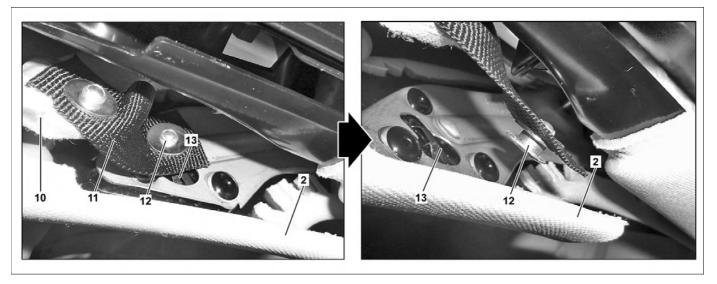
P68.30-3721-08

## Shown on model 222.1 with code Z07 (Top protection)

- 2 C-pillar paneling top section
- 10 Headliner
- 11 Check strap

- 12 Rivet
- 13 Spring clip

(12) together with check strap (11) out of opening.	
		Installation: Ensure that check strap (11) and rivet (12) are seated correctly.	
7	Unclip speaker cover (17) in upward direction		
8	Unclip seat belt guide trim element (15) and allow to hang down		
9	Unclip seat belt retractor cover (16)		
10	Unclip C-pillar paneling top section (2) along rear window		
11	Remove C-pillar paneling top section (2) in direction of travel		
12	Unscrew buckle clamps (6)	Model 222.0/1 except code Z07 (Top protection)  i Installation: Replace buckle clamps (6).	
13	Remove C-pillar trim lower section (3)	i Carefully swivel C-pillar trim lower section (3) toward front. Side trim in rear is connected via a pin with C-pillar trim lower section (3).  i Installation: Before assembly, install new strap buckles (6) on C-pillar trim lower section (3).	
14	Install in the reverse order

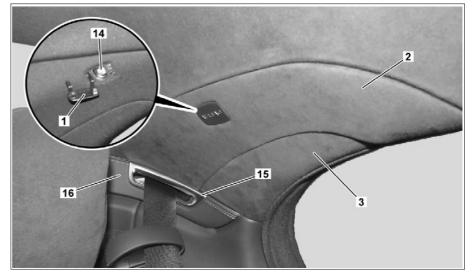
P68.30-4017-05

# Shown on model 222.1 with code Z07 (Top protection)

- 1 Cover
- 2 C-pillar paneling top section
- 3 C-pillar paneling bottom section
- 14 Screw
- 15 Seat belt guide trim element
- 16 Seat belt retractor cover

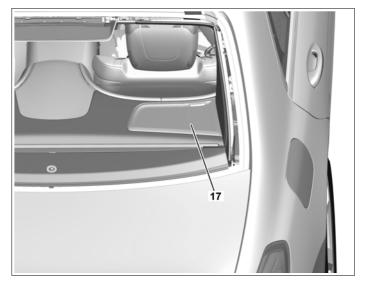
P82.62-4700-11

### 17 Speaker cover
