TRANSMISSION 722.6 in MODEL 211.0 /2

X	Removing, installing		
1	Remove key from electronic ignition switch (EIS)	Vehicles with Keyless Go code 889: Press start/stop button repeatedly until the ignition is switched off.	
2	Move front passenger seat to rearmost position		
3	Remove floor mat and fold back floor covering (1) in passenger footwell		
4	Remove impact absorber (2)		
5	Unscrew nuts (3) and fold over step plate (4)		
6	Unscrew bolts (5)		
7	Remove ETC control unit (N15/3) in direction of arrow		
8	Unplug electrical connectors (6, 7)	i Press detent (8) of connector lock.	
9	Install in the reverse order		
10	Read out fault memory with STAR DIAGNOSIS and erase if necessary	Diagnostic system STAR DIAGNOSIS	*WH58.30-Z-1048-13A
		erased in the faults must be processed and erased in the fault memories after completing the work. The stored faults may result from faulty components, removal and installation work or cables disconnected during test operations or from a simulation.

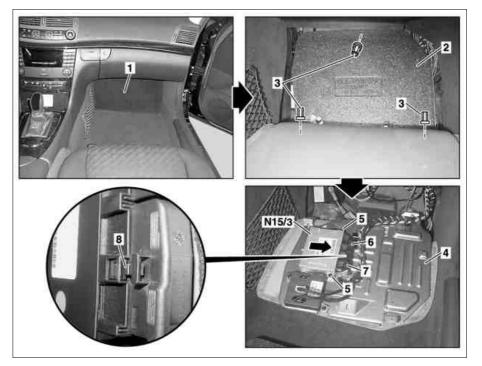
P27.19-2102-06

Floor covering

2 Impact absorber

3 Nut

4 5 6 Step plate

Bolt

Electrical connector

7 8 Electrical connector Detent

N15/3 ETC control unit
